# PREVENTIVE MAINTENANCE OF LONG-SPAN BRIDGES OF HONSHU-SHIKOKU BRIDGE EXPRESSWAY

The Honshu-Shikoku Bridge Expressway (HSBE) has 17 long-span bridges located over straits where environment is very harsh. In order to keep these bridges in sound state for more than 200 years, the Honshu-Shikoku Bridge Expressway Company Limited (the company) is conducting maintenance based on the concept of the preventive maintenance. This paper describes the idea of preventive maintenance and each maintenance element of the HSBE.

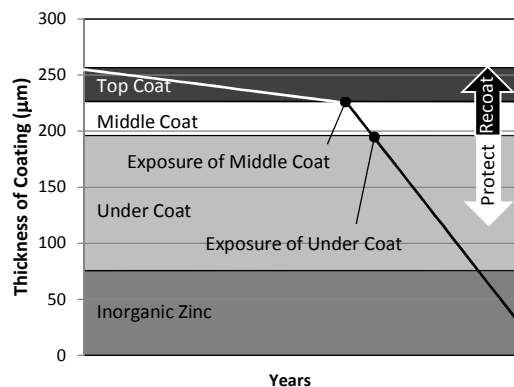
**Figure 7** Consumption of Coating

Recoating policy restricts recoating layers to deteriorated top and intermediate coats, keeping the inorganic zinc-rich paint in a sound state (Figure 7). This is because the recoating of the entire coat requires on-site blasting that is disadvantageous in terms of quality control, cost, and environment. In early recoating, fluorine resin paint was used as top coat. After 10 years of research, highly durable fluorine resin paint that has higher durability than existing top coat was developed and has been utilized for recoating since 2010.

In order to grasp the optimum recoating cycle, i.e., the timing when the top and middle coats disappears, consumption rate of coating must be understood with satisfactory accuracy. Since visual observation is not sufficient for this purpose, fixed observation points were set up on the existing bridges. At these points, thickness, glossiness, and adhesion of coating are tracked periodically. From the past results, measured consumption rates were found to be smaller than those initially estimated. Since the prolongation of recoating cycle significantly reduces LCC, the company is trying to improve the estimation accuracy by increasing the number of observation points.

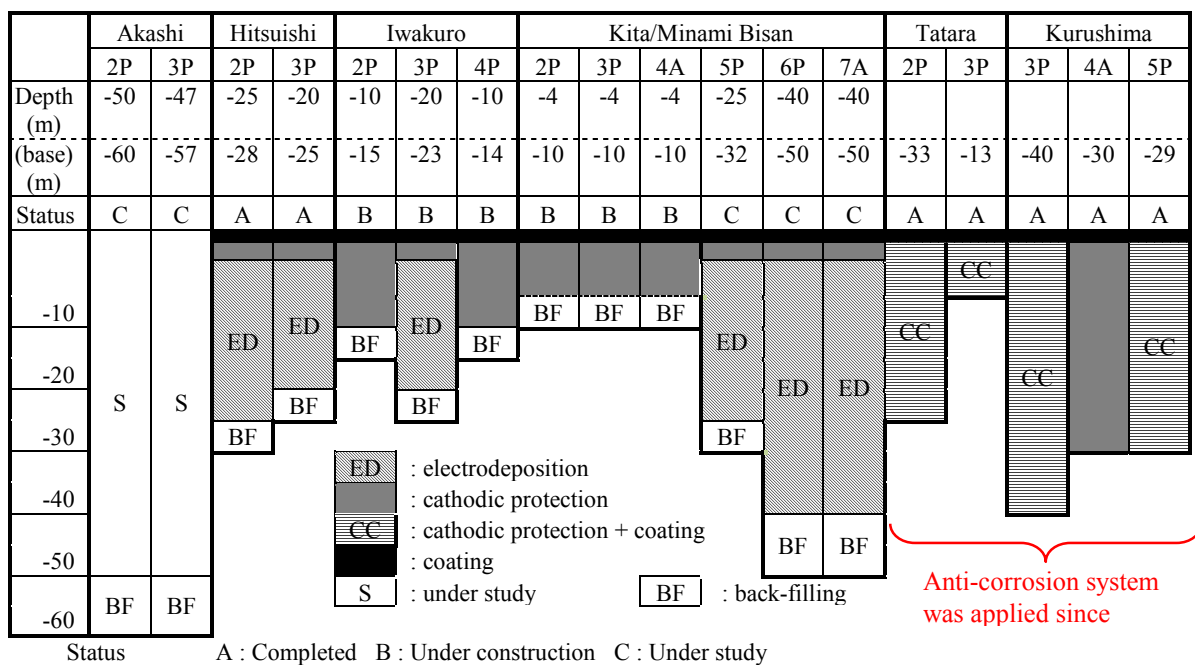
**Figure 13** Anticorrosion Measures for Steel Caissons of HSBE's Long-Span Bridges

On the other hand, since the splash zone and tidal zone are not always in the seawater, the ED method is not applicable. For these zones, an anticorrosion measure with coating system which is applicable to wet surface is selected. In order to long-lasting stable coating, rust on the surface of the steel caissons must be removed completely by blasting. Furthermore, at the boundary of each method, neither ED film nor coating may be applied and it becomes weak point. Therefore, for this boundary, cathodic protection method was applied with aluminum alloy anodes.

For shallow foundations, since the ED facility may be excessive and uneconomical, cathodic protection method was selected for under water zone. And for deep foundations, safe and economical method has to be studied because the application is considered to be difficult by the current ED facility.

Anticorrosion measures for the steel caissons is summarized in Figure 13.

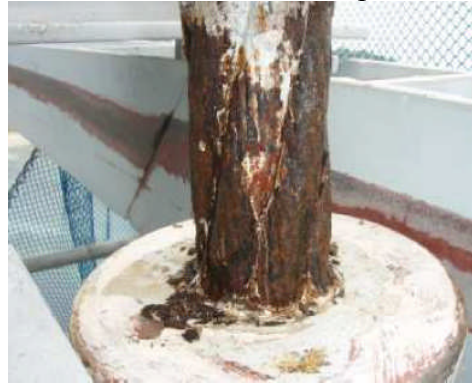
**Photo 4** Corrosion of Suspender Rope Near Anchorage (Ohnaruto Bridge)

Out of HSBE's 10 suspension bridges, 7 use center fit wire rope core (CFRC) ropes for suspender ropes (Figure 14, 15). Although each wire is galvanized and external surface of the rope is coated with polyurethane paint, corrosion was occasionally observed in these ropes (Photo 4). As shown in Figure 14, CFRC has void inside. Intrusion of water induces corrosion in this member.

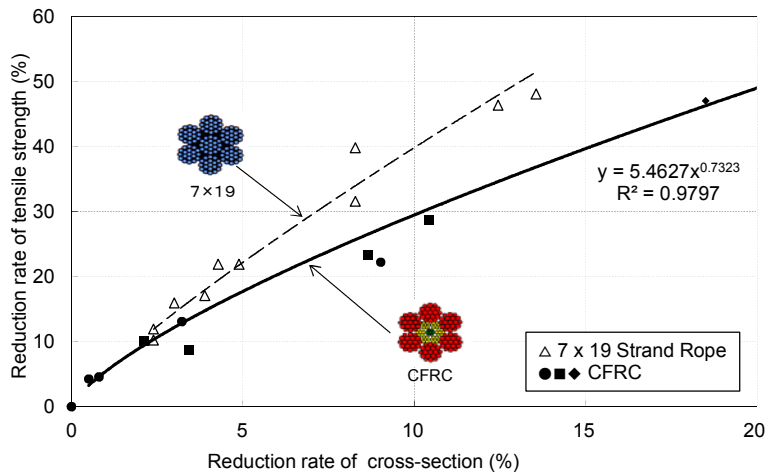
**Figure 16** Relation Between Reduction of Cross Section and Reduction of Tensile Strength

In order to evaluate remaining strength of the corroded suspender ropes, some ropes were removed and tested. Figure 16 shows relation between the reduction of the cross section and the reduction of the tensile strength. From the test, if the reduction of the cross

section reaches 20%, the remaining strength becomes half of that of the intact ropes.

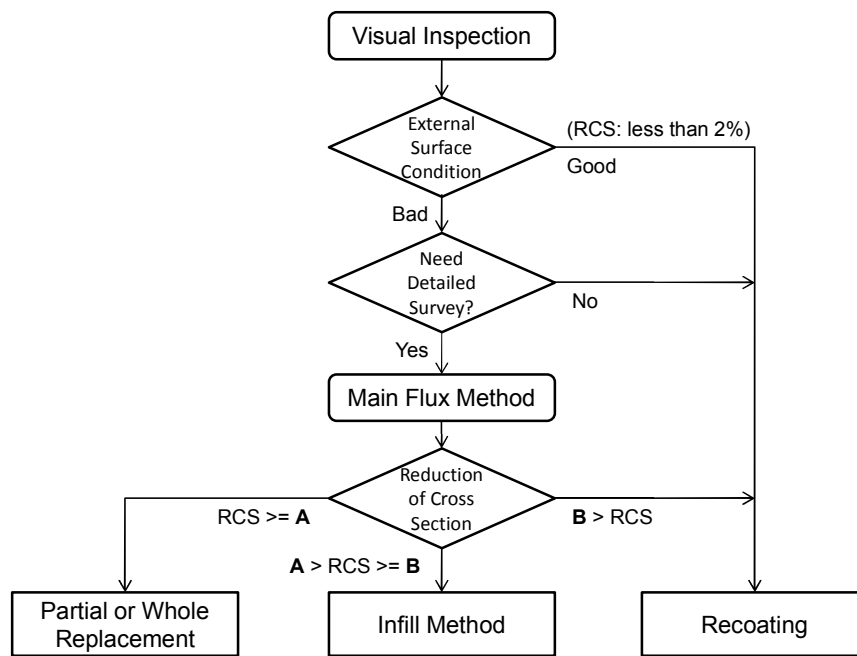
**Figure 18** Maintenance Flow of CFRC Suspender Rope

Figure 18 shows a maintenance flow of CFRC suspender ropes. If the corrosion state of the external surface by visual inspection is slight, recoating method is selected. If it requires detailed survey, reduction ratio of cross section is measured by the main flux method. If the ratio is less than B (5%), recoating method is selected. Threshold A is defined to keep safety factor (SF) of 3.0 considering measured tensile force of ropes. Since some bridges are designed with much larger loads, they have large safety margin. Therefore, A varies with each bridge. If the ratio is larger than A, the rope is replaced partially or wholly depending on the length of the rope. If the ratio is between A and B, infill method is selected. Infill method is to inject anticorrosive agent into the void of the rope. Through the investigation, petrolatum paste is found to be the best material.

A: 10 - 20%, B: 5%

\*RCS = reduction ratio of cross section
