# Sediment-related disasters and sabo-related facilities

- 「The 2011 off the Pacific Coast of Tohoku Earthquake」  
(March 11<sup>th</sup> 2011)
- 「The Northern Nagano Prefecture Earthquake」  
(March 12<sup>th</sup> 2011)
- 「Fukushima Prefecture Hamadori Earthquake」  
(April 11<sup>th</sup> 2011)

○Erosion and Sediment Control Division, Research Center for Disaster Risk Management, National Institute for Land and Infrastructure Management

○Erosion and Sediment Control Research Group, Public Works Research Institute

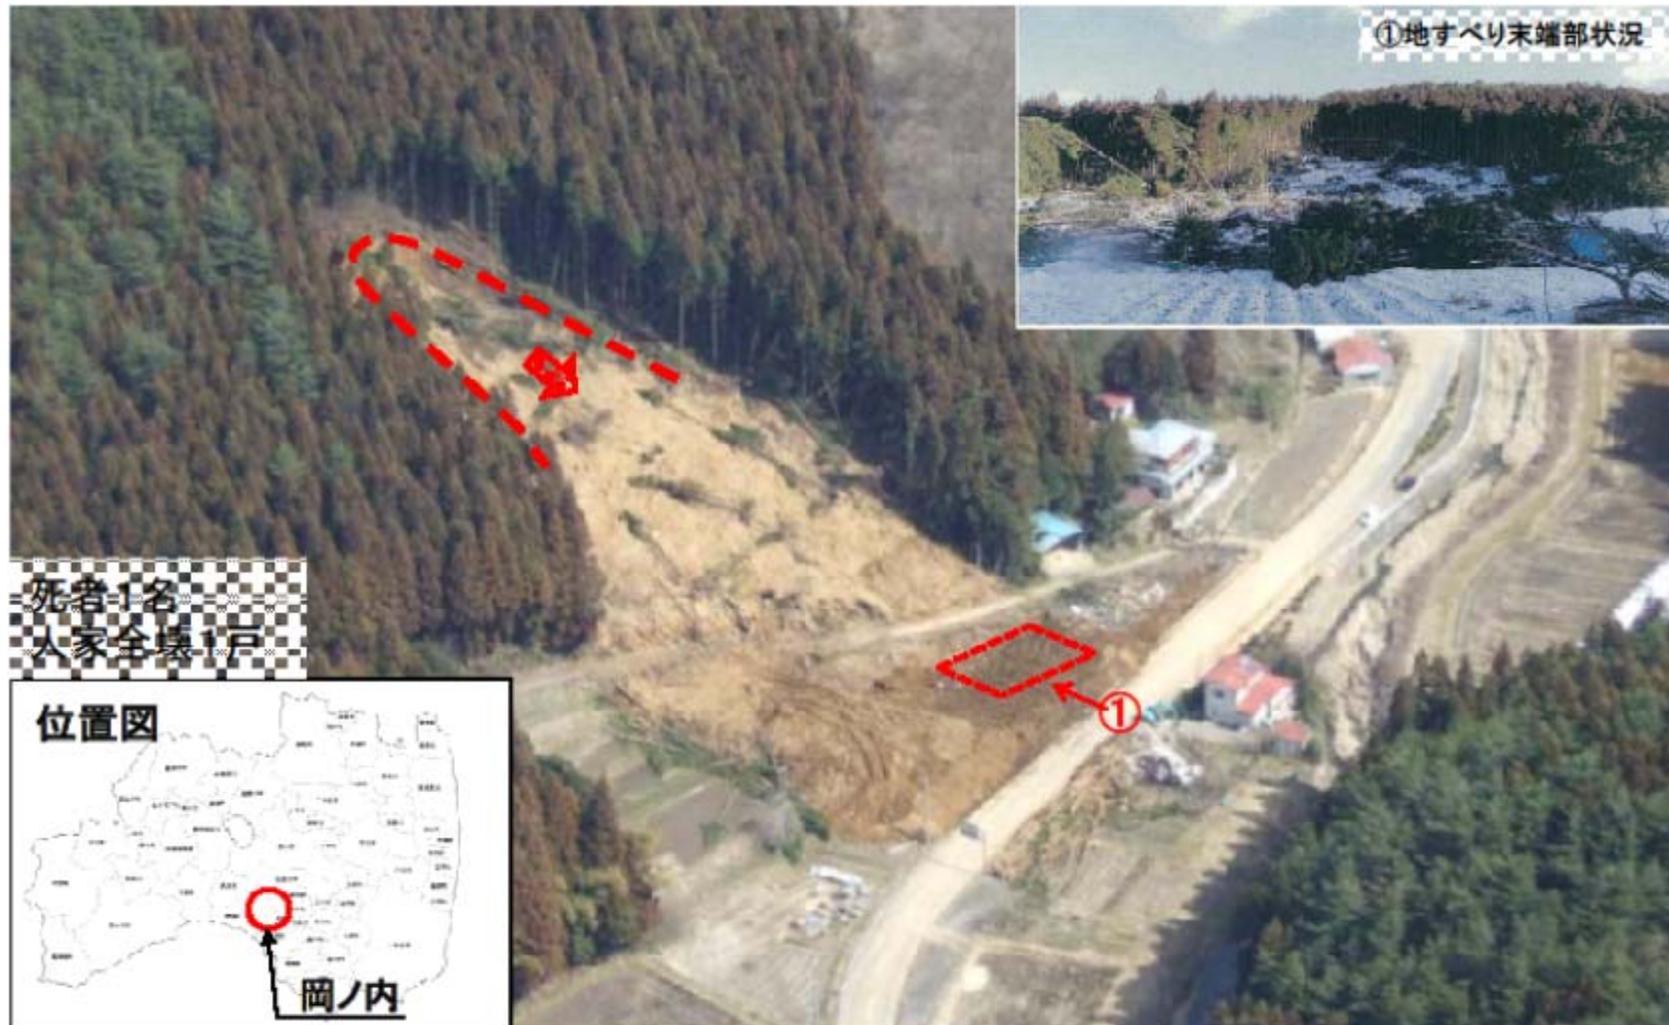
# Landslide destroyed 1 house and caused 1 death in Taishin-Kumado (Okanouchi) area in Shirakawa City, Fukushima Prefecture

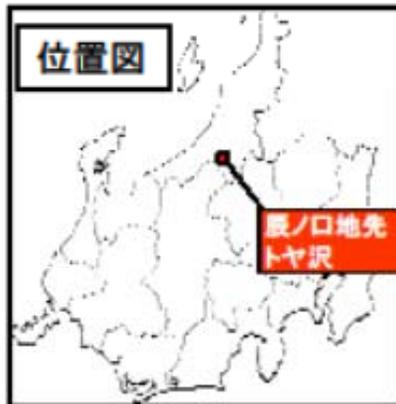
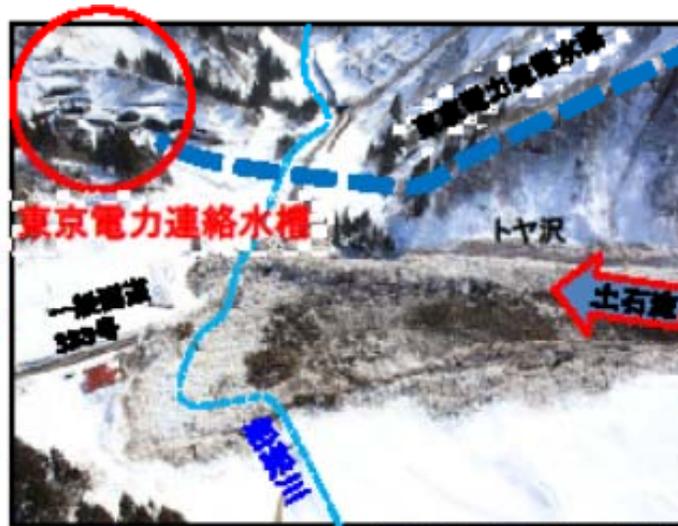
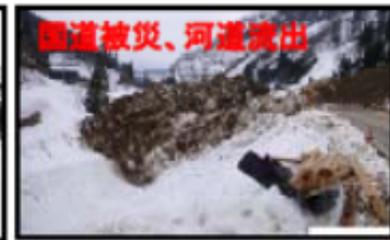
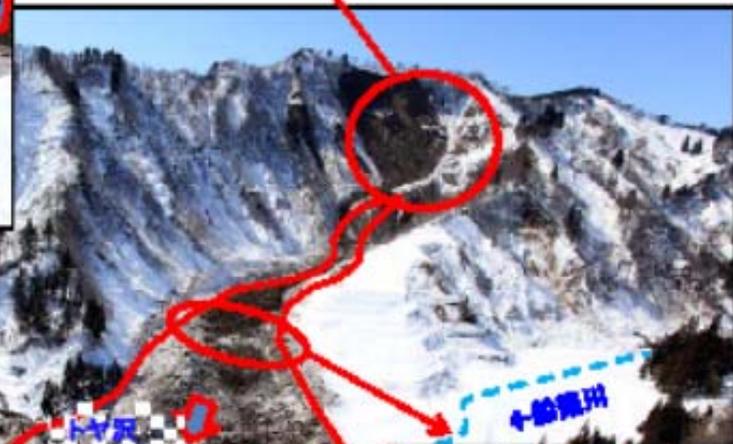
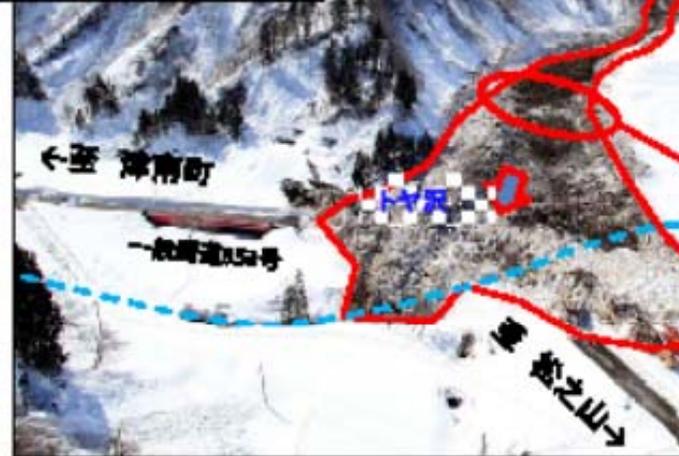
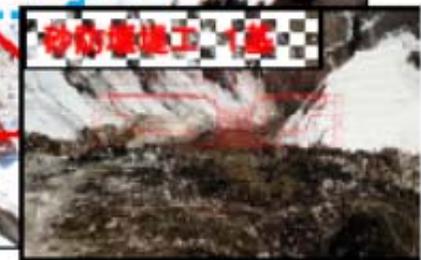
# Debris flow disaster at Tatsunokuchi area in Tsunan Town, Niigata Prefecture caused by the Northern Nagano Prefecture Earthquake on March 12<sup>th</sup> 2011

- 被害状況
- ・発生日時：3月12日
  - ・災害原因：長野県北部の地震  
(地点最大震度：6弱)
  - ・被害：国道353号、倉庫2棟  
全壊
- 対策工により守られる保全対象
- ・国道158号、宿泊施設1棟
  - ・水力発電関連施設

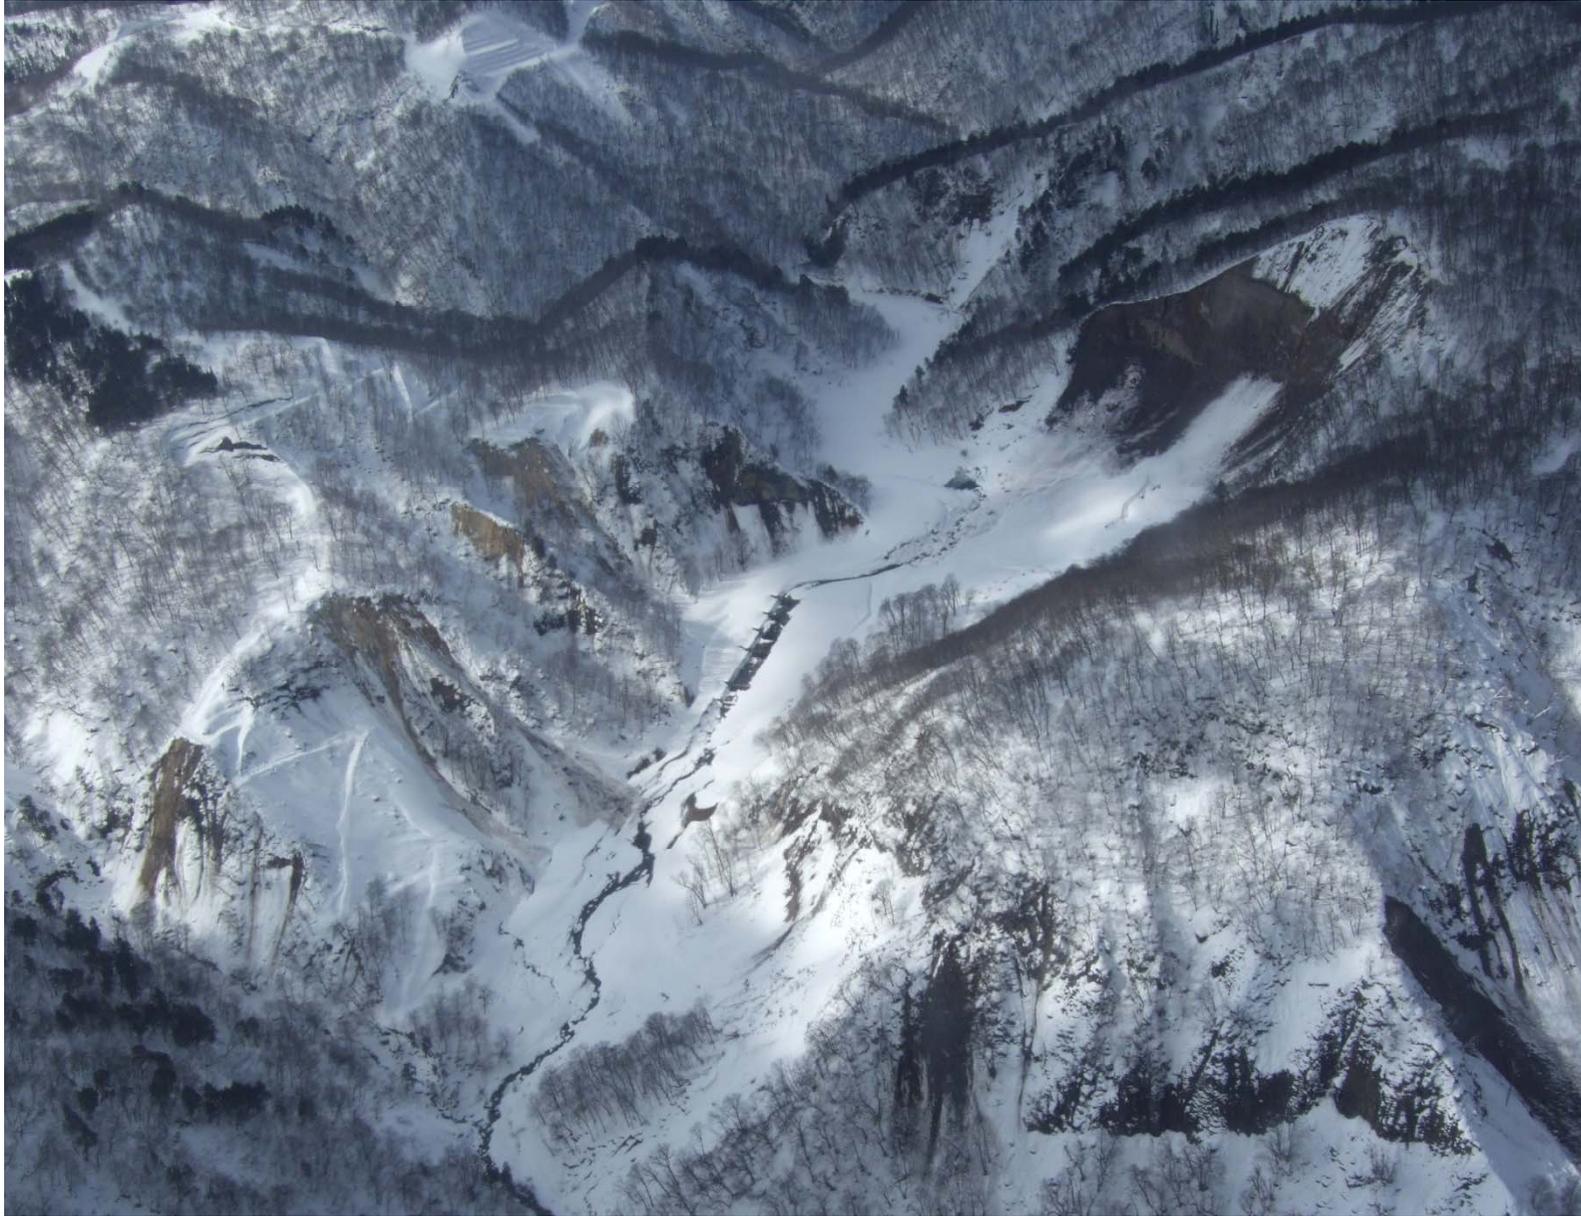
○ No large deformation was observed for the landslide dams generated by the Iwate-Miyagi Nairiku Earthquake in 2008 and the Mid Niigata Prefecture Earthquake in 2004

**Picture of landslide dam site (Yubama area in Miyagi Prefecture) caused by the Iwate-Miyagi Nairiku Earthquake in 2008**  
(The surface of the landslide slope in 2008 was thinly collapsed)

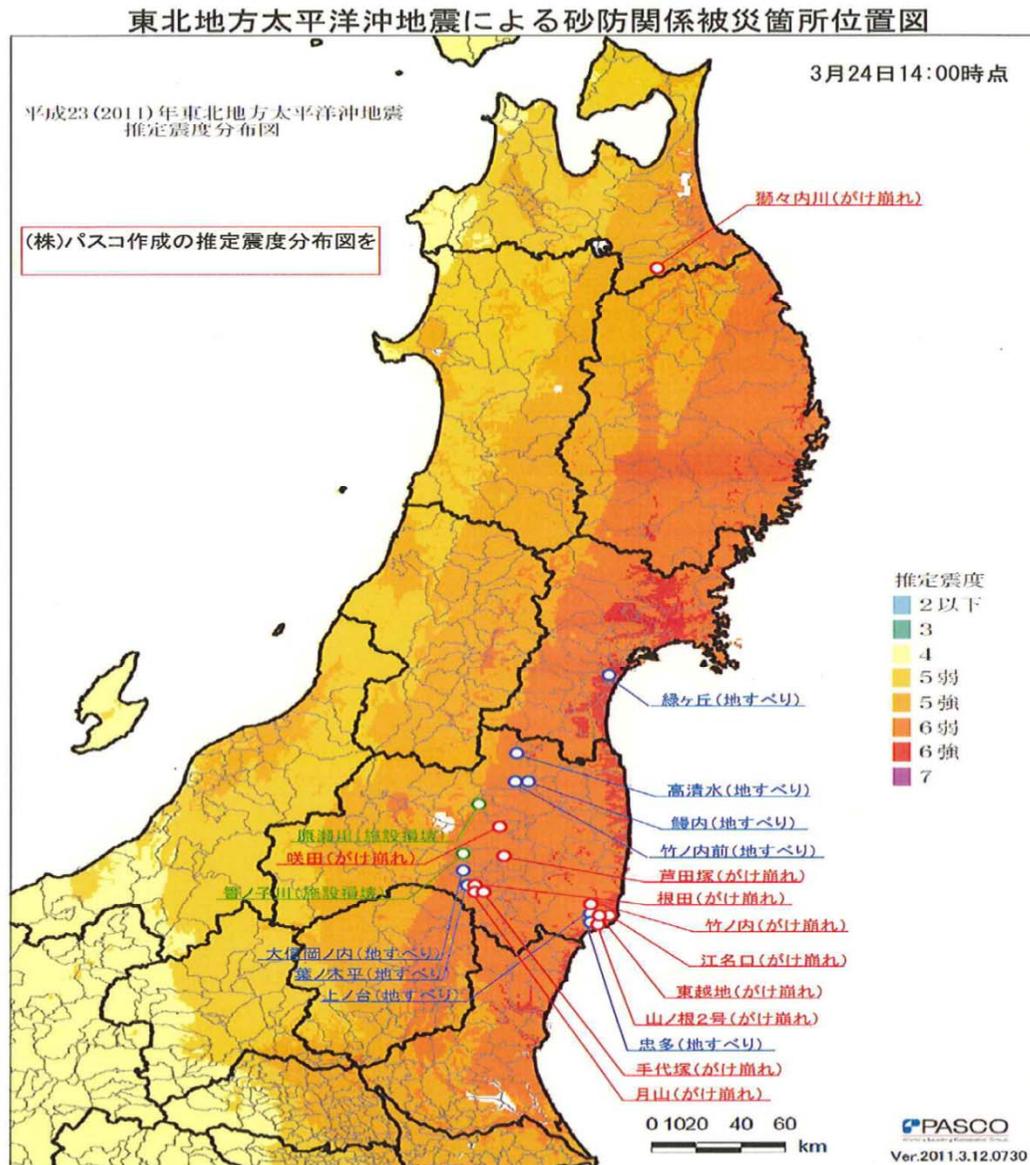
2. The density of sediment-related disasters did not necessarily correspond to the seismic intensity distribution

# Location of sediment-related disasters as of 14:00 on March 24<sup>th</sup> 2011 (based on disaster reports)

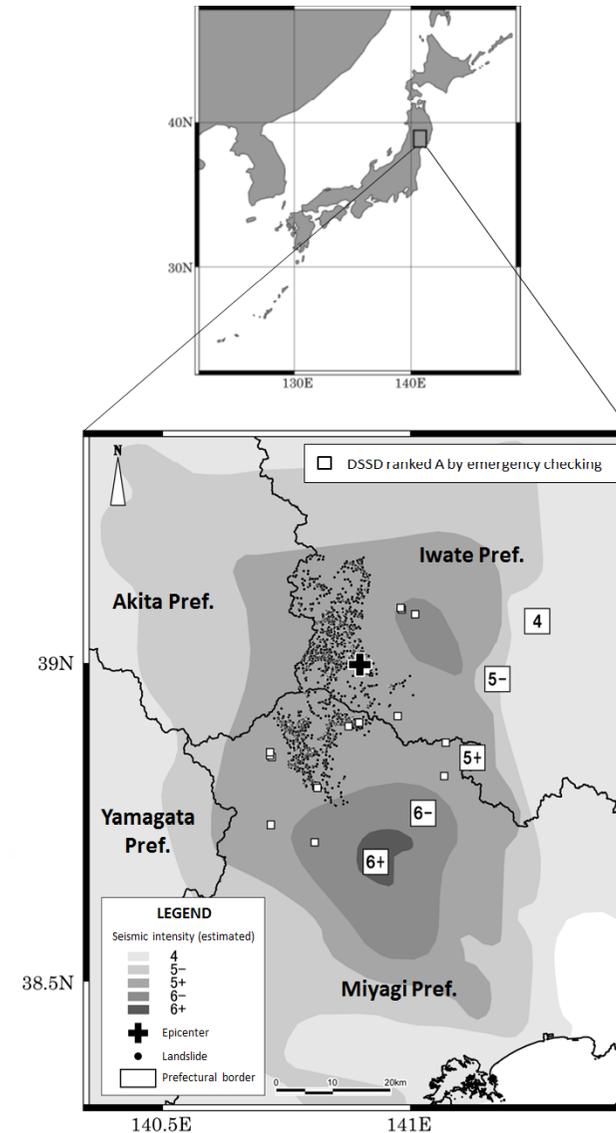
(The Iwate-Miyagi Nairiku Earthquake in 2008 caused approximately 3,500 landslides)

# Location of landslides caused by the Iwate-Miyagi Nairiku Earthquake in 2008

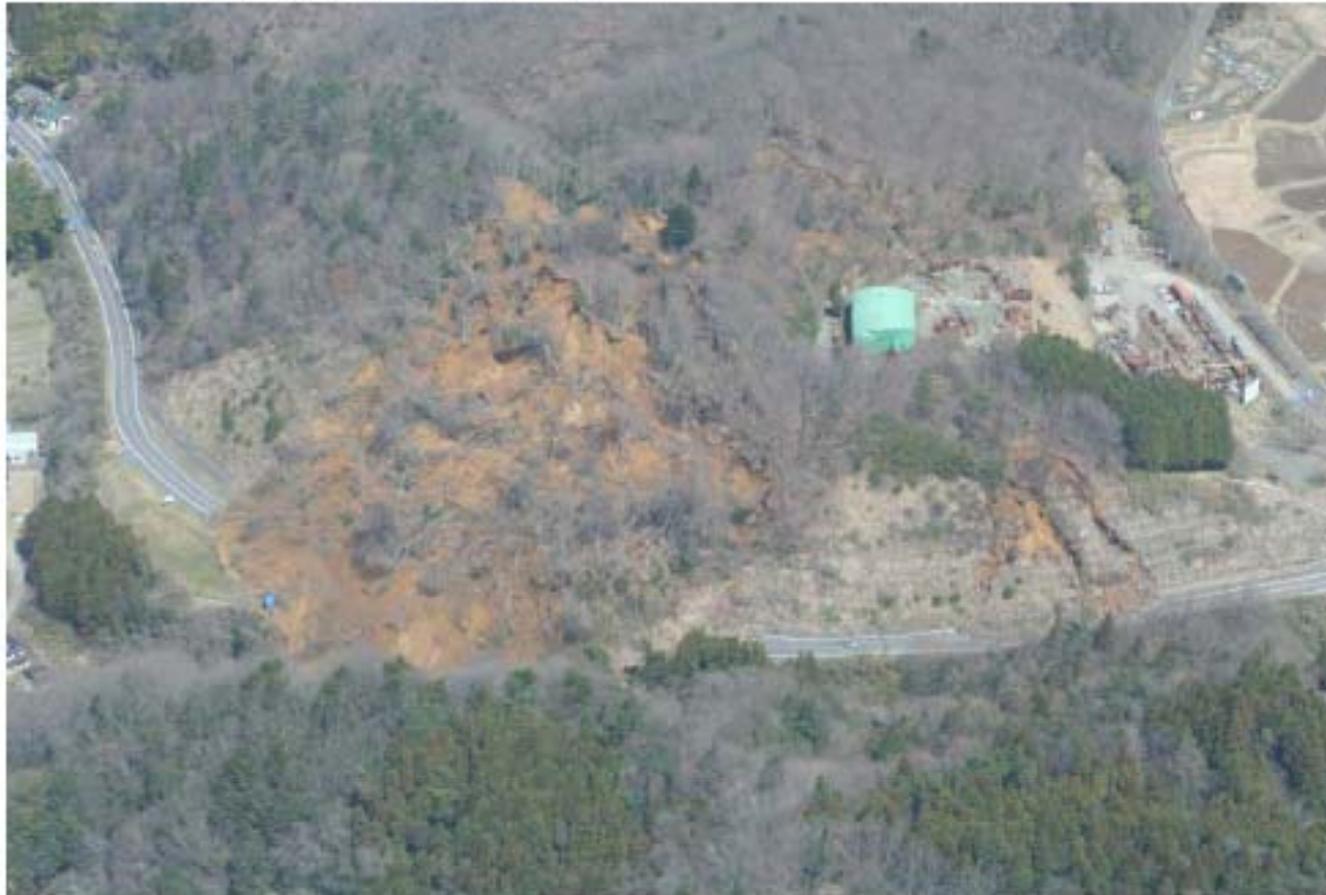
④いわき市常磐藤原町（県道14号）

**Landslide in Joban-Fujiwara, Iwaki City, Fukushima Prefecture (height: 100 m, width: 120 m) blocked the Prefectural Highway 14**

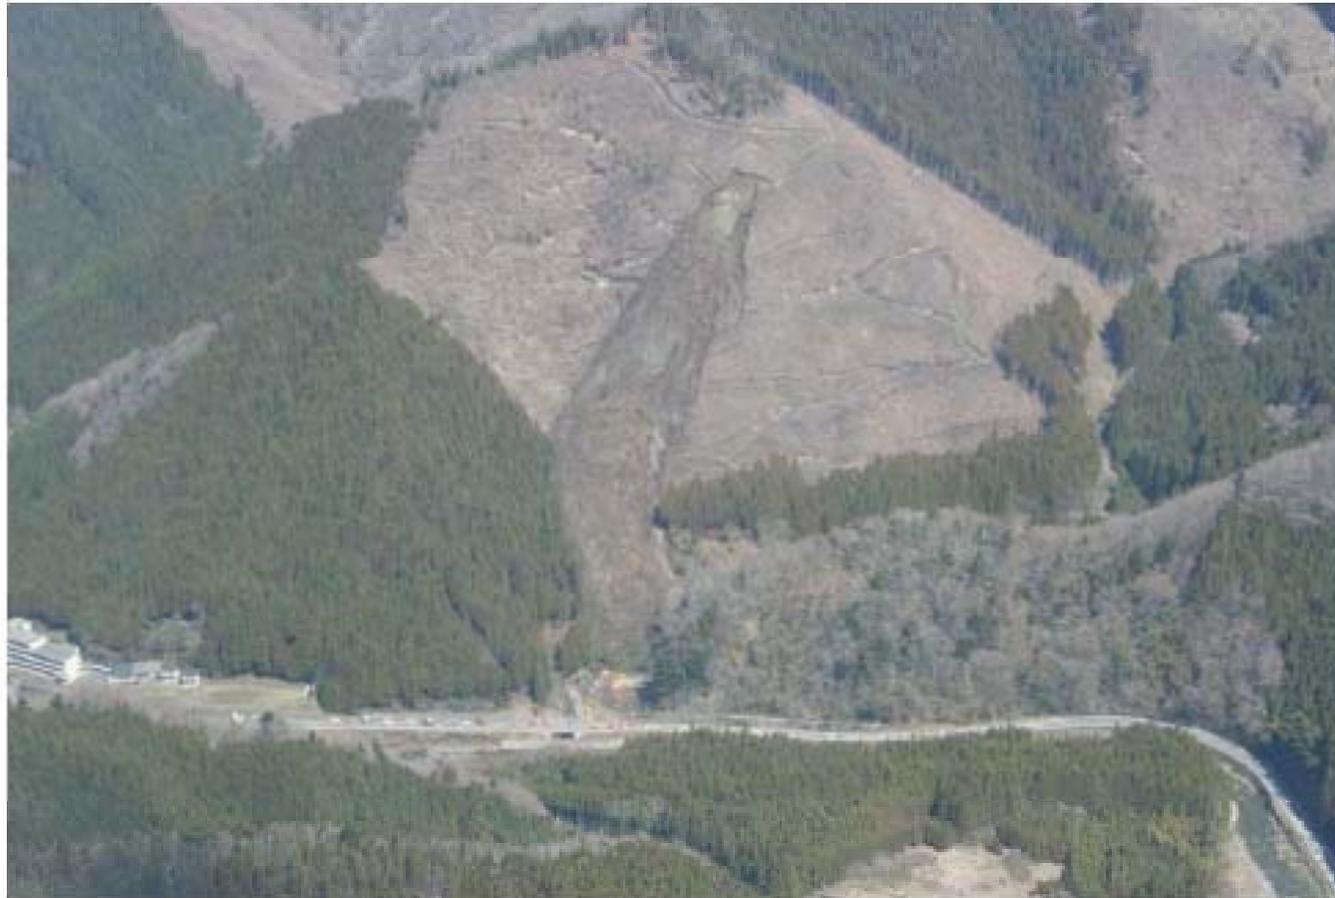
①いわき市田人町石住

**Landslide in Tabito, Iwaki City, Fukushima Prefecture  
(height: 170 m, width: 50 m) caused a landslide dam  
(height: 15 m, volume of stored water: 1,000—2,500 m<sup>3</sup>)**

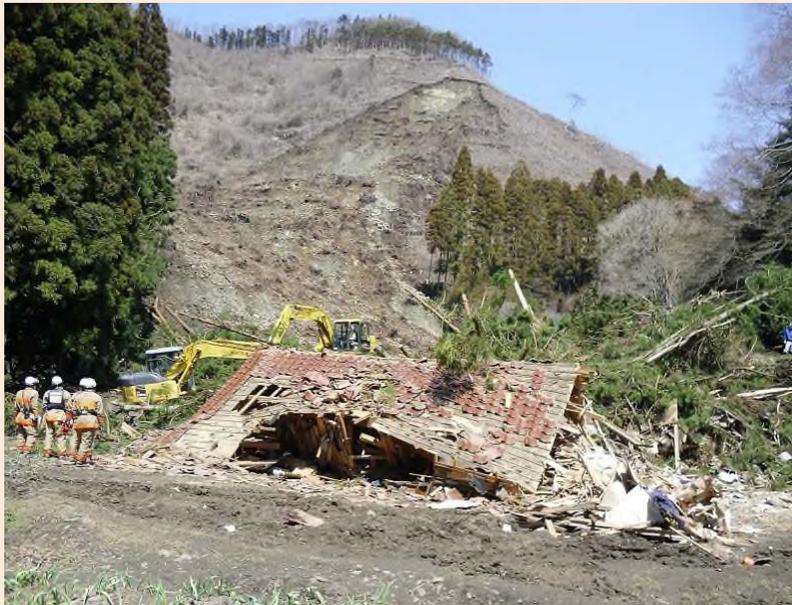
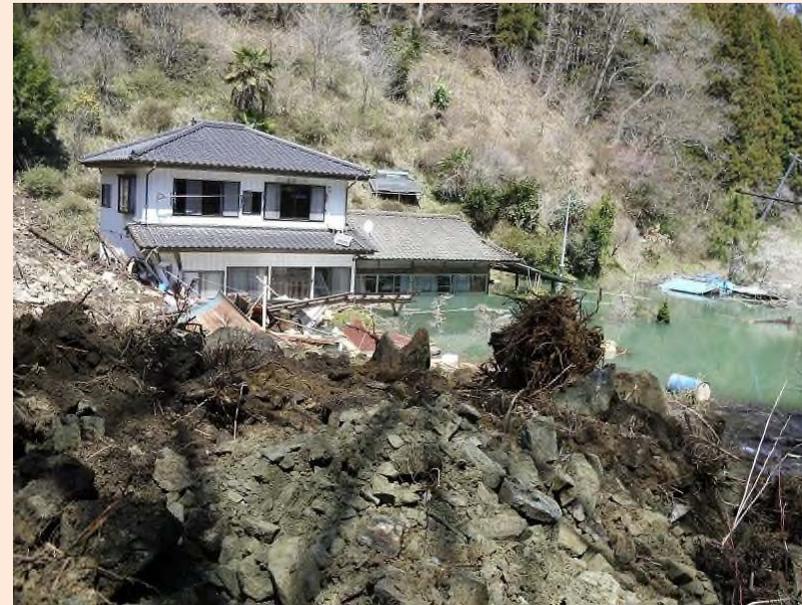
- Landslide destroyed 3 houses and caused 3 deaths in Tabito, Iwaki City, Fukushima Prefecture
- Sediments blocked the stream flow (Channel was already excavated)

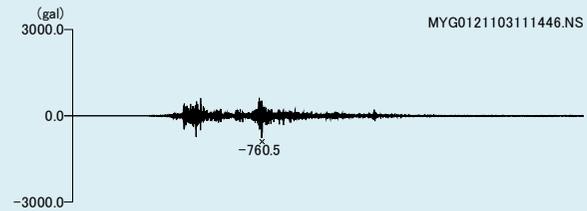
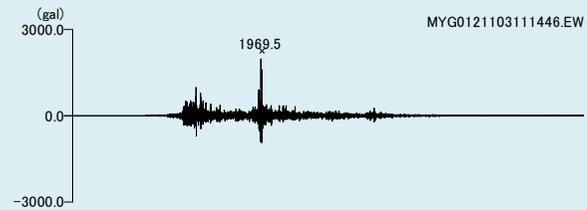
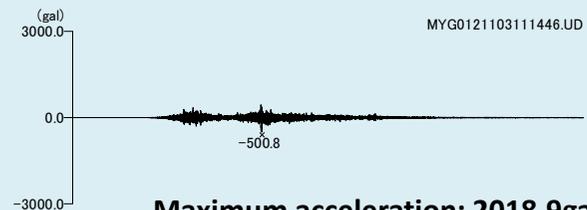
**Shiogama City,  
Miyagi Pref.**

**Maximum acceleration: 2018.9gal**

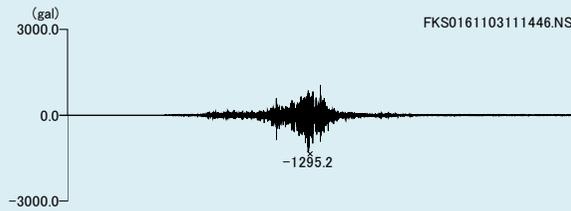
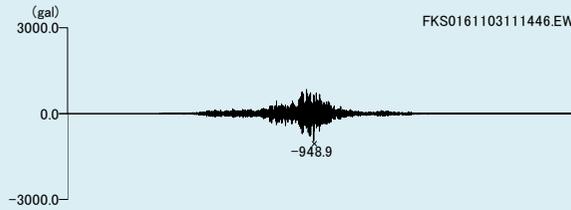
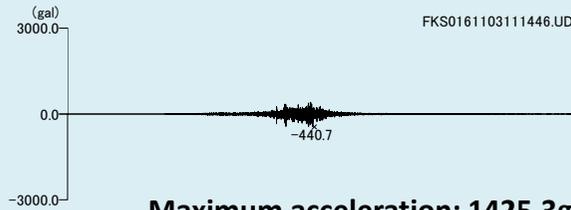
**Shirakawa City,  
Fukushima Pref.**

**Maximum acceleration: 1425.3gal**

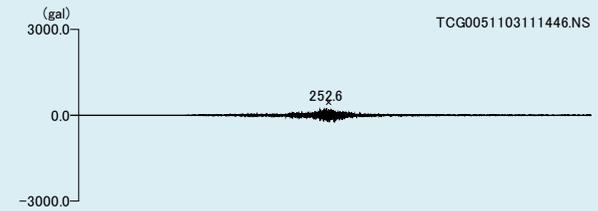
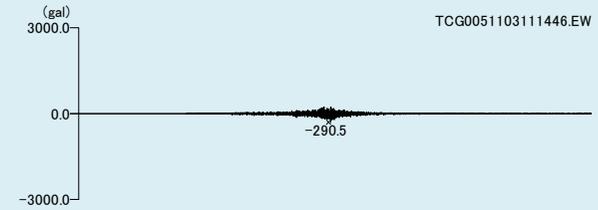
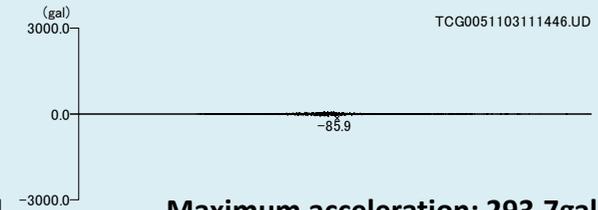
**Yaita City,  
Tochigi Pref.**

**Maximum acceleration: 293.7gal**

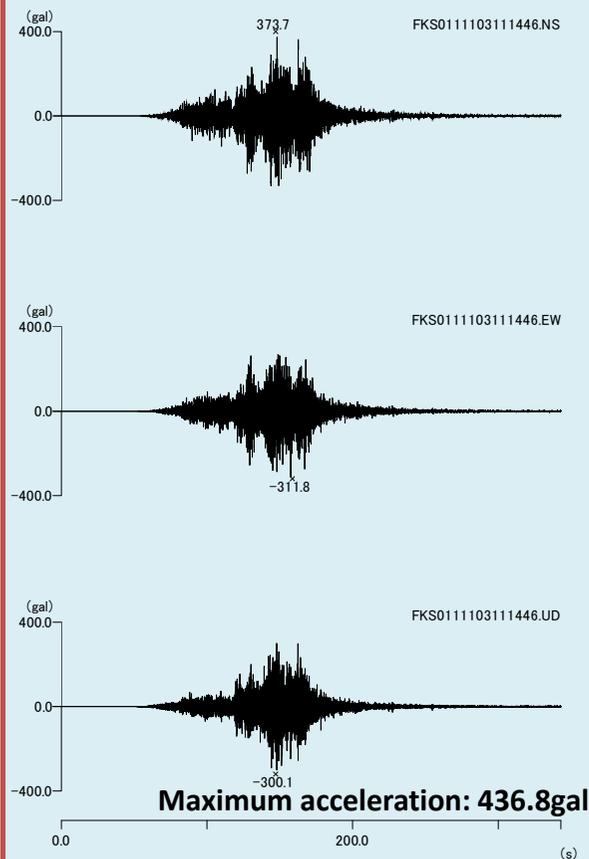
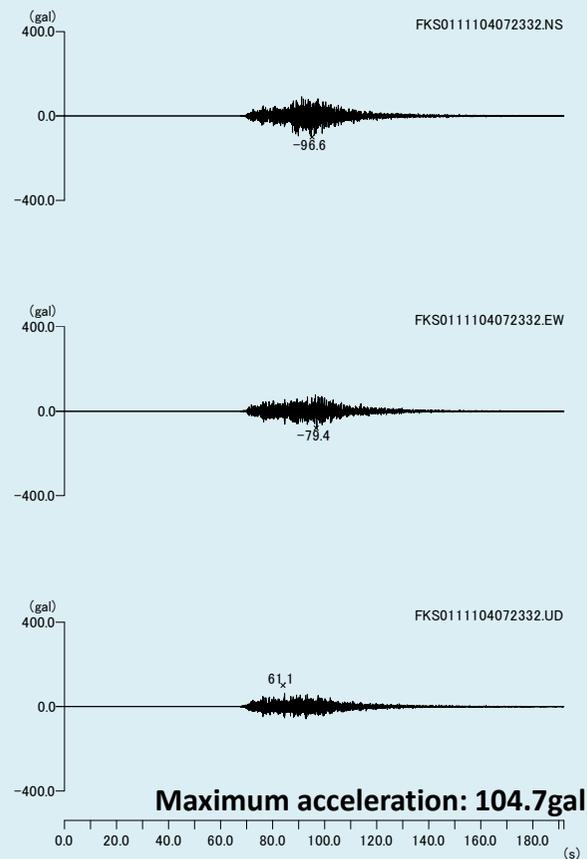
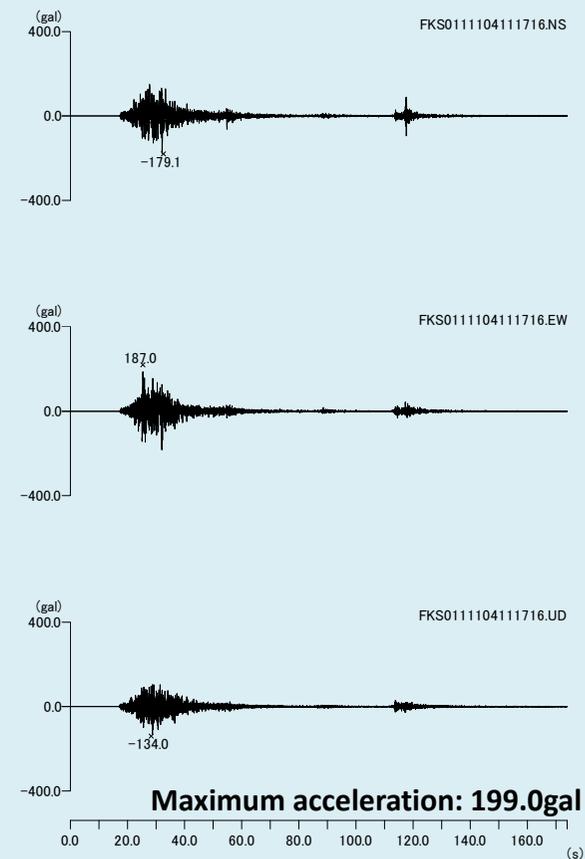
# Iwaki City, Fukushima Pref.: Main quake on March 11<sup>th</sup> and aftershocks on April 7<sup>th</sup> and 11<sup>th</sup>

(vertical axis: 400gal)

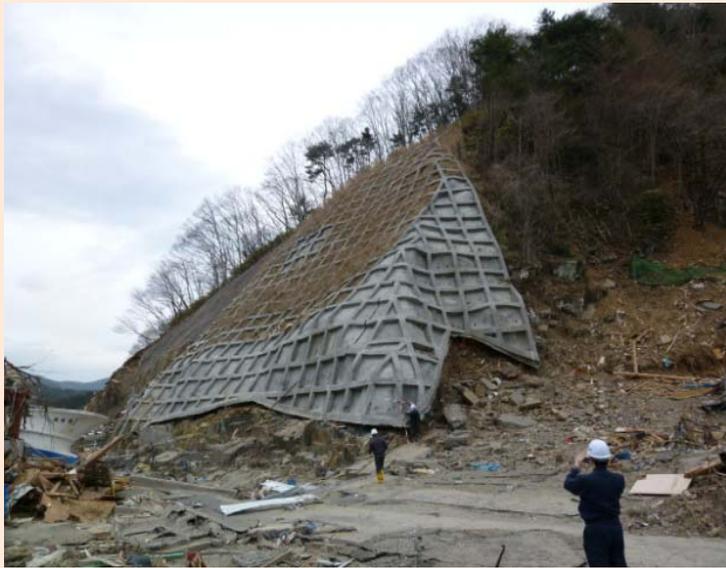
- Damage included loss of foundation ground of crib works, cracks along joints of crib works, loss of base spray material of crib works, buckling of rockfall prevention fence on retaining wall, and scratch mark on retaining wall.

Loss of foundation ground of crib works (Kawajiri area)

(All damage observed does not affect the function of slope failure prevention.)

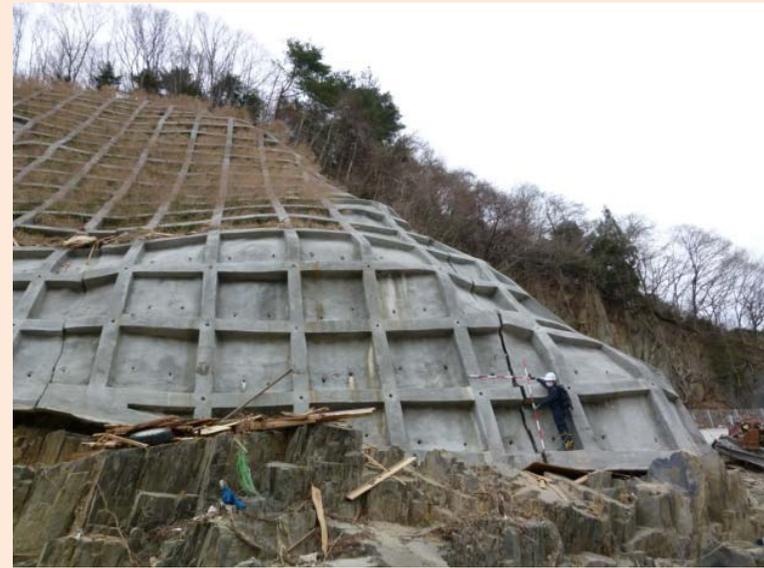
Cracks along joints of crib works (Kawajiri area)

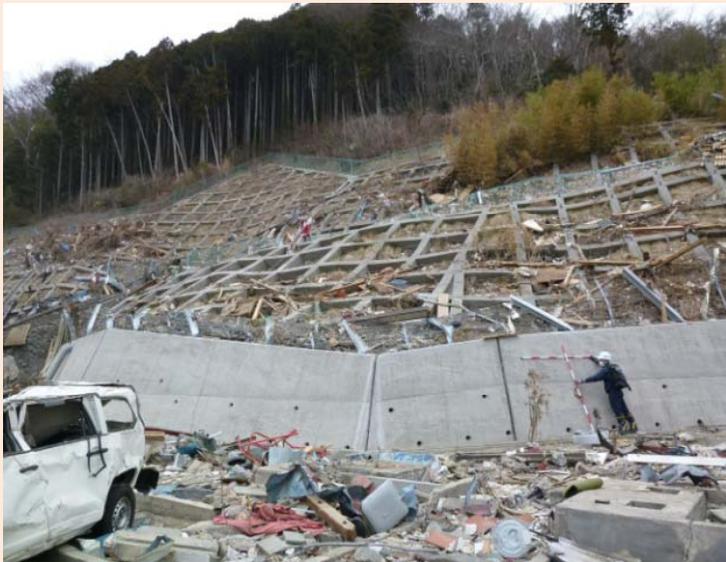
Buckling of rockfall prevention fence

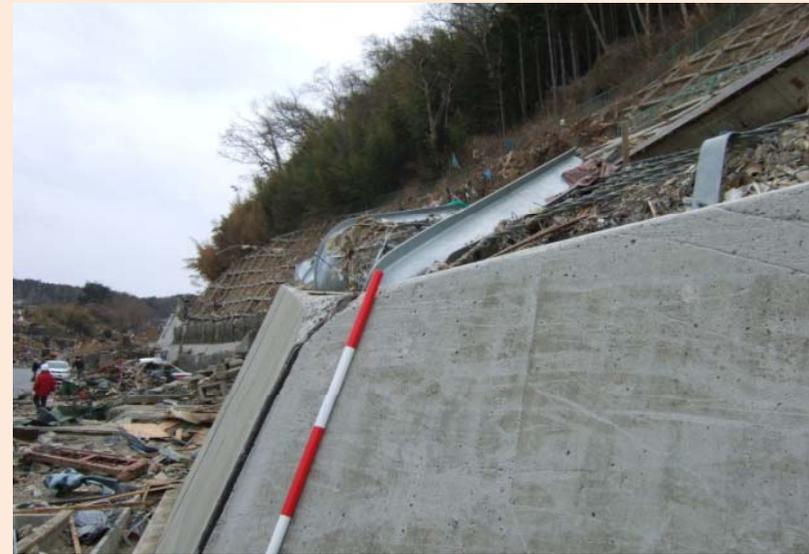
scratch mark on retaining wall

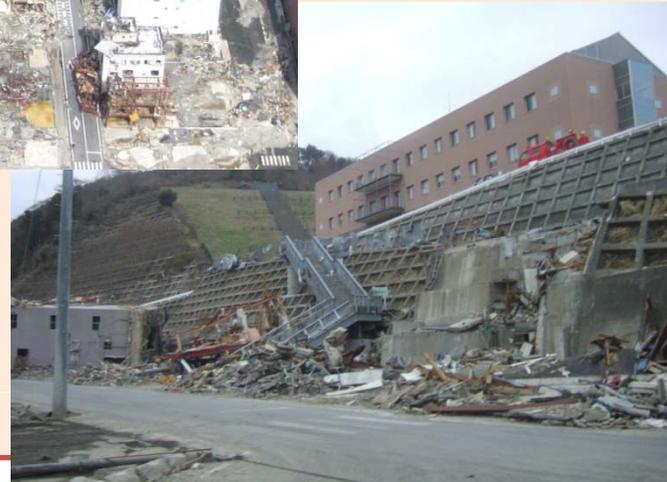
Steel stairs for evacuation from tsunami

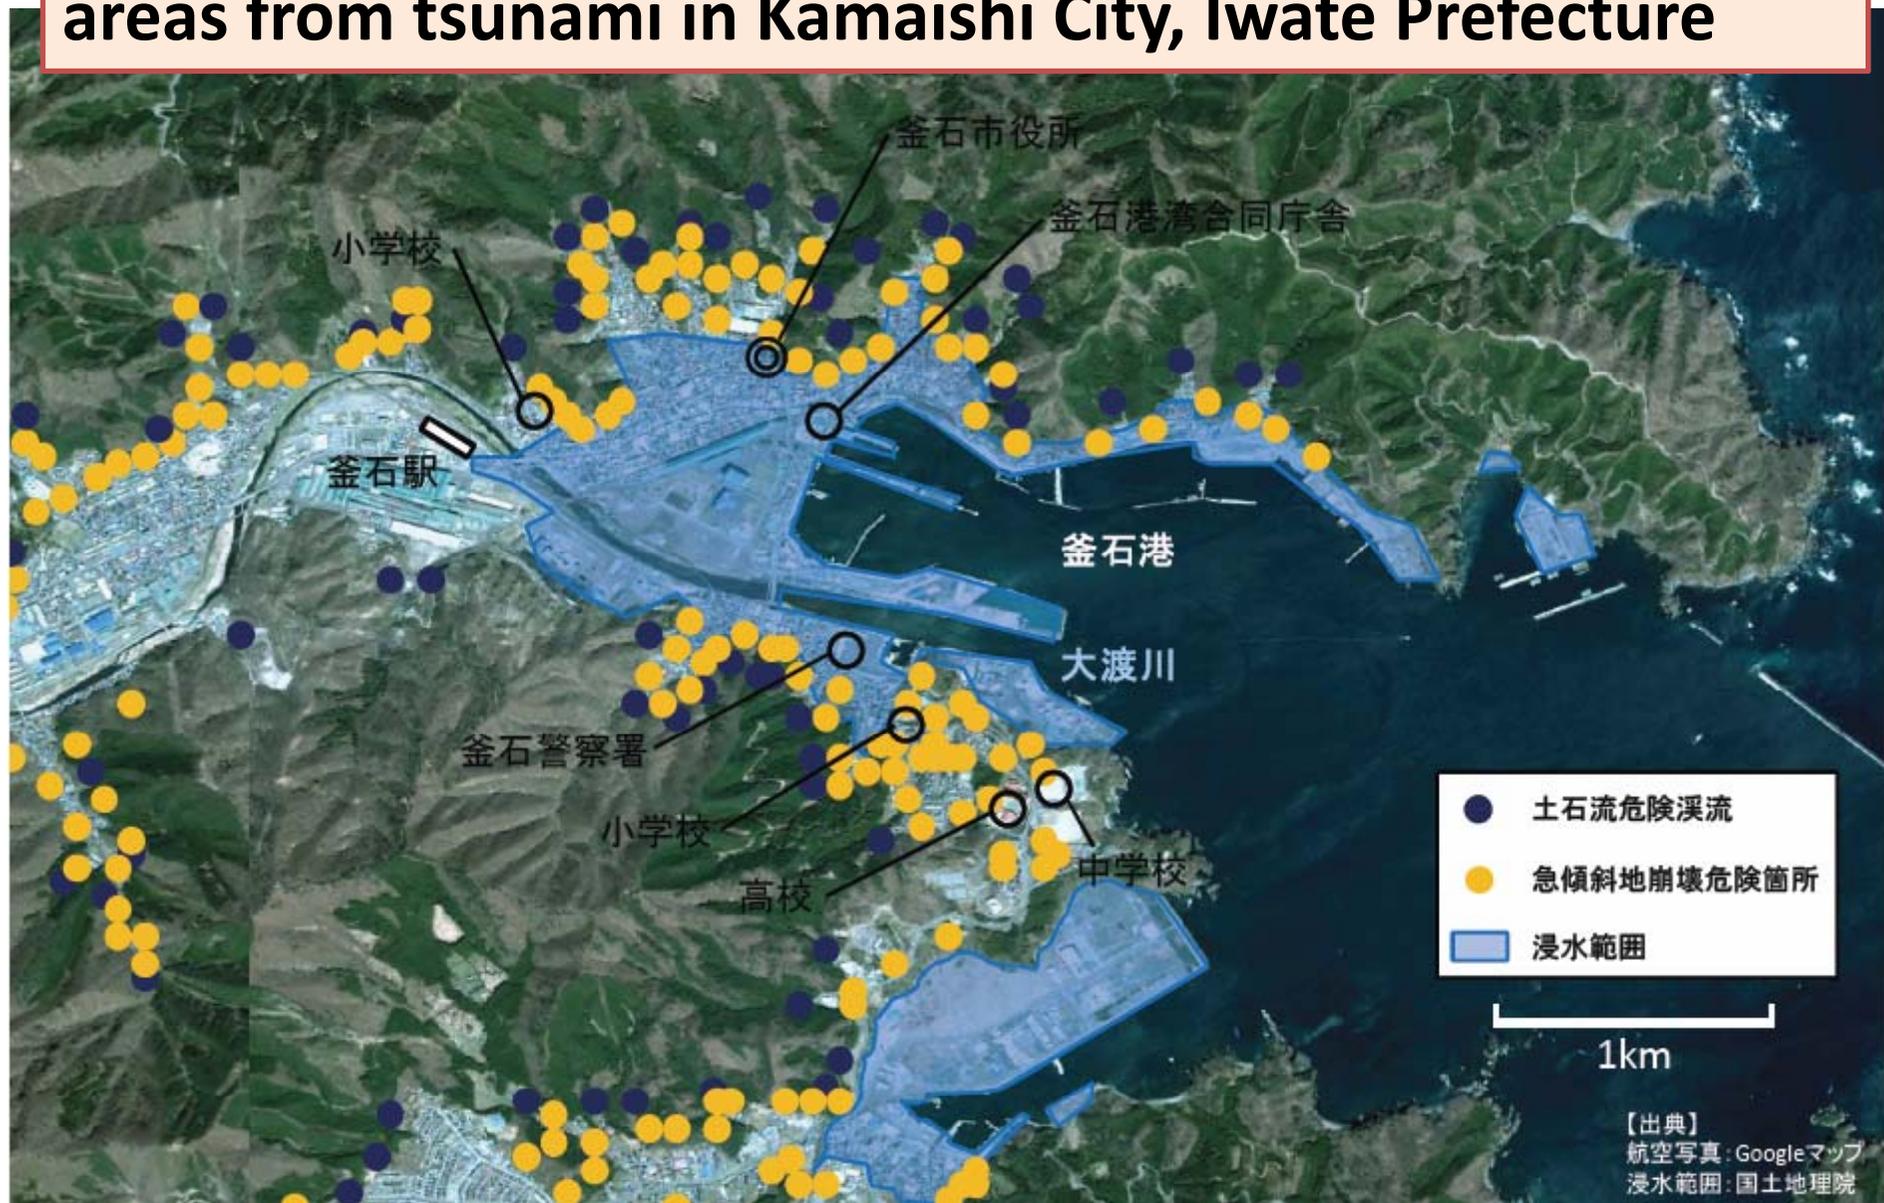
# Sites prone to sediment-related disasters and flooded areas from tsunami in Kamaishi City, Iwate Prefecture

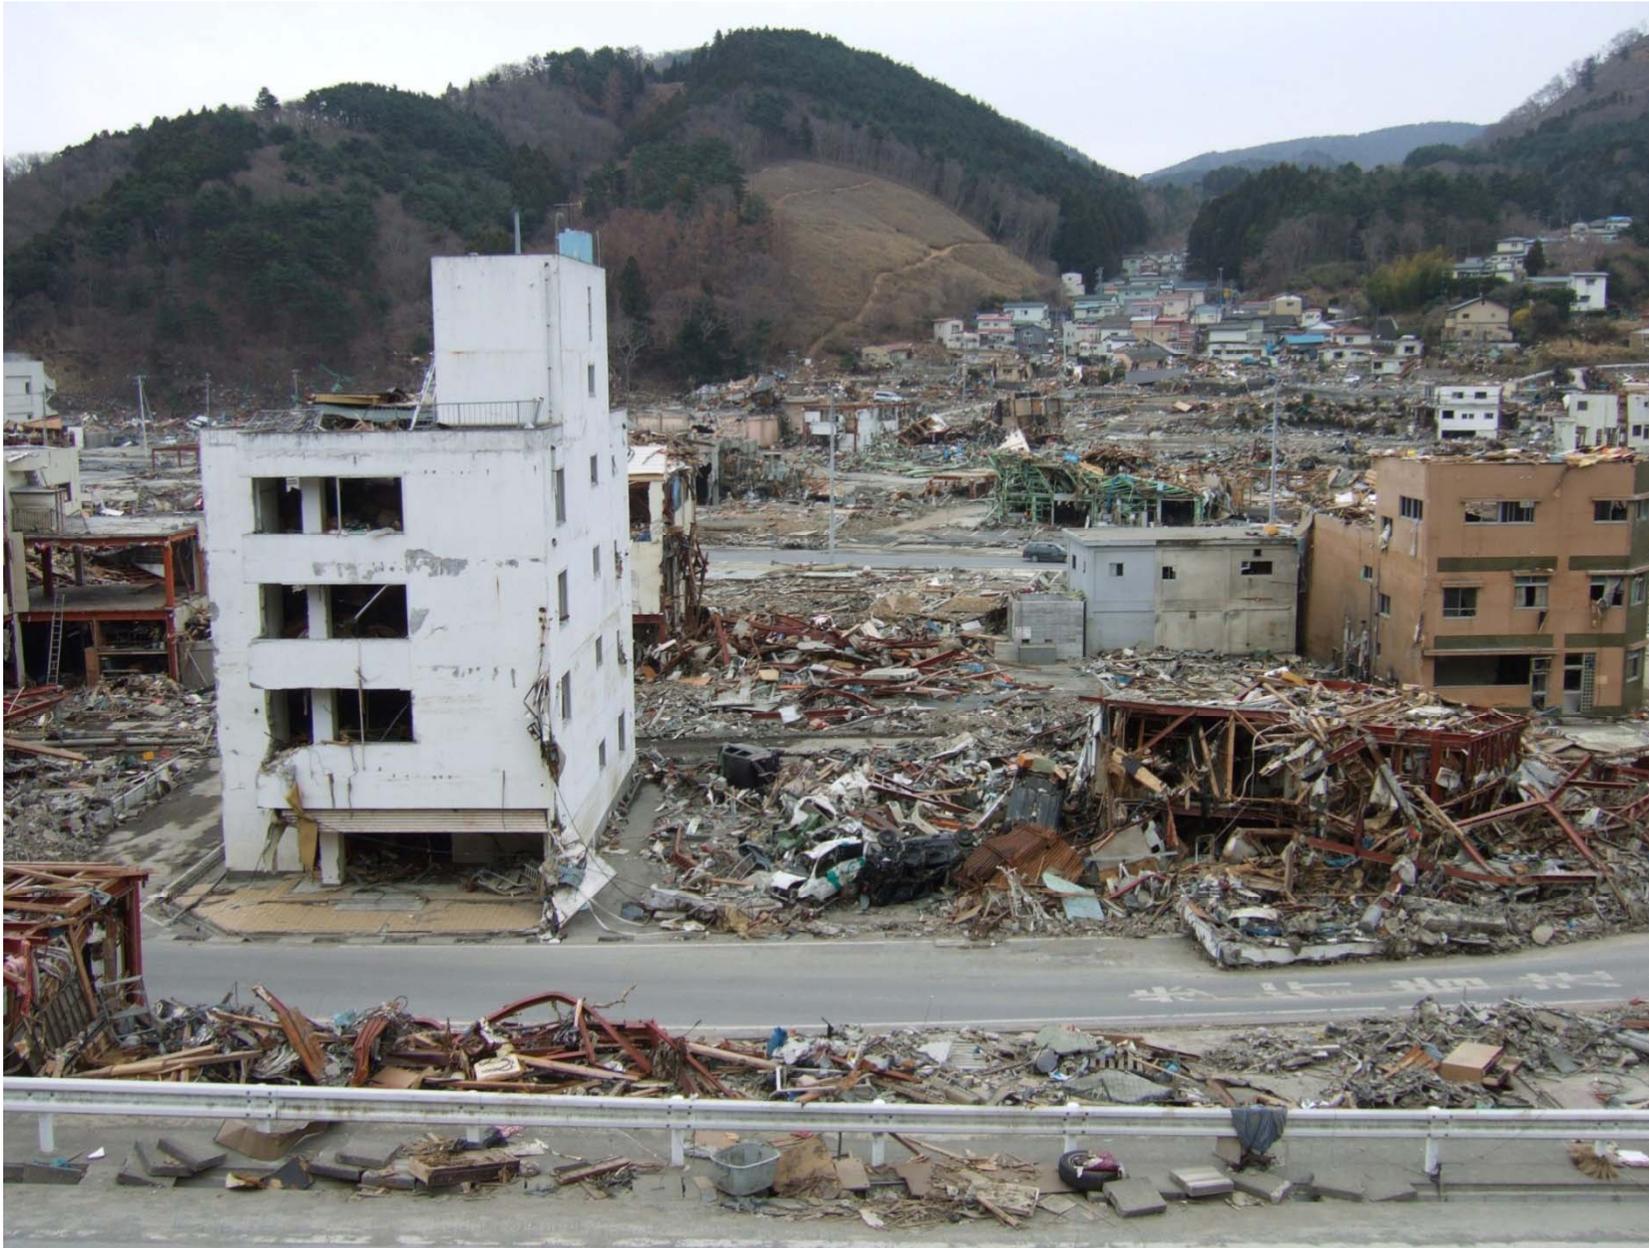
**Damage in southern part of Horikiri-Yama  
in Onagawa Town, Miyagi Prefecture**
