UJNR Panel on Wind and Seismic Effects Panel Update

Volume 6, Number 2, August 2008

## IWATE-MIYAGI NAIRIKU EARTHQUAKE

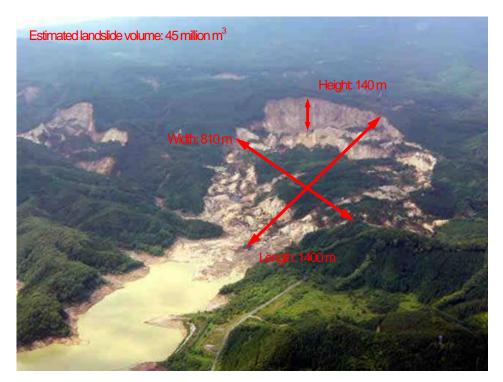
Figure 1. Landslide at Aratozawa

Landslides triggered by this earthquake crushed structures, buried people, cut off road traffic, and isolated local communities. Mud from landslides dammed up rivers that created 15 major landslide dams. Among these the largest landslide took place at Aratozawa (see Figure 1), located upstream of the Aratozawa Dam. The landslide area was 1400 m in length, 810 m in width and the estimated landslide volume was 45 million cubic meters.

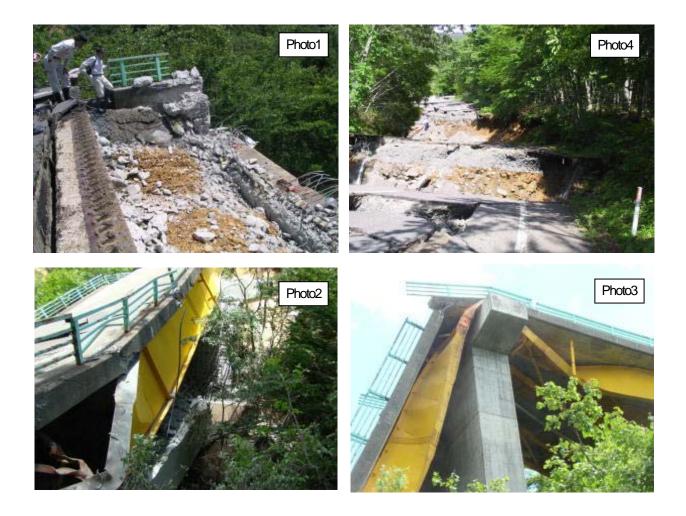
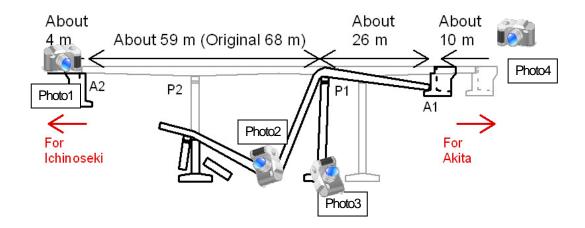
Figure 2. Collapse of Matsurube Oh-hashi Bridge

The 95 m Matsurube Oh-hashi Bridge collapsed due to sliding movement of the slope supporting one of the abutments (see Figure 2). The movement of the slope supporting abutment A1 and pier P1 resulted in a dislocation of about 10 m, and the lateral force caused by the sliding pushed through the bridge girder's opposite side of abutment A2. The girder buckled downward and pier P2 broke into three pieces.
