# Terrorist Threats Against the Pentagon

## ABSTRACT

The terrorist attack of 11 September 2001 against the Pentagon prompted USACE to perform a 30-day study to assist in the development of anti-terrorist methods for the Pentagon structure. Drawing on years of experience and model development, USACE provided and analyzed structural concepts for the rebuild and renovation of the Pentagon. USACE personnel assisted in the damage assessment immediately following the terrorist event, analyzed the current configuration and design concepts of the Pentagon wall system using simplified engineering-level and high performance computational models, and developed strength measures that were inserted into a PC-based vulnerability assessment code. Recommendations were provided to the Pentagon Renovation Program.

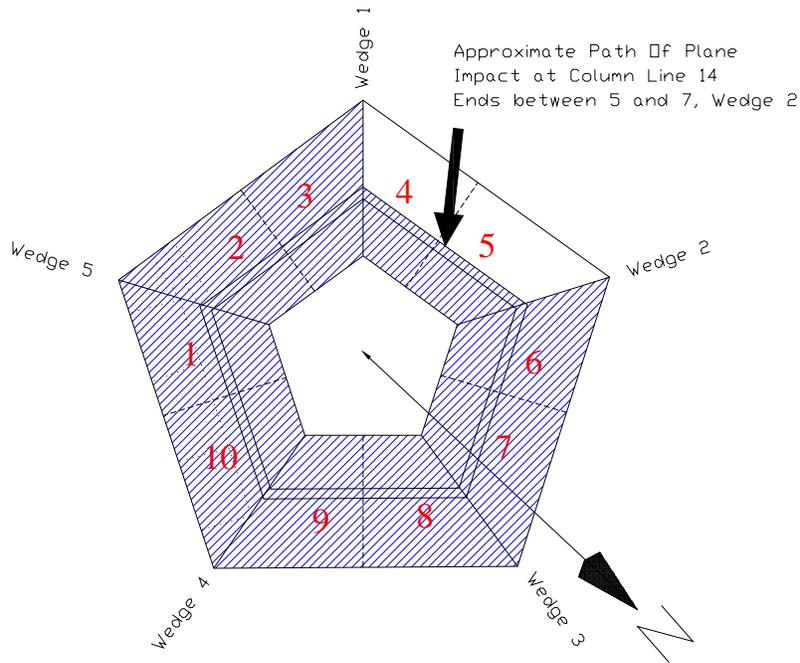
Figure 1. Layout of Pentagon showing impact location.

Figure 1 is a schematic of the layout of the Pentagon. Wedge 1 consists of sections 3 and 4 as shown in this figure. The impact location and orientation are also indicated on the figure. The exterior wall near the impact location is shown as Figure 2. The boundary of Wedge 1 (retrofitted) with Wedge 2 (non-retrofitted) is shown near the left side of the figure. The impact occurred near column line 14 of Wedge 1. The collapsed region (Figure 3) extended from the expansion joint near column line 11 to column line 18. Windows near the Wedge 1 - Wedge 2 boundary are shown in Figure 4. Damage to the non-retrofitted windows is higher than damage to the retrofitted windows, although the retrofitted windows are closer to the impact area and subsequent fuel fire/blast.

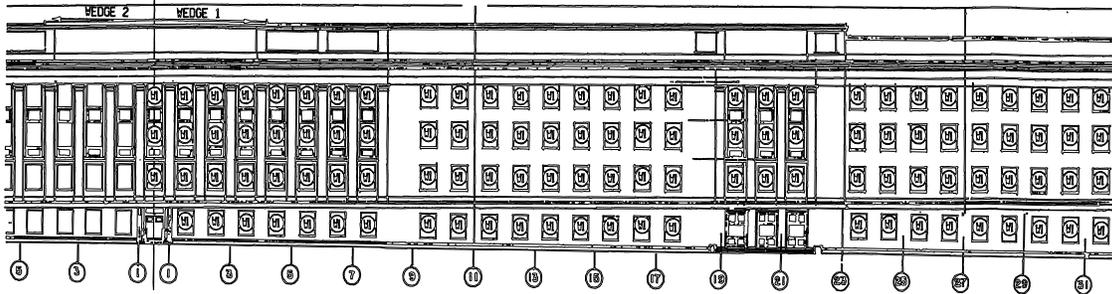
Figure 2. Exterior of E-Ring of Pentagon Wedge 1 and 2 with column line designations. W1 designation on windows denotes non-operable (fixed) retrofit window. Impact occurred near Column Line 14, collapsed region extended from construction joint at Column Line 11 to Column Line 18.

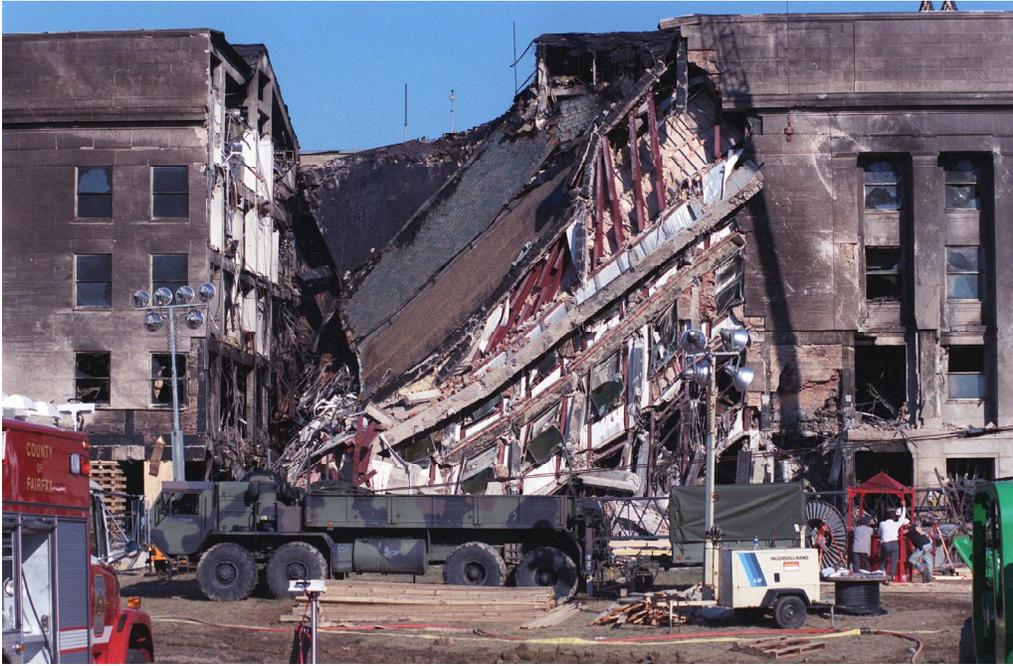
Figure 3. Collapsed section/plane impact area in Wedge 1. Plane entered the 1<sup>st</sup> floor at an angle of approximately 40 degrees from perpendicular moving toward the left into Wedge 2.

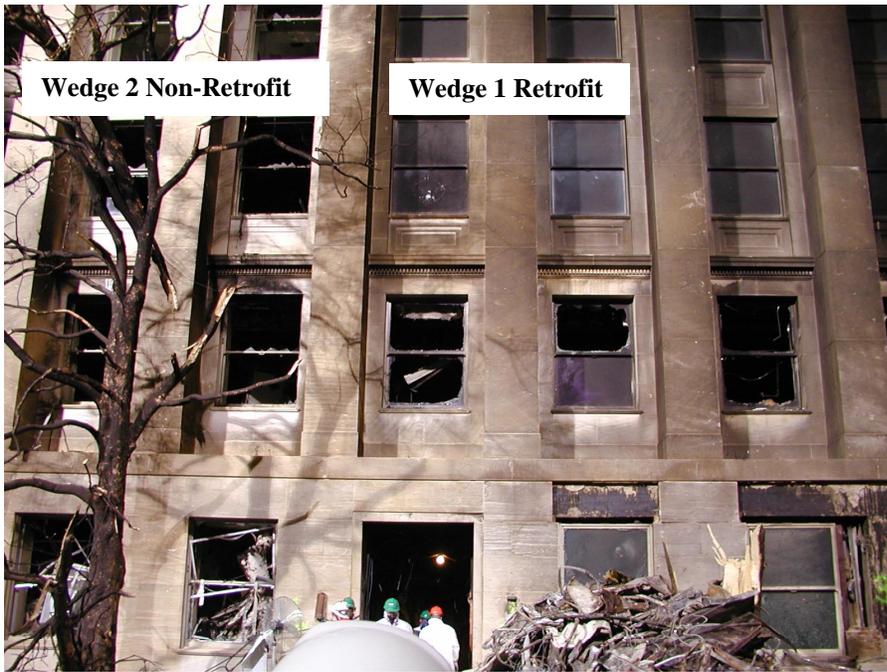
Figure 4. Exterior view of transition between Wedge 1 (on right, retrofit) and Wedge 2 (on left, non-retrofit). First floor non-retrofit window adjacent to transition may be High Hazard blast response. Second and 3<sup>rd</sup> floor fire damage. Approximately 135 ft (44.2 m) North of plane impact point.

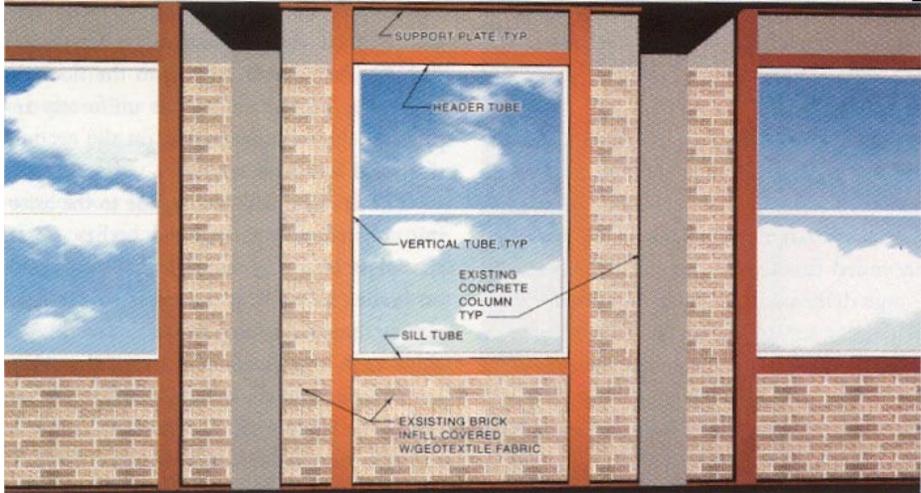
Figure 5. Current retrofits.

The retrofits currently used in the Pentagon renovation (Figure 5) include blast hardened windows, supported by horizontal tubes that frame into vertical tubes that run from floor slab to floor slab. The 6"x6" or 8"x8" tubes transfer the dynamic reactions from the windows and the exterior masonry walls to the floor slabs. The E-Ring retrofit window for the W1 type consists of an insulated, or double pane glazing. The outer pane is 1/4 in. thick thermally tempered glass, with a 1/2 in. air gap. The inner pane is a laminate consisting of 3/8 in. thermally tempered glass, .090 in. PVB inner layer, and 3/8 in. thermally tempered glass. In addition, a

geotextile membrane is used over the interior surface of the masonry wall to prevent the masonry from becoming a debris hazard during a blast event.

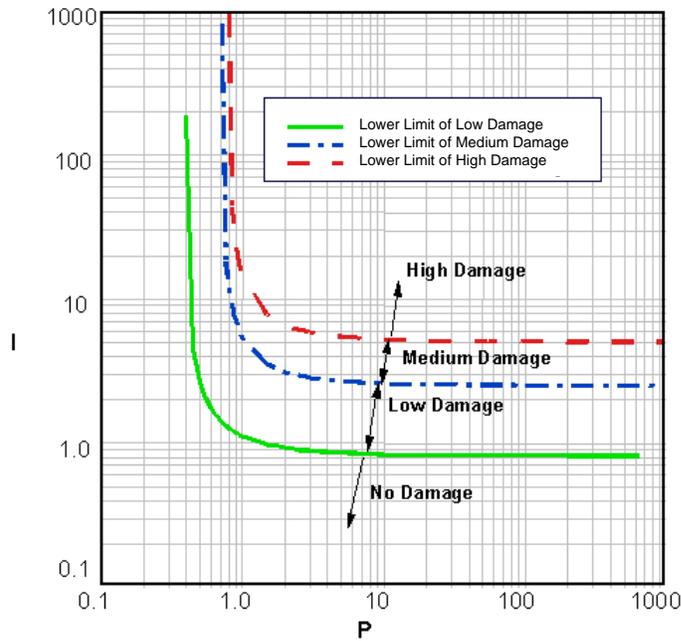
**No damage:** No appreciable damage; the component is reusable without repair. This damage level can be equated with a **High Level of Protection**.

**Low damage:** The component is probably repairable and it has provided a generally adequate level of protection to personnel and equipment from the effects of the explosion. This damage level can be equated with a **Medium Level of Protection**.

**Medium/Moderate Damage:** Repair of the component is not feasible, but it has not collapsed, and it has provided substantial protection to personnel and equipment from the effects of the explosion. This damage level corresponds to the greatest degree of damage that might be accepted, thus it can be equated with a **Low Level of Protection**.

**High Damage:** The component is definitely beyond repair but it has not necessarily completely collapsed. It has undergone a deformation such that it cannot be counted on with high certainty to protect personnel and equipment from the effects of the explosion. This damage level is equated with “**Collapse**” as it is used in terms of a **Level of Protection**. However, components with 100% damage will most probably not be collapsed in the general usage of this word.

Figure 7. Hazard/Protection Levels.

vehicle bomb attack. A description of a PI curve is shown in Figure 6. The hazard/protective levels used by AT Planner in this study are shown in Figure 7. AT Planner has a set of default damage diagrams and the capability to read in user specified diagrams. The AT Planner default building components (excluding windows and non-reinforced masonry walls) are normalized so that the user can modify the span and thickness of the component. The user specified diagram is not normalized; therefore a different diagram must be developed for each different building layout. For this reason, a significant amount of time was spent studying construction diagrams in order to determine nominal specifications before the damage diagrams were developed.

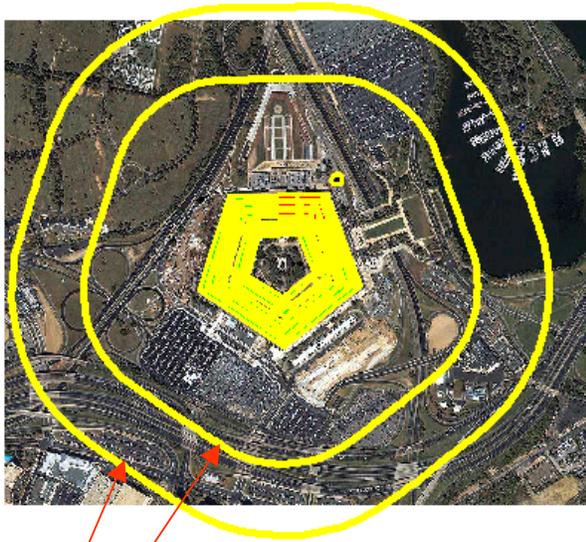
**Small Bomb**  
**Large Bomb**

Figure 8. Stand-offs to prevent high hazard for the large and small truck bombs for the unretrofitted Pentagon.

Range-to-effect (RTE) and PI curves for the Ring E walls and windows were developed and entered into AT-Planner. In addition, PI curves for the reinforced concrete roof panels required to perform AT Planner assessments. Roof panel retrofits were not required for blast protection in subsequent scenarios – the curves used for the roof panels are constant throughout this report. RTE curves for this report are shown for components exposed to normally reflected loads. They are not shown for roof panels since realistic roof loads are closer to incident pressures rather than normally reflected pressures. The damage levels obtained from the supporting FE models match well with the PI diagrams developed using WAC, thus validating the PI diagrams. The PI curves presented above are used in AT Planner to define safe stand-offs

around the Pentagon for the large and small truck bomb threats as shown in Figure 8 (the windows control these stand-offs).

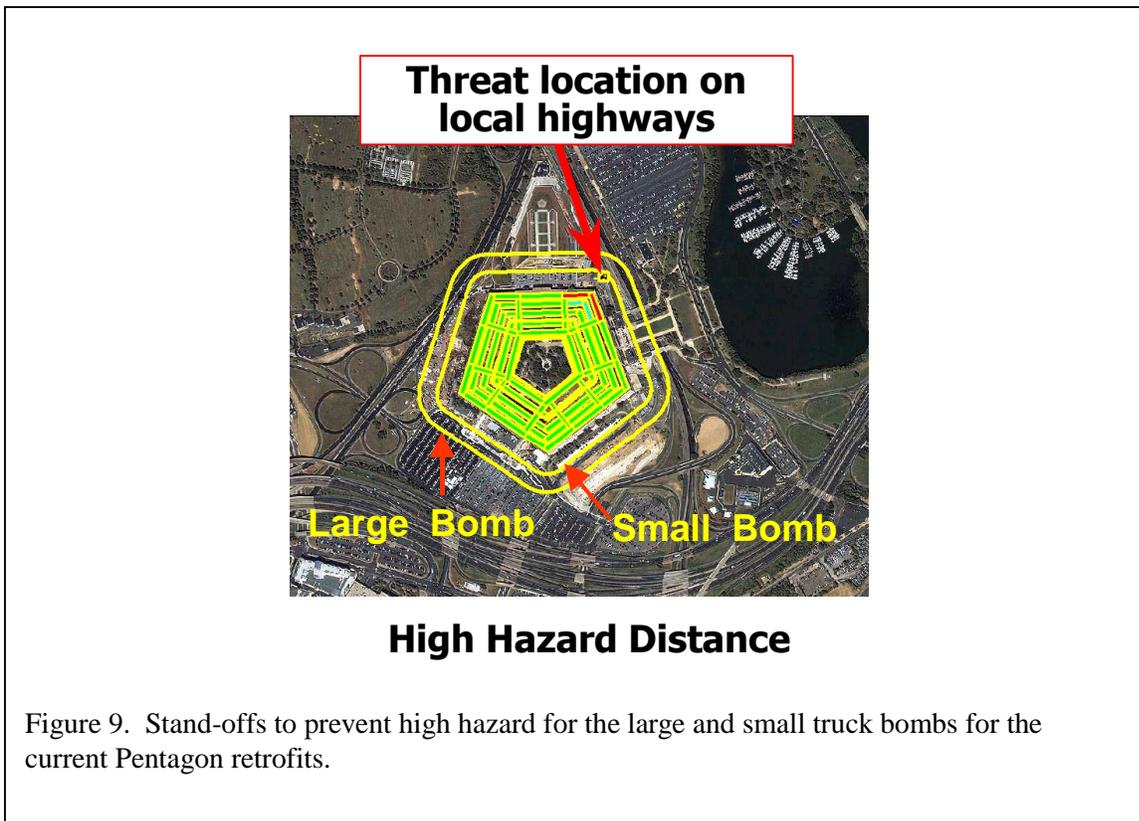
Figure 9. Stand-offs to prevent high hazard for the large and small truck bombs for the current Pentagon retrofits.

To analyze the existing retrofits response to blast load, SDOF models of the wall and window systems were developed. The wall model did not consider the effects of window failure. The resistance of the wall included the strength of the façade, the masonry wall, and the tubular framing system (dominant contribution). The wall system model was used in WAC to generate RTE and PI curves and these curves were validated with FE analyses. The high level PI curves were used in AT Planner to define safe stand-offs around the Pentagon for the large and the small truck bomb threats. The custom PI diagrams for the window and wall retrofits of the exterior wall of the E-Ring were used for all walls. Damage plot in figure 9 are intended to illustrate damage to the outside of the E-Ring only.
