# FIRE RESISTANCE OF STEEL FRAMES

This paper verifies analytically the fire resistance of the World Trade Center's steel frames and also examines precautions to be taken in designing skyscrapers.

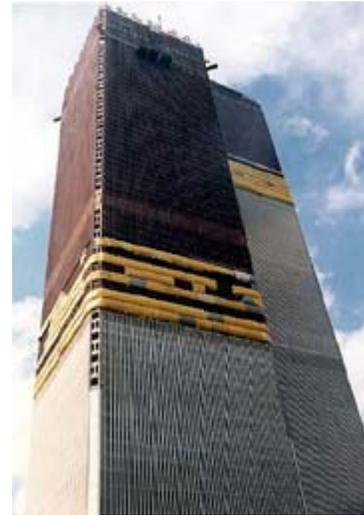
Photo 1. WTC under construction

The collapse of the World Trade Center Towers (hereafter referred to as “WTC,” Photo 1 : at the time of construction”) was caused by damage to the structures due to aircraft impact and ensuing fire exposure that led to loss of the structures’ load-bearing capacity.

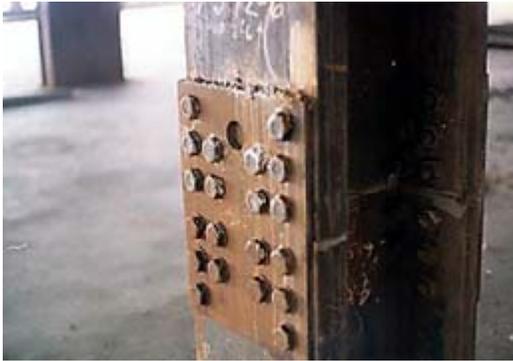
Photo 2. Core column (ultra-jumbo H-shape)

Photo 2 shows the core column of ultra-jumbo H-shape before fire protection and Photos 3 and 4 show the floor trusses before and after fire protection. The motion damper inserted between the outer wall and the end of the lower chord of the truss was not fire-protected, as it was not a load-carrying member of the main structure. It can be assumed from the photo that spraying to such a small cross-section members posed great difficulties.

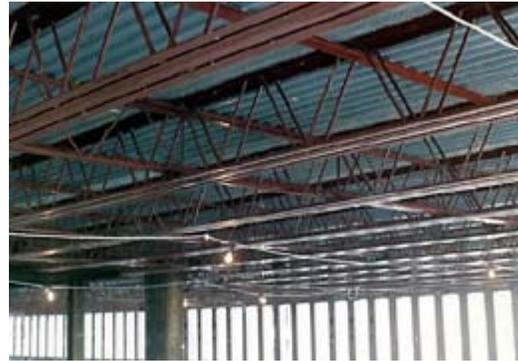
Photo 3. Floor truss (before protected)

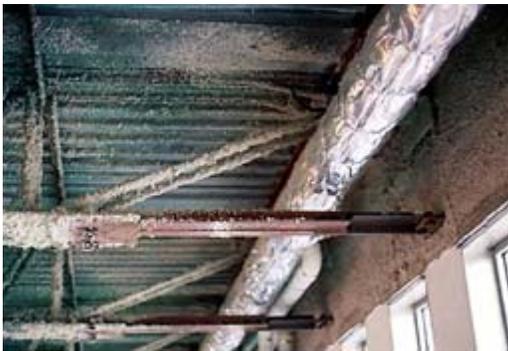
Photo 4. Fire Protection of floor truss

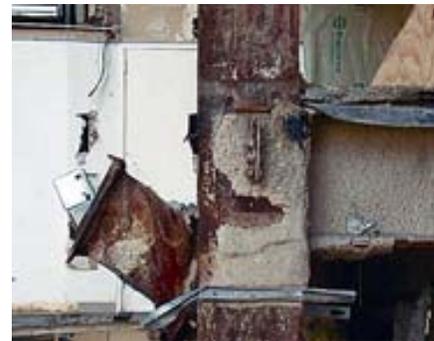
Photo 5. Fire protection at Bunker Trust Building

According to the FEMA Report, the aircraft incursion supposedly blasted away the vast majority of fire protection on the impact floors. Photo 5 shows the steel frames of adjoining Bankers Trust Building that was hit directly by the columns falling from WTC2. Their fire protection was largely blown away, and it is not hard to imagine that the same phenomenon occurred at the impact floors of WTC1 and WTC2.

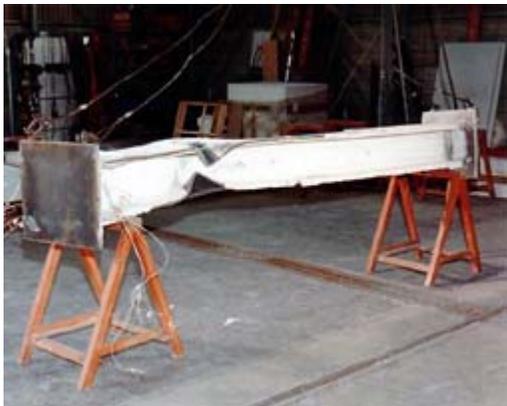
Photo 6. Buckling of Column after Loaded Heat Test

heating (the heat test). The condition of failure immediately after a loaded heat test made on a column is shown in Photo 6. The proof stress of steel frames decreases with the increase of temperature, leading to the loss of the frame's load-bearing capacity.

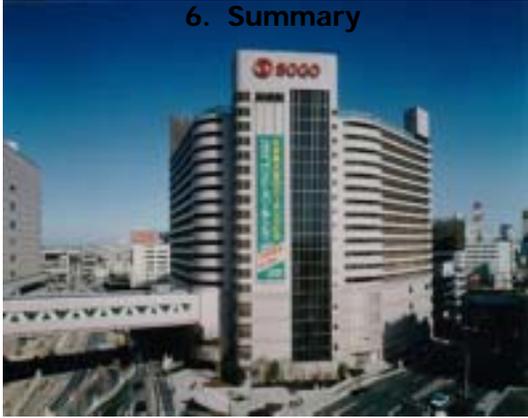
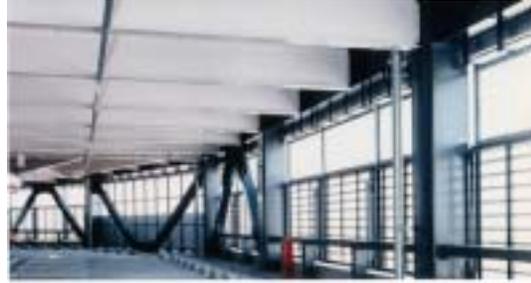
Photo. 7. View of Sen City Car Plaza

Photo. 8. Steel Frame of Sen City Car Plaza

Photos. 7 and 8 show the application of FR Steel to a multi-story car park. This 17-story car-park building, constructed close to Chiba Station, is one of the largest of its kind in Japan. It will accommodate 1,800 vehicles. Conventional steel-frame car parks present a dark and dirty appearance because the steel-frame protection blackens by exhaust gases and exfoliates when exposed to rain and wind. With FR Steel, no protection is required for the frame and making the columns slender enlarges the parking area.

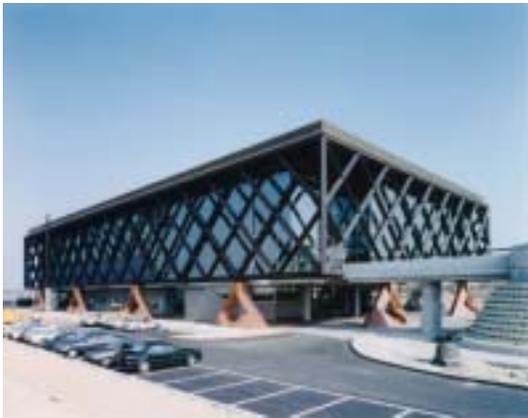
Photo. 9. View of Tokoname Park Gymnasium

For this gymnasium, constructed at Tokoname Park (Aichi Prefecture), a dynamic structure was adopted in which the roof, a space truss structure measuring 100.8 x 50.4 m, is supported on four sides by large truss structures (Photo 9). For the large truss structures, prestressed concrete was at first considered because protection is necessary when a steel-frame structure is adopted. However, FR Steel that matches the design intention was adopted as the material for this large truss structure.

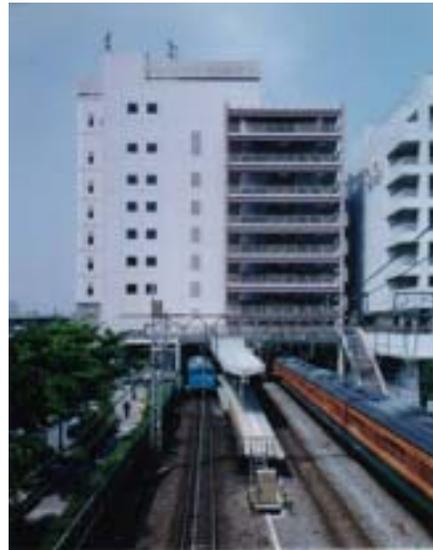
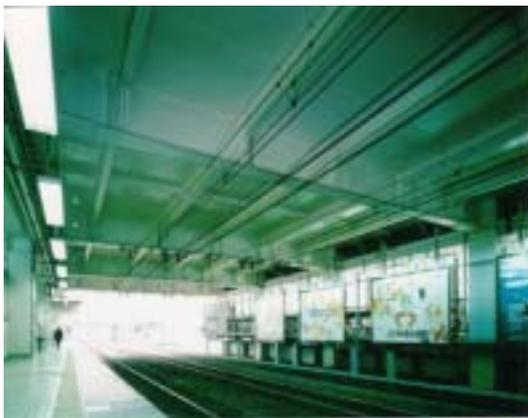
Photo. 10. Steel Frame of Sen City Car Plaza

Photo. 11. View of Oimachi Station Building

East Japan Railway Company constructed a commercial building spanning the tracks of Oimachi Station in Tokyo (Photos. 10 and 11). In the case of constructing a large-scale building spanning a railway, it is necessary to provide protection for steel frames in the vicinity of the tracks. However, because of the exfoliation of maintenance, steel-frame construction without protection was required for this building.

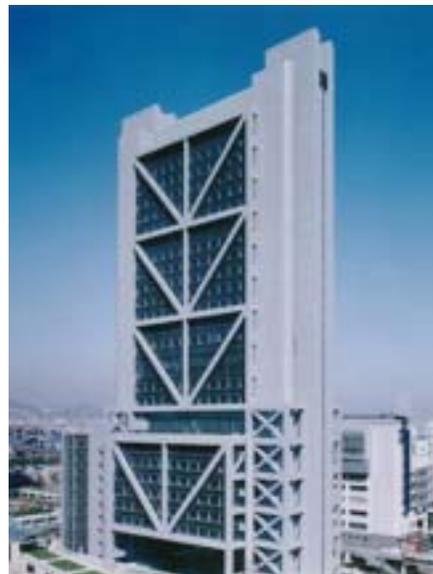
Photo. 12. View of P&G Building

This 31-story building in Kobe houses offices and research laboratories (Photo 12). A suspended mega-structure, in which six stories are structured as one unit, was adopted for the construction of the building. It features a structural design in which the mega-structure is presented as the building's structural design element. In the building construction, FR Steel was adopted to give the impression of slenderness of the structural members through the application of lighter protection to columns and beams.
