# 2004 Indian Ocean Tsunami in South-West Coast of Sri Lanka and Its Damage

Takashi Tomita<sup>1</sup>, Taro Arikawa<sup>2</sup>, Tomohiro Yasuda<sup>3</sup>, Fumihiko Imamura<sup>4</sup> and Yoshiaki Kawata<sup>5</sup>

The 26 December Earthquake off the west coast of Northern Sumatra generated a terrible tsunami in the Indian Ocean. The number of death and missing persons due to the tsunami rose to 300,000 in the world. The tsunami caused the devastating damage in Sri Lanka which locates far from the epicenter of the earthquake at 1600km, and the death toll of Sri Lanka stood more than 30,000 by the tsunami attack after two hours of the earthquake occurrence. Many houses in coasts, fishery boats, port facilities, railways etc. suffered heavy damage. This paper reports the results of the on-site investigation on the tsunami and its damage in the south-west coast of Sri Lanka.

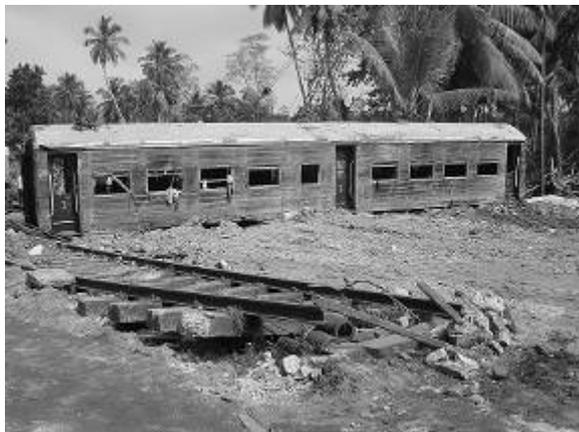
Many low-lying coastal areas were inundated by the tsunami. For example, in Kahawa north of Galle, the train was carried away by the tsunami. The railway was about 190m away from the nearest beach (Figure 5). The inundation due to the first tsunami stopped the train, and then many inhabitants living in the region boarded the train to escape from the tsunami. The first tsunami was not so big as to cause severe damage. However, the second tsunami whose height was bigger than the first one washed out the train (Photo 1). 1500 people were killed in this region.

Photo 1: Passenger car of the train flooded.

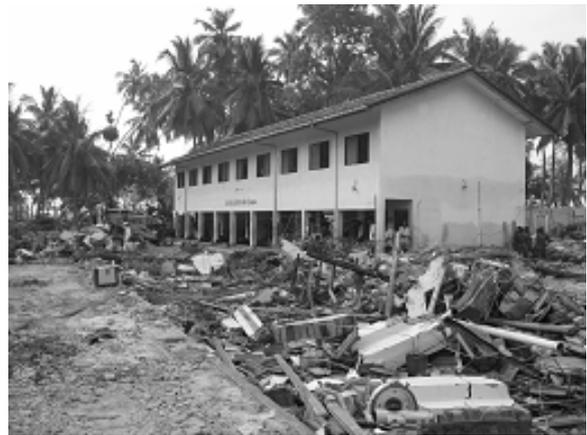
Photo 2: Remained building.

A solid and high building (Photo 2), which was a school building, remained near the damaged train, although the buildings were inundated even on the second floor. Such a structure was effective to save human lives in low areas, because tsunamis were able to flow flat areas very easily.

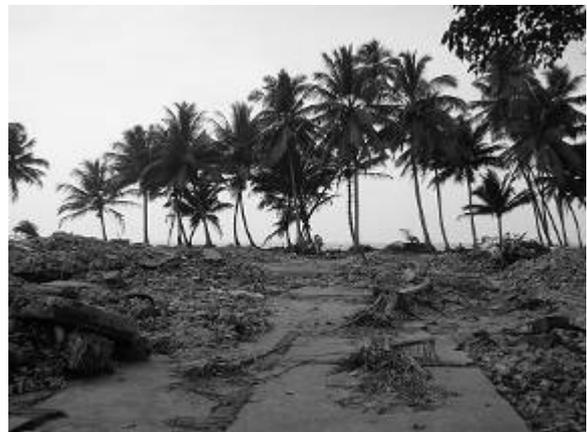
The wooden houses and brick houses were completely destroyed in the low-lying coastal

Photo 3: Destroyed coastal houses.

areas by the 5m tsunami (Photo 3). On the other hand, the rigid concrete houses suffered a few damage. This result was a good agreement with Matsutomi [4] in which the tsunami of more than 2m destroyed the wooden houses and gave the concrete houses a few damage.

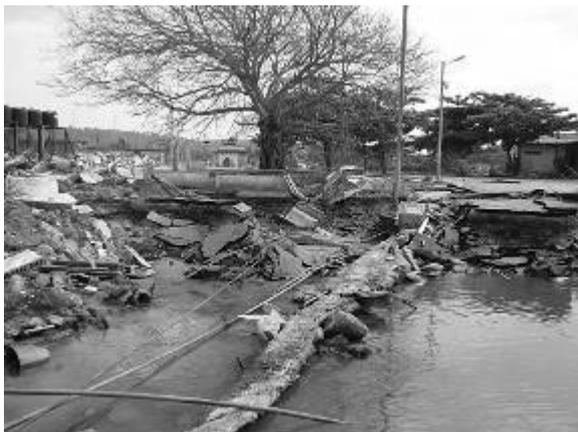
Since the heights of watermarks in Galle Port were in the range from 5m to 6m, the 5-6m tsunami attacked there. The quay walls in the most inner part of the port collapsed by the tsunami action (Photo 4), and a dredger (1,169 tons) was lifted on another quay (Photo 5). However, the breakwaters which were made with stones of 1-2m in diameter had a few damage. In other coats, many jetties consisted of stones were still in good condition after the tsunami disaster. The stones of about 50cm in diameter that prevent coasts erosion were flooded onto the land.

Photo 4: Damage of quay wall.

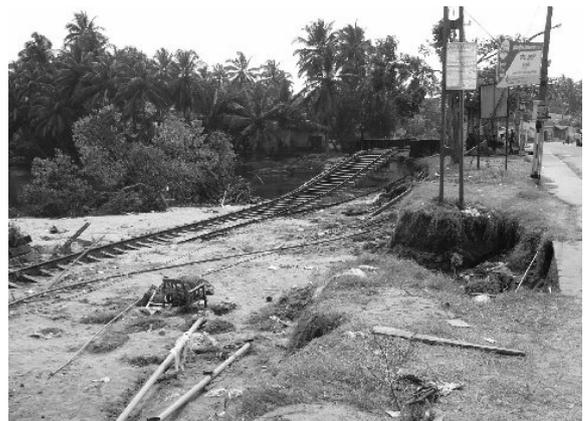
Some beaches were eroded by the tsunami flowing. The receding tsunami shaved off land. It also took away the base of structures, and then the structure had severe damage even if there was little damage in the structure. In Ambalangoda the ground under a railway was eroded by the tsunami overflowed a river, and the railway tracks were greatly bent (Photo 6).

Photo 6: Damaged railway by erosion.

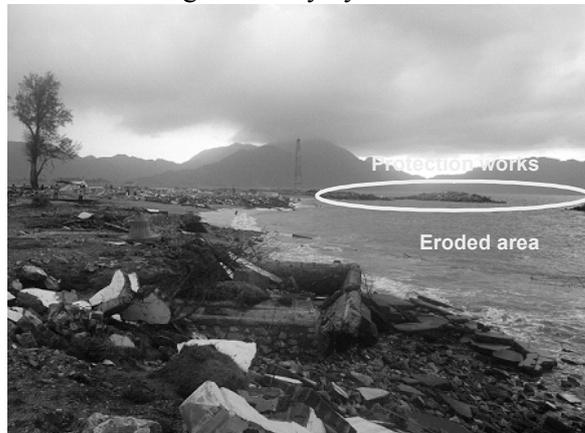
At Banda Aceh in Northern Sumatra, Indonesia, which was near the epicenter, the 10m tsunami eroded the coast severely (Photo 6) and coastal topography was changed. Although there were protection works by stones in this

Photo 7: Eroded beach in Indonesia.

area before the tsunami, the protection works were completely destroyed and the reclaimed areas behind the protection works were eroded more than 1.5m in height. The topographic change can be also seen in Thailand. A sand spit was eroded by the tsunami.
