Continuity and/or Resiliency of Building Function after Disasters

Hiroshi Fukuyama¹, Koichi Morita², Tomohisa Mukai², Taiki Saito¹, Hitomitsu Kikitsu⁴,
Yoshihiro Iwata³, Yoshio Wakiyama³, and Seitaro Tajiri³

ABSTRACT

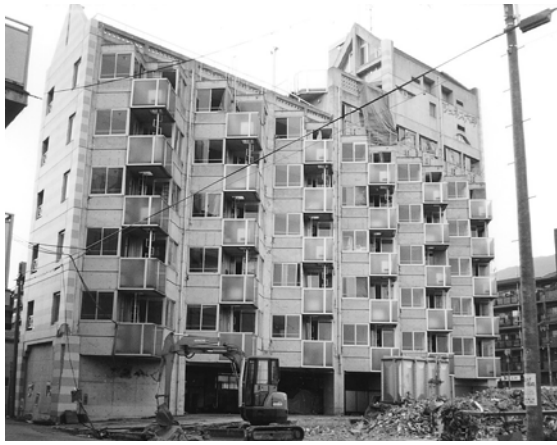
(a) Full view of the building (RC rigid joint structure)

Photo 1 Building designed in accordance with the New Earthquake Resistance Standards: Seriously damaged by the Southern Hyogo Earthquake in 2005, though not collapsed

according to the current seismic code did not collapse as requested by the codes and protected the human life, the damages of structural frame were serious, which needed very large restoration cost, thus the damaged buildings were finally tore down and reconstructed, (refer to Photo 1 as an example.) The cases show the importance of design to have a viewpoint of damage control and of functional resilience. The Geiyo Earthquake in 2001, the Tokachi-Oki Earthquake in 2003, and the Southern Miyagi Earthquake in 2005 generated damages caused by dropping large scale space ceiling. The West-Off Fukuoka Earthquake in 2005 generated damages of window glass of office buildings and of walls and fittings of condominiums (Photo 2). Thus, there appeared the cases that also the damages of those nonstructural members induce danger of human life similar to the cases of damages of structural framework, and that the loss of building function and of dwelling ability results in the difficulty of continuous use of the buildings after disasters.

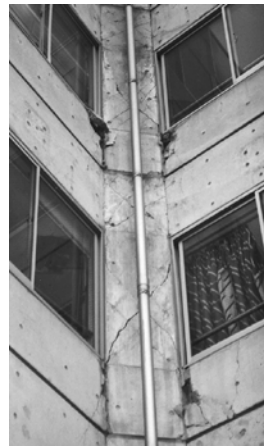
(b) Shearing fracture and damage of pillar

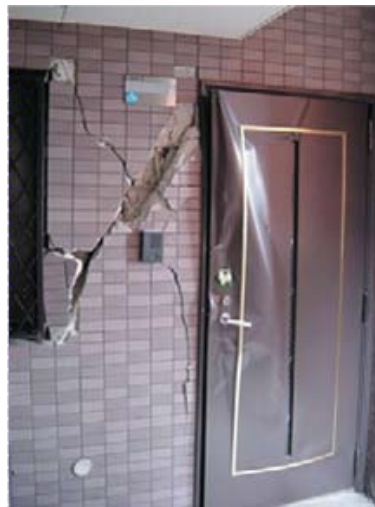
Photo 2 Crack damage of nonstructural wall of corridor of a condominium by the West-Off Fukuoka Earthquake in 2005
