HIGHLIGHTS - TECHNICAL SITE VISITS 39TH MEETING OF THE US-JAPAN PANEL ON WIND AND SEISMIC EFFECTS 17-19 MAY 2007

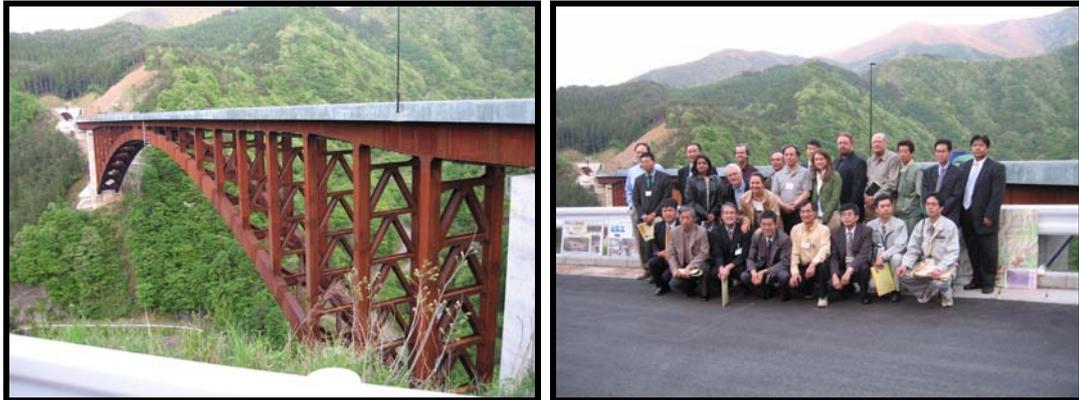
Figure 4: Overview of the Karematsuzawa Bridge (left) and group photo of members of the Panel Delegation at the site (right)

The delegation visited the Karematsuzawa Bridge on the Sanriku National Highway under management of the Tohoku Regional Development Bureau near Kamaishi City, Iwate Prefecture. This 310 m long steel arch bridge, one of the longest arch bridges in Japan, was constructed over the gorge to straighten the 15 km section of a winding highway on steep topographic conditions. The bridge eliminated 46 sharp curves, and reduced a stretch of highway having a 9.6% grade to a 4% grade. The realigned highway and bridge significantly reduced vehicle accidents and driving time. The cost of this 15 km highway construction was \$700 million.

The bridge's steel members were fabricated using weathering steel to reduce bridge maintenance. An issue that may exist is possible environmentally detrimental releases from steel's surface treatment or its interaction with adjoining materials. The delegation was briefed on the method (the cable erection method) used to construct the bridge over an 80 m deep gorge.
