Field Tests of RC Deck Slabs Deterioration Assessment System by Digital Images

Shinya Okada¹, Kenji Ikeda², Kazunori Watanabe³
Hiroshi Koide⁴, Masakazu Uekita⁵

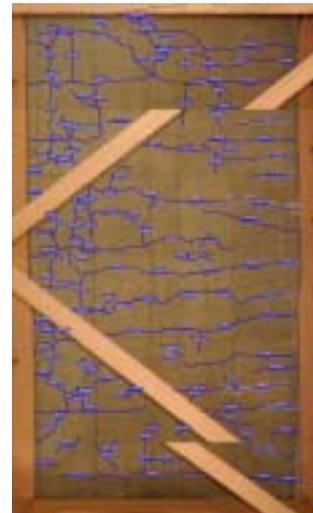
One of slab panels of Viaduct A was evaluated with the System. First, we traced the cracks from digital images of the panel. The automatically calculated cumulative length of the cracks was 58.5m. Based on the spacing between cracks and crack index, the panel was evaluated to have a deterioration level of 4.

Cross cracks

Crack spacing: $0.3 \text{ m} \leq L < 0.5 \text{ m}$

Crack index: $3.0 \text{ m/m}^2 \leq p < 5.0 \text{ m/m}^2$

Deterioration level: 4 --- This assessment result conformed to the assessment produced by the System automatically.

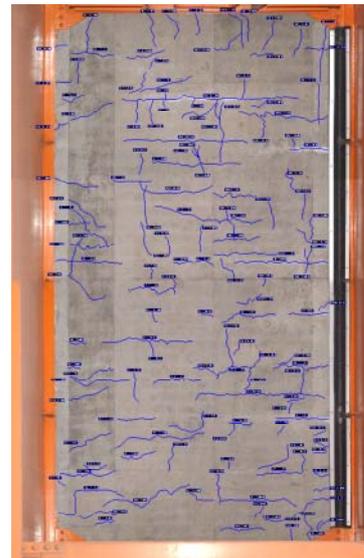
Example 2

Cross cracks

Crack spacing: $0.3 \text{ m} \leq L < 0.5 \text{ m}$

Crack index: $3.0 \text{ m/m}^2 \leq p < 5.0 \text{ m/m}^2$

Deterioration level: 4 --- This assessment result conformed to the assessment produced by the System automatically.

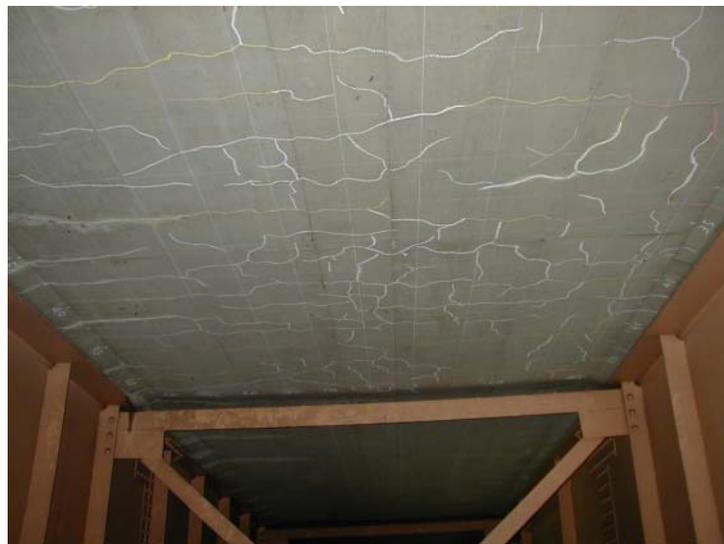
Figure 2 Photograph of the deck panel

By measuring the crack lengths on the diagram made by the inspector, cracks of widths exceeding 0.1 mm had a cumulative length of 75.04 m. Based on crack spacing and crack index, the panel was judged to have a deterioration level of 4. The assessment results and a photograph of the observed deck follow (Figure 2).

Cracks in two directions

Crack spacing: $L = 0.3$ m: 0.3 m $\leq L < 0.5$ m

Crack index: $p = 75.04 / 18.36 = 4.09$ (m/m²): 3.0 m/m² $\leq p < 5.0$ m/m²

→ Deterioration level: 4

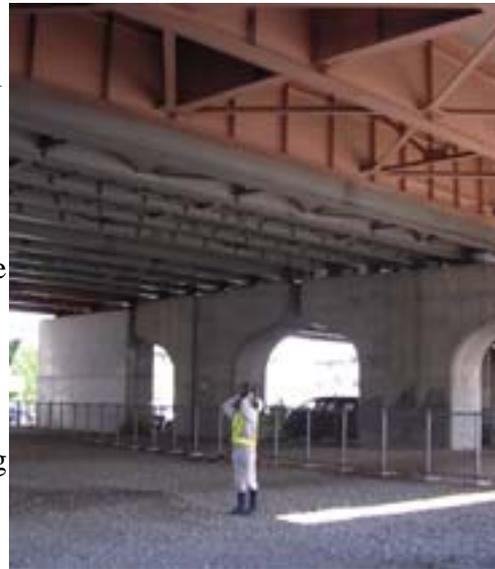
Figure 4. Photographing the

- 1) The deck slab is photographed at the bridge site with digital camera, a process which takes less than 5 minutes per panel.
- 2) In the lab, the digital image is processed, taking about 45 minutes per panel. Cracks in the panel are traced, taking about 10 minutes per panel.
- 3) The deterioration level of the panel is assessed from the traced cracks, requiring only a few seconds per panel.
