# PERFORMANCE EVALUATION OF SHEAR LINKS AND ORTHOTROPIC BRIDGE DECK PANELS FOR THE SAN FRANCISCO-OAKLAND BAY BRIDGE

Chia-Ming UANG<sup>1</sup>, Frieder SEIBLE<sup>1</sup>, Cole MCDANIEL<sup>2</sup>, and Chung-Che CHOU<sup>3</sup>

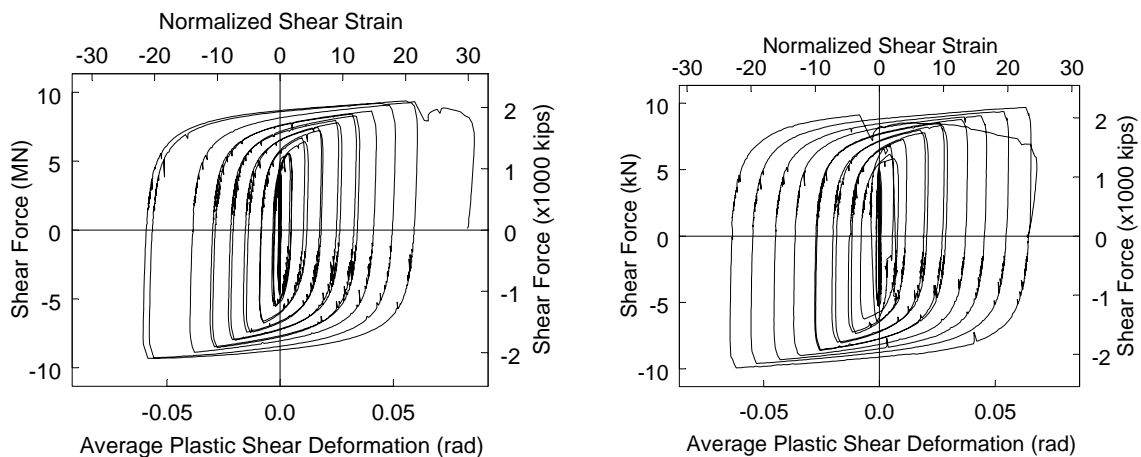
(a) Type 1 Specimen

(b) Type 3 Specimen

**Figure 10** Link Shear Force versus Inelastic Rotation Relationships

The link shear versus average shear deformation relationships of the deformable region are shown in Figure 10. Excluding the last incomplete cycle, the inelastic rotation reached 0.06 and 0.066 radians for the TYPE 1 and TYPE 3 links, respectively. The shear deformation in the connection regions was low, with the response remaining in the elastic range throughout the test.

The overstrength factor developed in each of the two test specimens was calculated by dividing the maximum shear strength by the plastic shear strength, which was based on the measured yield strength of the web material. The corresponding overstrength factors are 1.83 and 1.94, indicating that the value (1.25) recommended by the AISC Seismic Provisions for capacity design is non-conservative by a large margin.

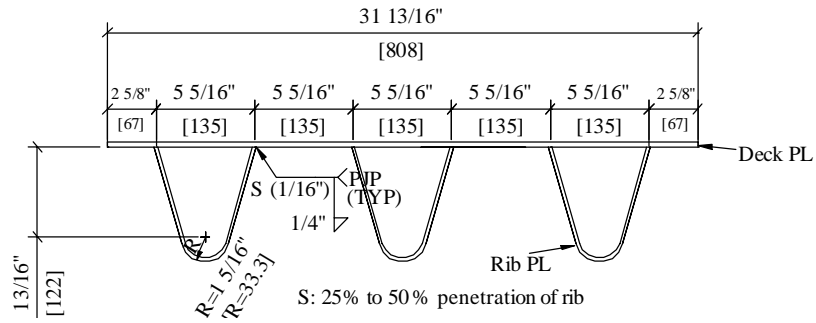
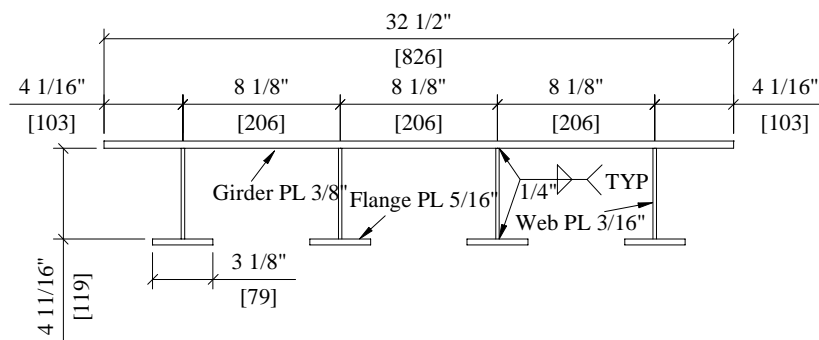
(a) Specimen 1

(b) Specimen 2

**Figure 13 Cross Section of Orthotropic Bridge Deck Specimens**

Portions of the top and bottom decks of a box girder (Figure 3) were investigated in this study. Since floor beams are spaced at 5 m on center inside the box girder, each deck can buckle longitudinally in an S shape. To study the buckling behavior of the stiffened panels in both positive and negative bending directions, it was decided that each specimen include two spans. Reduced-scale models were tested due to the high force demand for testing. Figure 13 shows the cross sections of both specimens. Specimen 1, with a scale factor of 0.45, was composed of three closed ribs and a top deck plate; Specimen 2, with a scale factor of 0.48, was made up of a bottom deck plate and four T-shaped ribs.

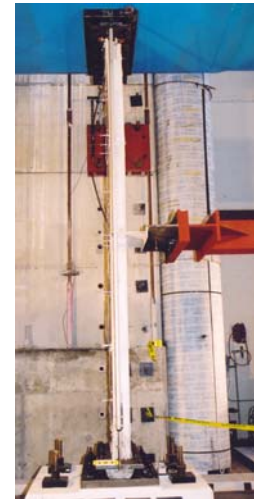
(a) Schematic

(b) Elevation

**Figure 14 Bridge Deck Test Setup**

The test setup, shown in Figure 14, was composed of a horizontal loading beam, pin devices at both top and bottom ends, a specimen, and a concrete support. A lateral support connected by a diaphragm plate at the mid-height of the specimen was designed to simulate the lateral restraint provided by the floor beam.

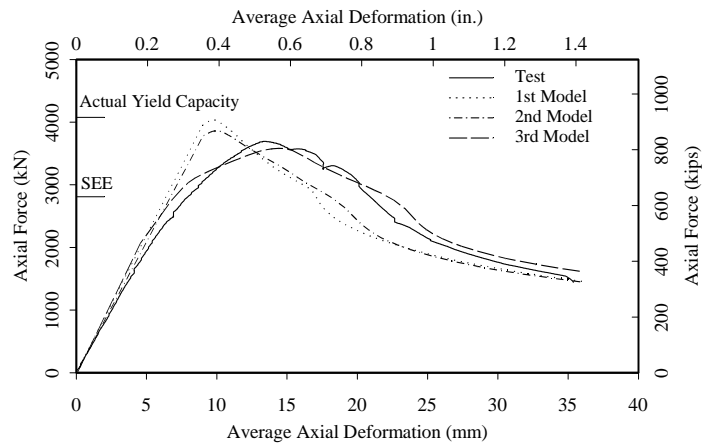
(a) Specimen 1

(b) Specimen 2

**Figure 15 Applied Load versus Axial Deformation Relationships (Deck Specimens)**

The applied load versus axial deformation relationship of Specimen 1 is shown in Figure 15(a), in which both the yield capacity based on the actual yield strength and the seismic demand produced by an SEE event are marked. As the load was gradually applied, the maximum strength of the specimen was reached at  $\Delta = 14$  mm. The upper panel buckled in one direction and the lower panel buckled in the other direction as shown in Figure 16(a). As the imposed axial deformation was increased further, local buckling of the deck plate across the width of the upper panel was observed, which then triggered rib buckling; the symmetric bulging buckling configuration of the ribs shown in Figure 16(b) was compatible in deformation with the buckling pattern of the deck plate. Figure 16(c) shows the buckling of the ribs that occurred near the upper end of the lower panel; note that the deck plate did not buckle. This buckling configuration is different from that shown in Figure 16(b) for the upper panel. The difference was primarily caused by the direction of bending after the maximum strength of the specimen was reached.

The applied load versus axial deformation relationship of Specimen 2 is shown in Figure 15(b), in which the SEE demand and actual yield capacity are also marked. The peak compression force was reached at  $\Delta = 17$  mm, with the specimen buckled in reverse curvature as shown in Figure 17(a). Torsional buckling of the T-shaped ribs was observed in the lower panel of the specimen [see Figure 17(c)], but torsional buckling of the ribs was not observed in the upper panel [see Figure 17(b)]. Twisting of the specimen at the lower panel was also observed at the later stage of testing. It was due to the loss of torsional rigidity of the section after the T-shaped ribs experienced torsional buckling. No torsional buckling of the T-shaped ribs and twisting of the section was observed in the upper panel, but local buckling of the deck plate was observed between the intersection points of the web and girder plates.

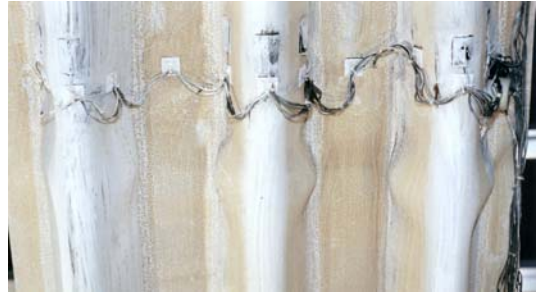
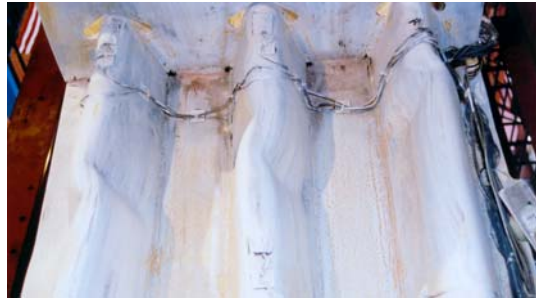
(a) Overall View

(b) Upper Panel

(c) Lower Panel

**Figure 16 Deformed Configurations after Testing (Deck Specimen 1)**

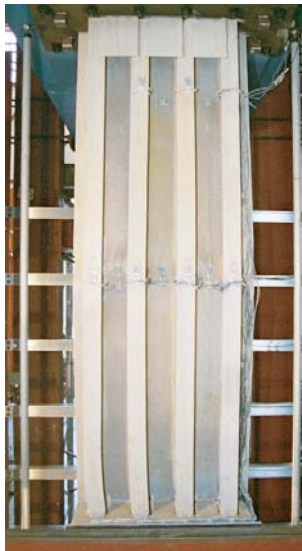
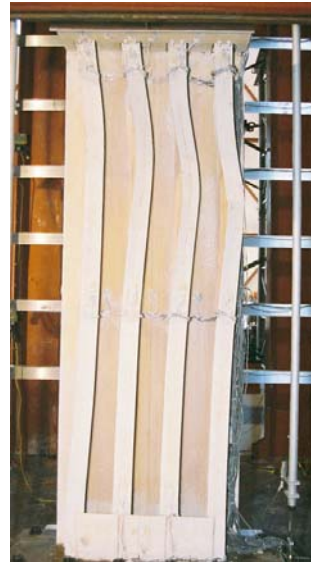
(a) Overall View

(b) Upper Panel

(c) Lower Panel

**Figure 17 Deformed Configurations after Testing (Deck Specimen 2)**
