STATIC AND FATIGUE BEHAVIOR OF THE CONNECTIONS OF ALUMINUM DECKS TO STEEL GIRDERS

ABSTRACT

Keywords: aluminum deck, steel girder, static and fatigue behavior, shear connector, non-shrinkable mortar

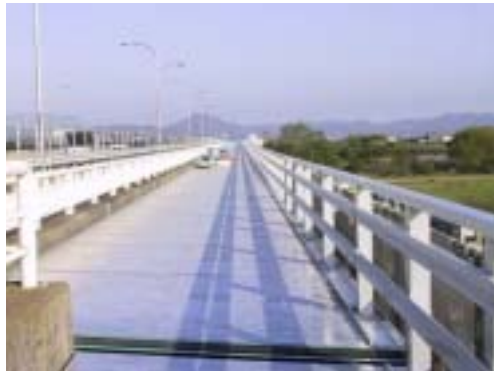
Figure 1. Aluminum deck of the Shin-kakogawa bridge

Since then, as shown in Fig. 1, an aluminum deck was adopted for the sidewalk to widen the roadway of the Shin-Kakogawa bridge in Hyogo prefecture. The aluminum deck used is about 4 m in width and about 400 m in length.

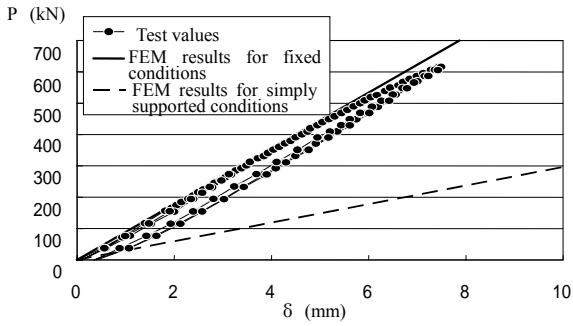
Figure7. Relation between load and deflection at span center

Figure 7 presents the relation between the load and the vertical deflection at the span center. The load is taken on the vertical axis, and the vertical deflection is done on the horizontal axis. The thick solid line represents the FEM results for the fixed conditions at both the ends of the beam of 2m in length, and the thick broken line does for the simply

supported conditions.

For the first loading to 294 kN, the residual deflection is almost zero. The curve for the second loading to 618 kN is not on the unloading curve, leaving a residual deflection. Since the curves for the first and second loadings have almost the same slope as that of the thick solid line, the degree of the connection of the aluminum extrusion to the steel girder is near the fixed conditions at both the ends.

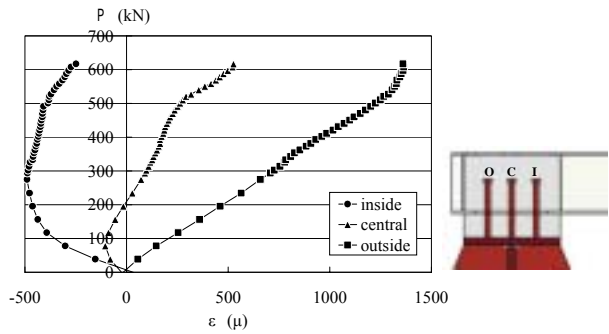
Figure8. Relation between load and strains of studs [North connection]

Figure 8 shows the relation between the load and the strains of the stud shear connectors. The strains are an average of the two strain gauges which are glued symmetrically about the axis of the studs. The tensile force is produced in the central and outside studs, and the compressive force is done in the inside stud. The compressive force of the inside stud decreases at the load 300 kN. While the increase in strain of the outside stud stops above the load 520 kN, the strain of the central stud increases. Accordingly the share of the load shifts from the outside stud to the central and inside ones.

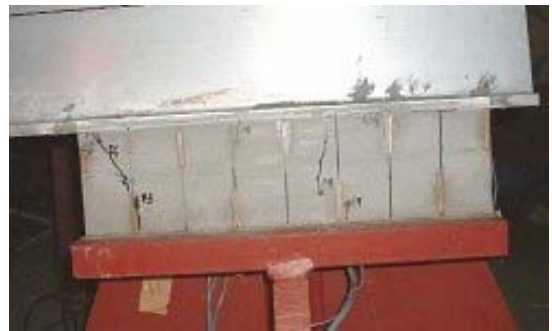
Figure10. Appearance of cracks of supporting mortar of simple beam type specimen [North connection, Back side]

Figure 10 shows the appearance of the cracks on the side of the supporting mortar after the loading to 618 kN. Since the width of the cracks is too small to see, the cracks are exaggerated by a marker.

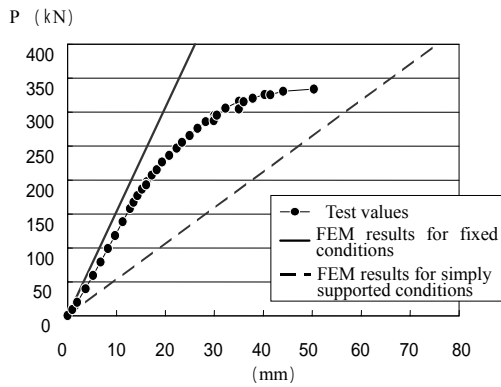
Figure 12. Relation between load and deflection

Figure 12 presents the relation between the load and the vertical deflection just under the load. The test results are the values for the fourth loading. The thick solid line is the FEM

results for the cantilever beam of 1 m in length, and the thick broken line is those for the overhang beam of 1 m in length with the simple beam of 2 m in length. The test values vary linearly until 207 kN. The test values are closer to the FEM results for the cantilever beam than those for the overhang beam. From this, as in the simple beam type specimen, the connection of the overhang type specimen is also rigid.

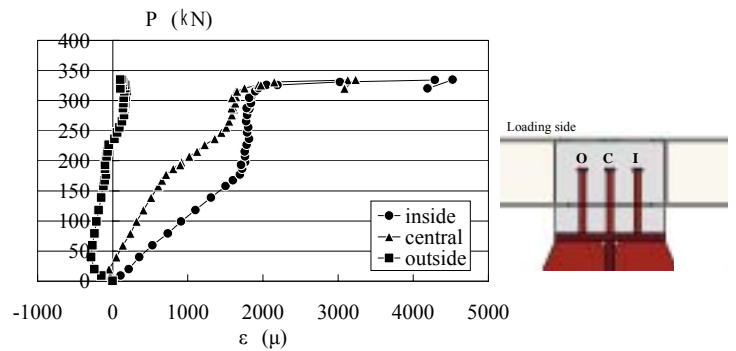
Figure 13. Relation between load and strains of studs [North connection]

Figure 13 shows the relation between the load and the strains of the stud shear connectors. The strains are the axial strains, that is, the average strain mentioned in Subsection 3.1.3. The tensile force is developed in the central and inside studs. In the outside stud, the force is compressive until 220 kN, and after that, it is tensile. While the increase in strain of the inside stud stops at the load 177 kN, the strain of the central stud increases. As in the simple beam type specimen, the force shifts from the inside stud to the central and outside ones.

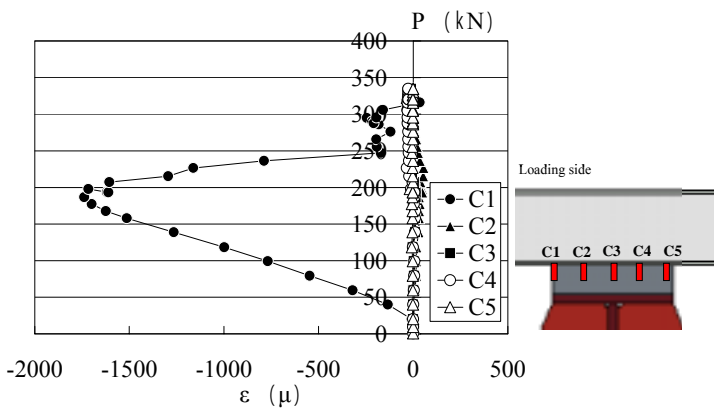
Figure 14. Relation between load and strains on the side of supporting mortar [North connection]

Figure 14 shows the relation between the load and the vertical strains on the sides of the supporting mortar. The compressive strain is developed only at the strain gage C1. The values of the strain gage C1 decreases at the load 190 kN, since the strain of the supporting mortar around the strain gauge is released due to cracking.

As in the simple beam type specimen, the tensile force of the studs and the compressive force at the edge of the supporting mortar develop a moment, which makes the connection rigid.

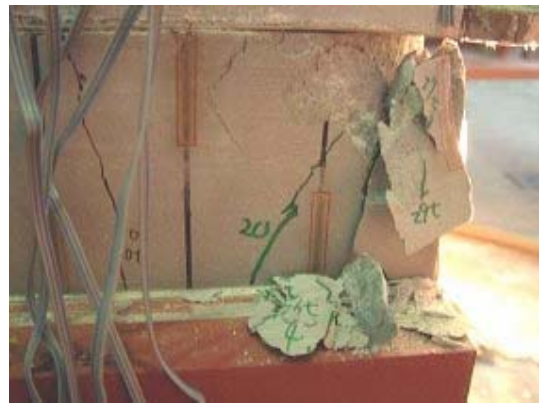
Figure 15. Crushing of supporting mortar in overhang type specimen [North connection, Back side]

Cyclic loadings were repeated 5 times with a gradual increase at each loading. The maximum loads were 98 kN, 138 kN and 178 kN at the first, second and third loadings, respectively. At the load 334 kN in the fourth loading, the edge on the loading side of the supporting mortar of the north connection was crushed. At the load 326 kN in the fifth loading, a crack started at the edge of the air-release hole of the top flange on the loading side of the aluminum extrusion. Then the statically loading test was terminated.

Figure 15 shows the appearance of crushing of the supporting mortar after the loading to 334 kN.

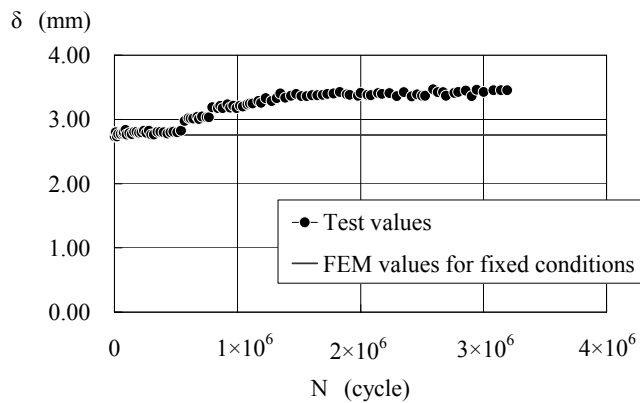
Figure 16. Relation between deflection at span center and number of cycles

Figure 16 shows the relation between the deflection at the span center and the number of cycles. On the vertical axis, the deflection at the upper load 245 kN is taken, and on the horizontal axis, the number of cycles is done. In the figure, the horizontal line represents

the deflection given by the FEM for the beam of 2 m in length with both the ends fixed.

The deflection at the first loading was identical to the FEM value. The deflection suddenly increased at 5.7×10^5 cycles and 7.95×10^5 cycles, since the outside studs of the south and north connections broke at these numbers of cycles, respectively. The deflection increased moderately from 7.95×10^5 cycles to 2.59×10^6 cycles. After 2.59×10^6 cycles, the deflection did not vary.

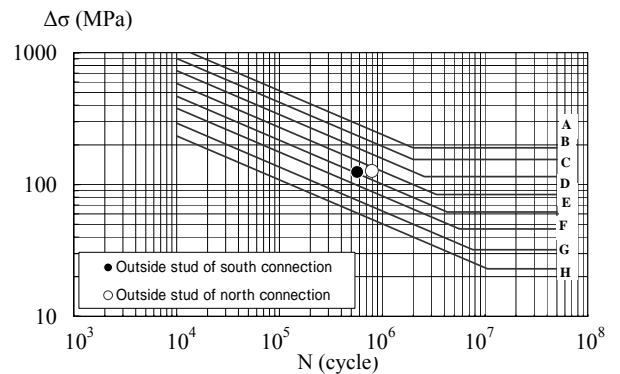
Figure 17. S-N relation of studs

Figure 17 shows the range of axial stress of the studs and the number of cycles when the studs broke due to fatigue cracking. The range of axial stress of the studs is taken on the vertical axis, and the number of cycles is done on the horizontal axis. The design S-N curves specified in the Japanese Fatigue Guideline²⁾ are also presented in the figure. The

fatigue strength of the studs used in the connections is compatible with the grade E, as was predicted.

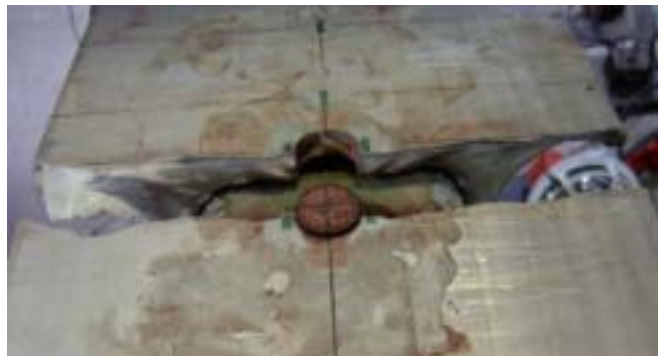
Figure 18. Fatigue crack initiated at the air-release hole of the top flange of the aluminum beam

At 1.2×10^5 cycles, as shown in Fig. 18, a fatigue crack was initiated at one edge of the air-release hole of the top flange of the aluminum beam on the loading side in the north connection, and at 1.43×10^5 cycles, a fatigue was produced at another edge of the hole. At 1.88×10^5 cycles, the fatigue cracks propagated to both the edges of the top flange. At 1.89×10^5 cycles, when the load was statically loaded to measure the deflection and the strains, the top flange of the aluminum beam broke at the load 94 kN.

To avoid the cracks at the air-release hole, it is required to move the location of the hole or to change the shape of the hole to an ellipse.

- (4) In the fatigue test of the overhang type specimen, fatigue cracks are initiated at the air-release hole on the top flange of the aluminum beam. It is required to move the location of the hole or to change the shape of the hole to an ellipse.
