Advanced Composites for Rehabilitation/Improvement of Existing Bridges

John M. Hooks¹

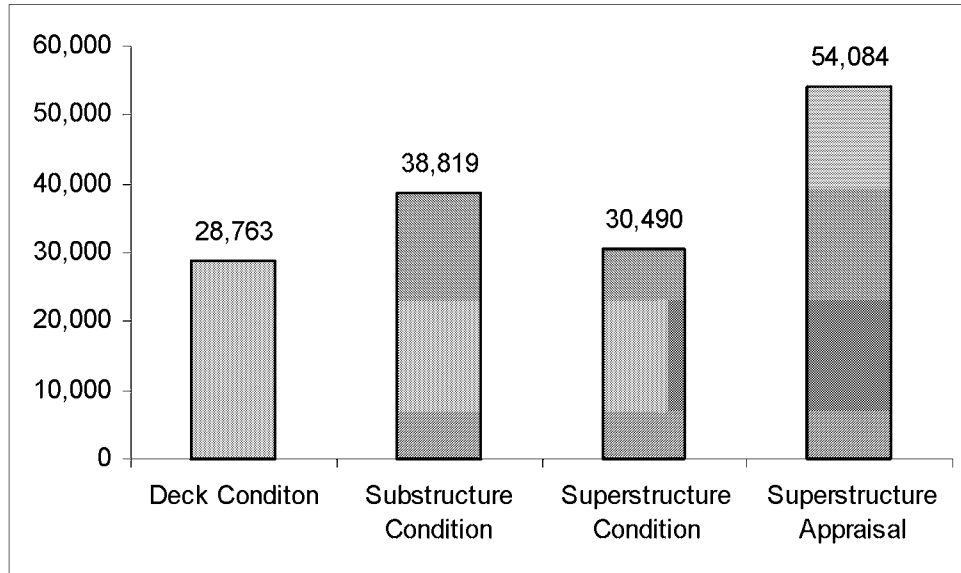
Figure 2 – Major Causes of Bridge Deficiencies

rating and superstructure condition rating. Figure 2 shows the numbers of bridges rated deficient on the basis of various poor condition ratings or appraisal ratings.

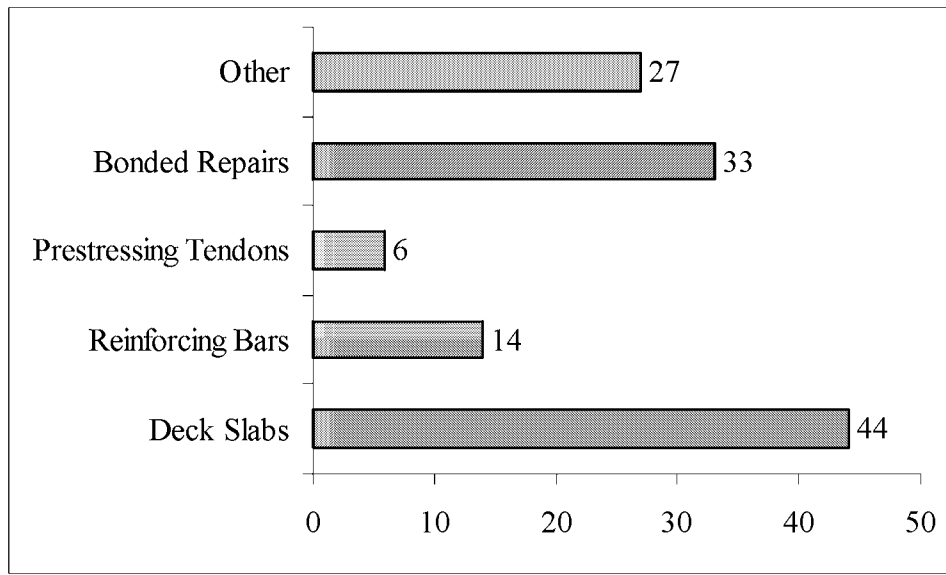
Figure 3. IBRC Projects, 1998 – 2003 Using FRP Composites in Highway Structures

One hundred and twenty-four of these projects involve the use of FRP composites applications including bridge decks, concrete reinforcement, prestressing tendons, column wrapping or bonded sheets to increase bridge strength. Figure 3 shows the distribution of types of IBRC projects using FRP composites for bridge repair rehabilitation or new construction.

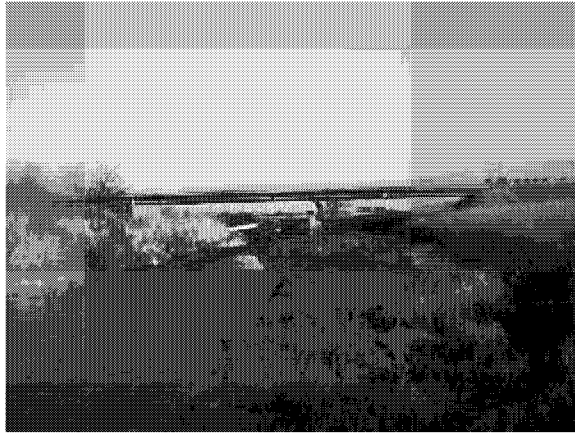
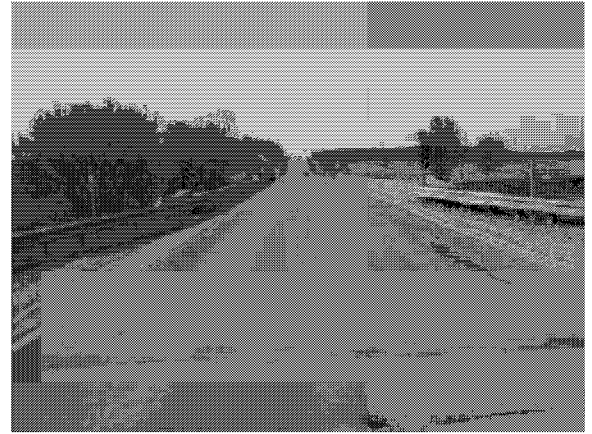
4 (a) Side view

4 (b) Road way

Figure 4. State Highway 141 bridge over Willow Creek (Wipf et al, 2003)

Iowa bridge number 3903.0S 141, designed and built in 1955, carries Iowa State Highway 141 over Willow Creek in Guthrie City, Iowa. As seen in Figure 4, this bridge is a three span continuous rolled shape steel girder-bridge, 210 feet (64.0 meters) in length and 26 feet (7.9 meters) wide. The bridge consists of two end spans of 64 feet (19.5 meters) and a center span of 82 feet (25.0 meters) with four beams spaced at 8 feet & 3 inches (2.5 meters) on center. The roadway width carries two traffic lanes and a narrow shoulder. The interior beams are wide flange (WF) 33 X 141 and the exterior beams are WF30 X 116. The bridge is currently rated with an HS 11.0 Inventory Rating and an HS 18.7 Operating Rating. This bridge is rated structurally deficient due to a

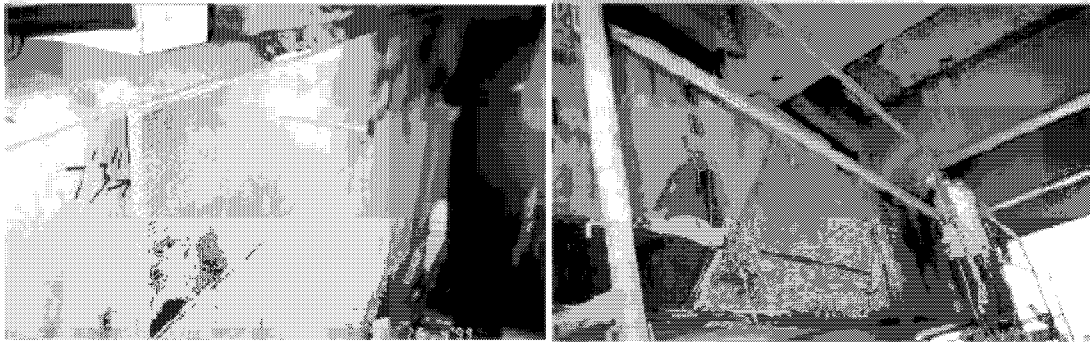
Figure 7. Flexure and shear plates for FRP repairs (Hag-Elsafi, 2002)

The targets for improvement were an increase of 10 percent in the capbeam's shear capacity and an increase of 20 percent in the capbeam's moment capacity. Flexural and shear plates, made of carbon/glass hybrid and glass materials, respectively, were used for strengthening of the Pier 3 capbeam (Figures 7a and 7b). The flexural plates are 0.5 inches (13 millimeters) thick, 10 inches (254 millimeters) wide, and 17 feet (5.18 meters) long. The shear plates are .27 inches (7 millimeters) thick, 3.6 feet (1.1 meters) wide, and 5.6 feet (1.7 meters) long, shaped as seen in Figure 7. The FRP plates were bonded to the capbeam surfaces (Figure 8) by an epoxy resin. Surface preparation was a simple power washing to remove loose debris and concrete. Two different methods were used to ensure adequate contact while the resin was curing. On one side, anchor bolts applied clamping force and on the other side, a wooden clamping frame was used to apply a more uniform clamping force.

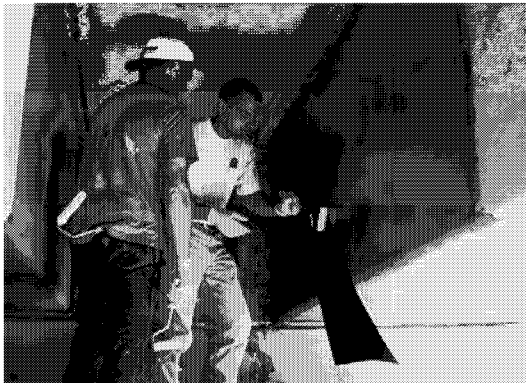
Figure 11 – Placing Carbon Fabric on Beams

After surface preparation of injecting cracks and filling voids, fabric was placed on 45 degree angle (Figure 11)
