# Pile to Slab Bridge Connections

## Abstract

Slab bridges are a common bridge type, where the pile extends directly from the ground to the superstructure. Most codes provide little direct design guidance for pile extension connection details for slab bridges. Unlike the column to box-girder bridge connections, which are often under extensive discussion, slab-bridge connections are rarely discussed. The project results will provide standardized details as well as rational methodology for designing and analyzing these connections. Eight large to full-scale column-slab bridge connection will be tested in this study. Column (pile)-slab connections include drop cap-column, flat slab-column, and knee. The first two columns have been tested and two others specimens are preparing for testing. The paper will discuss model selection and design, test setup, instrumentation of the specimens, loading program, observation during tests and the future steps.

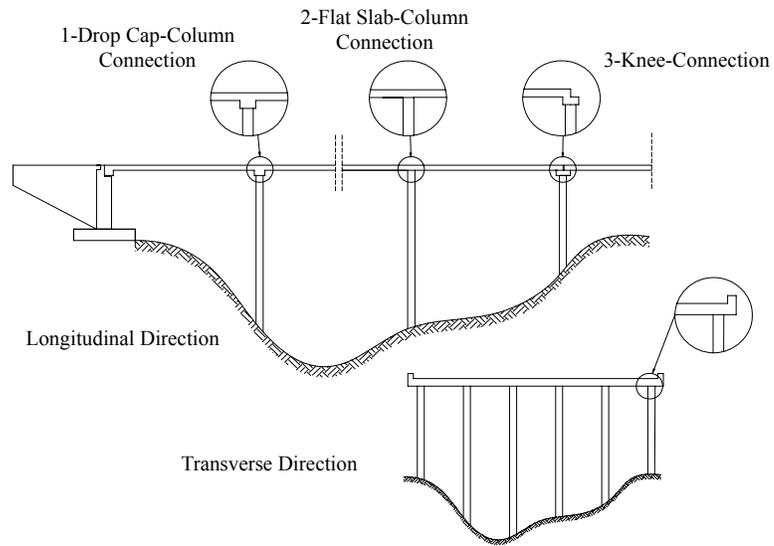
Figure. 1 Slab Bride Connections.

The State of California has a large number of highway bridges; many of them are slab bridges. Although slab bridges are a common type of bridge, the current version of the Bridge Design Specification (BDS) [Caltrans, 2006] and the Seismic Design Criteria (SDC) [Caltrans, 2007] provides little direct design guidance for pile extension connection details for slab bridges. The drawings for slab bridges examined in this study are extracted from the Bridge Design Aid (BDA) [Caltrans, 2004] of Caltrans. This project focuses on the design and detailing of the connection region for pile extension to slab bridges, see Figure 1.

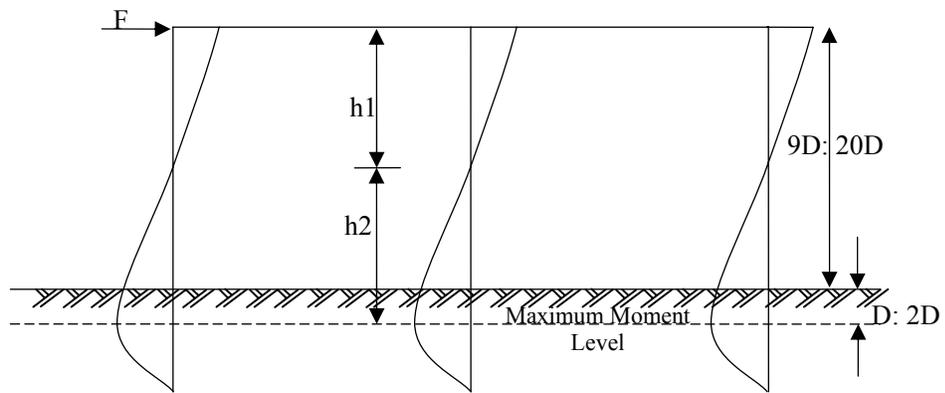
Figure 2 Typical Moment Diagram for Lateral

The embedded length of the column varies according to the soil type. In the plans submitted by Caltrans to University of Nevada, Reno (UNR), the height of the column above the ground ranged from 9D to 20D. Therefore, an average height of the column above the soil surface equals 14.5D. The point of the maximum moment for the individual column can be approximated at D to 2D under the surface of the soil as shown in Figure 2. This increases the average total length to 15.5D to 16.5D, the column inflection point was chosen to be approximately halfway between column top and maximum moment point in the soil. Therefore, the data indicates that the columns are typically flexural members. Columns with shear lengths

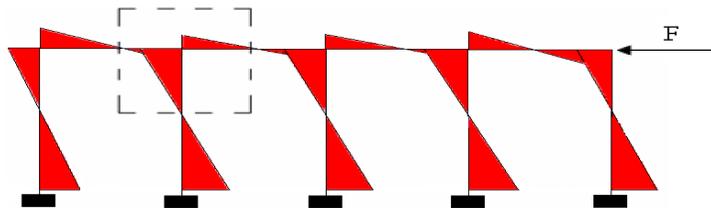
Figure 3 Moment Diagram System for Lateral Load

equal or greater than 6D are considered flexural members. Therefore, the height of the specimen was chosen to be 7D. The effective slab length of the specimen in the direction of loading (transverse of the bridge) is determined by the distance between the points of zero moment due to lateral load as shown in Figure 3.

**Test Setup:** The test setup was selected to provide the same loading as the actual bridge. A comparison between Figures 3 and 4a shows the same moments at the joint. The transfer of axial loads to the specimen was accomplished through a steel I-beam that was placed across the column top as shown in Figure 4b. The initial axial load force was applied by means of hydraulic jack on top of the I-beam. Prestressing bars were extended vertically and anchored at the top of the jacks and the bottom of the slab. Longitudinal beams were used beneath the slab to transfer the force to the slab. To minimize axial load fluctuation under different drift levels, a pressure accumulator was hooked to the hydraulic system between the pump and the jacks. At the beginning of each test, the desired axial load was applied prior to lateral loading. To create the inflection point and prevent moment generation at the slab ends, hinges were used to enable the slab to rotate (see Figure 4b). Lateral load was applied by means of a 220-Kip MTS hydraulic actuator. The actuator was connected to reaction blocks. In its initial position, the actuator was level and had a potential maximum stroke of plus/minus 15 inches (380 mm)

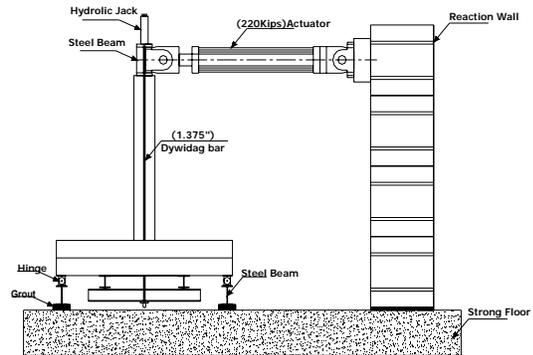
Figure 4b Test Setup

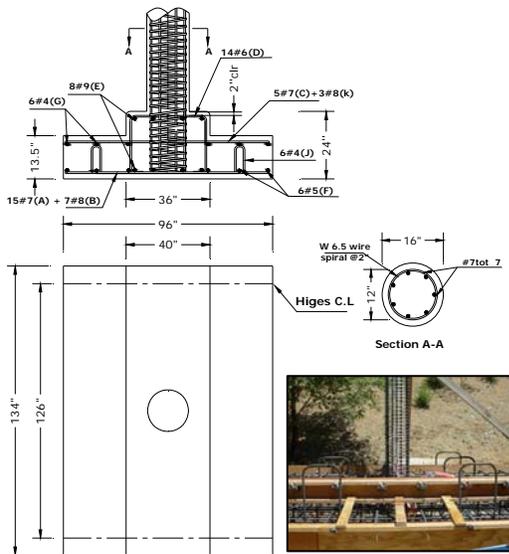
Figure 5 DCRC1 Specimen Dimensions and Reinforcement

**DCRCCI Reinforcement:** This specimen represents the slab-column connection for a 34-ft (10.4-m) multi-span bridge. The reinforcement is the same as what would be found in the prototype bridge since the specimen is full scale (see Figure 5)

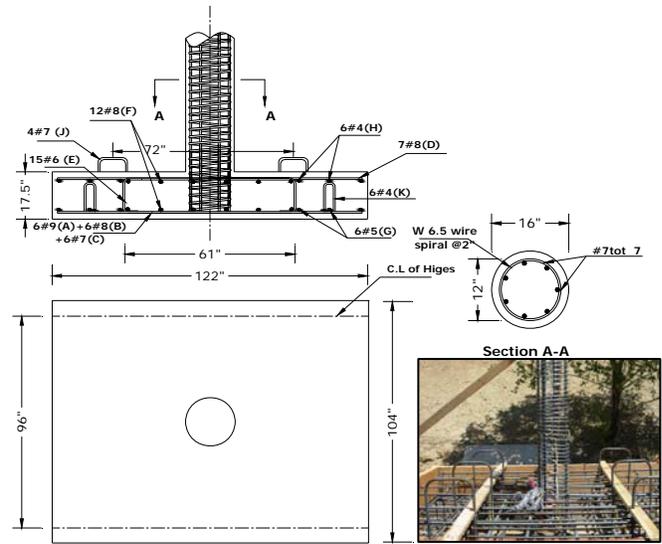
Figure 6 SRCC1 Specimen Dimensions and Reinforcement

**FSRCCI Reinforcement:** This specimen represents the slab-column connection for a 24-ft (7.3-m) two-span bridge. The reinforcement is the same as what would be found in the prototype bridge since the specimen is full scale (see Figure 6).

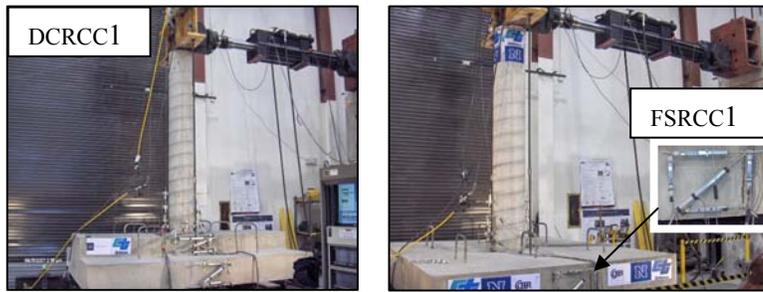
Figure 7 LVDT's Instruments

The specimens were instrumented with an array of strain gauges, linear variable differential transformers (LVDT's), and load cells. Longitudinal and transverse reinforcement in the column and slab region were instrumented with strain gauges. Strain in the concrete and curvature along the potential plastic hinge length of the column were determined by means of five pairs of LVDT's. The LVDT's were placed within a height of 20 inches (500 mm) from the bottom of the column as shown in Figure 7. The lateral deflection of the column was measured along the center-line of the lateral load. Vertical and lateral loads were monitored by load cells.

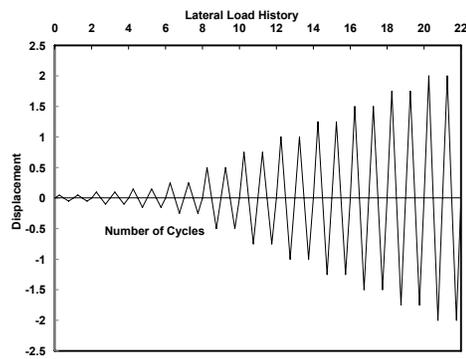
Figure 8 Typical Cyclic Load Diagram

The basic test program will be the same for all eight specimens. The axial load will depend on the particular case. The cyclic loading (see Figure 8) is divided into two parts: force control and displacement control. The load is increased until it reaches 75 % of the estimated yield load. A displacement ductility of one is based on the displacement of 4/3 times the displacement at 75% of the estimated yield load. The specimen was considered to be failed when the lateral load capacity for the specimens dropped to 80% of its maximum capacity.

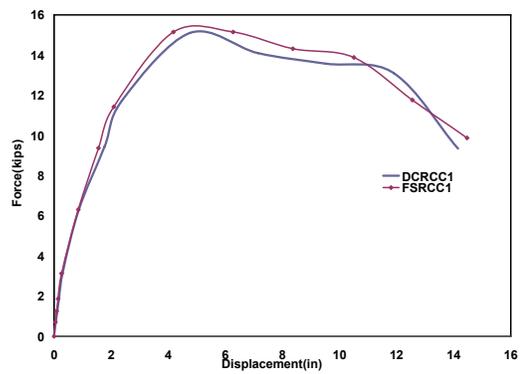
Figure 9 Push-Over Curve

**Specimen FSRCC:** The specimen was subjected to constant axial load equal to 70.40k (313.2 kN). This is approximately  $0.078f'c A_g$  of the column. The corrected force-displacement relationship for the experimental results (Push-over curve) is plotted in Figure 9. The hysteretic load-displacement response of specimen FSRCC1 is shown in Figure 12. At displacement ductility ( $\mu_{\Delta}$ ) of approximately  $\pm 1$ , the specimen did not show signs of strength decay or significant stiffness degradation. During the second excursion of  $\mu_{\Delta} = \pm 2$ , slight stiffness degradation was apparent. When the specimen was taken to the second cycle of  $\mu_{\Delta} = \pm 2$ , the concrete started to spall on both sides of the column. The peak measured lateral load was 15.15 kips (67.39 kN) The peak load occurred at the end of the second excursion of  $\mu_{\Delta} = \pm 3$ . As the specimen was pushed to higher ductility, the cover concrete at the bottom of the column spalled off at an increasing rate. Flexural cracks also developed along the column height. During the second excursion of  $\mu_{\Delta} = \pm 4$  one of the longitudinal bars fractured. During the first excursion of  $\mu_{\Delta} = \pm 5$  the spiral and longitudinal reinforcement were exposed. Spalling appeared on the slab as shown in Figure 13. When the specimen was pushed to 14.34 inches (364 mm), the longitudinal bars on the compression side completely buckled and the spiral fractured. The ultimate displacement was 12 in at a  $\mu_{\Delta}$  of 5.80 and a load of 12.12 kips (53.91 kN) (80% of the maximum load). Figure 14 shows the specimen during last stages of the test. A review of the strain gauge data showed that yielding occurred in the column longitudinal reinforcement. One column transverse reinforcement strain gauge showed yielding towards the end of the test. The column transverse reinforcement in the connection had high strains but did not yield. None of the slab longitudinal reinforcement yielded. The slab transverse stirrups showed high strains, but didn't yield.

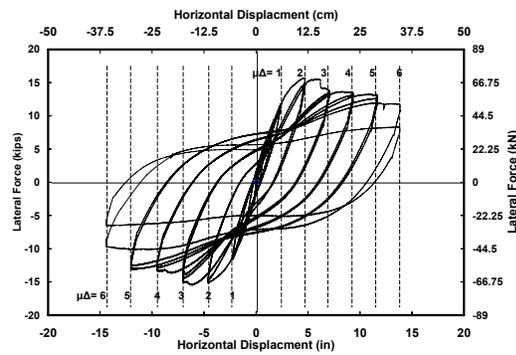
Figure 10 Measured Lateral Load-Deflection Hysteresis Loops - DCRCC1

***Specimen DCRCC1:*** The specimen was subjected to constant axial load equal to 76.40 kips (340 kN). This is approximately  $0.072f'_c A_g$  of the column. Due to the column deflection, the axial load generates a horizontal component in the opposite direction of the horizontal force of the actuator, so the horizontal force must be corrected. The corrected force-displacement relationship for the experimental results (Push-over curve) is plotted as shown in Figure 9. The hysteretic load-displacement response of specimen DCRCC1 is shown in Figure 10. At displacement ductility ( $\mu_\Delta$ ) of approximately  $\pm 1$ , the specimen did not show signs of strength decay or significant stiffness degradation. During the second excursion of  $\mu_\Delta = \pm 2$ , slight stiffness degradation was apparent. When the specimen was taken to the second cycle of  $\mu_\Delta = \pm 2$ , the concrete started to spall on both sides of the column. The peak measured lateral load was 15.1 kips (67.2 kN). The peak load occurred at the end of the second excursion of  $\mu_\Delta = \pm 2$ . As the specimen was pushed to higher ductility, the cover concrete at the bottom of the column spalled off at an increasing rate. Flexural cracks also developed along the column height. During the first excursion of  $\mu_\Delta = \pm 4$  the cracks started to widen and the spiral and longitudinal reinforcement started to be exposed. When the specimen was pushed to 14.15 in (359 mm), the longitudinal bars on the compression side were completely buckled and the spiral fractured.

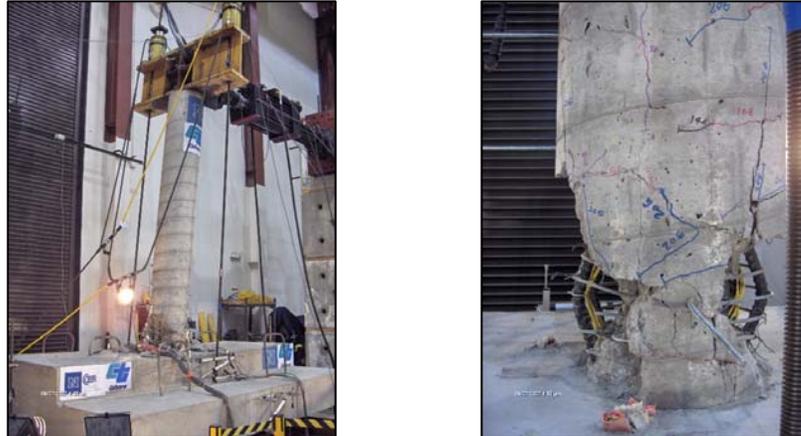
Figure 11 Specimen DCRCC1 During Last Stage

At a load equal to 75% of the maximum load, the displacement was equal to 1.768 in (44.9 mm) and ductility displacement was set at  $0.75\mu$ . Therefore at the ultimate displacement of 14.15 in (359 mm), produces a ductility of  $\mu_\Delta = 5.98$ . Figure 11 shows the specimen during last stages of the test. At the end of the test the slab had no significant crack and all the failure occurred in the

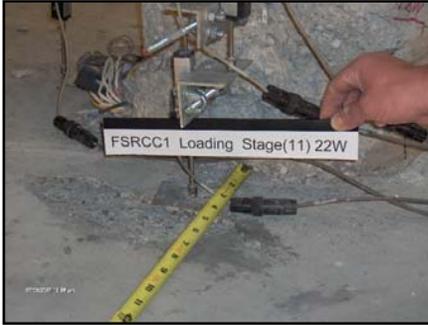
Figure 13 Minor Cracks on the Slab Surface

The visual inspection showed that there were no cracks in DCRCC1. Minor cracks were seen

because of surface spalling as mentioned before in FSCRCC1. That inspection proved that the design of slab was good.

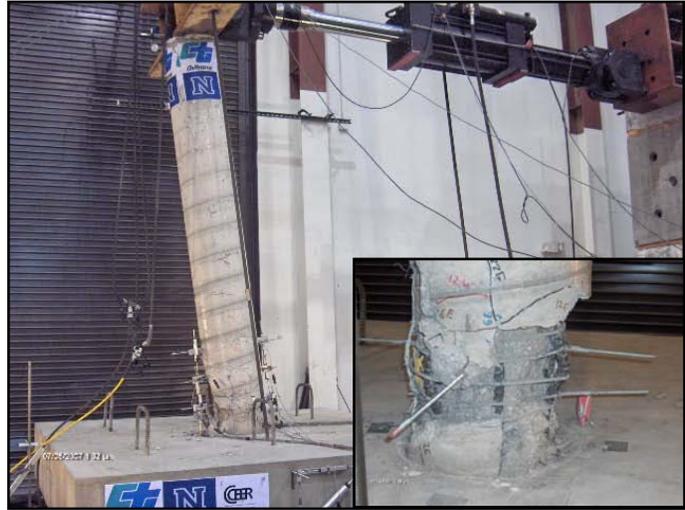
Figure 14 Specimen FSRCC1 During Last Stage
