SEIMIC REINFORCEMENT OF 1ST IBI VIADUCT

Abstract

The 1st Ibi viaduct is a three-span continuous bridge with two abutments and two piers. The piers of the bridge are designed flexible to follow the superstructure's displacement caused by the temperature change and by others.

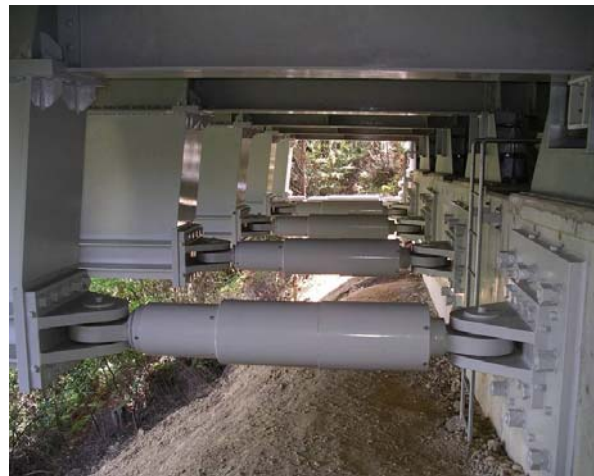
Photo 1 DAMPERS INSTALL (4A)

Photo 1 shows the dampers which were installed in the 1st Ibi viaduct (at 4A). Since the safety of the bridge at large-scale earthquakes is dependent on these dampers, they are required to have their functions for a long time, and to work certainly in case of any earthquakes. It is necessary to get their condition correctly, and to maintain them in good condition.

It is thought that the dampers would have high durability, since it has been checked that the silicone resin, which is used as the resistance object of the damper, has high chemical stability and durability by the accelerated weathering test. However, the durability of the dampers has not yet checked

directly. And the dampers had begun to apply to bridges recently, so there are not so many dampers installed for long period. The information about their durability is not enough. Therefore, in order to get reliable information more, we and the maker of the dampers have started the damper's exposure test.

In this test, the small damper of same type installed in the bridge is used. This test damper is designed to have the resistance of 100kN. After its resistance is checked, it will be placed on the open air test site, in order to be exposed to the actual atmosphere such as sunlight and rain. This exposure test is planned to be continued for ten years, and the performance of the test damper is planned to be examined two or three times within this period. This test will show useful data about the durability of the damper. We are going to determine the maintenance plan of dampers, from this data.
