Study on the Durability of Surface Coating Materials for Concrete Structures

Abstract

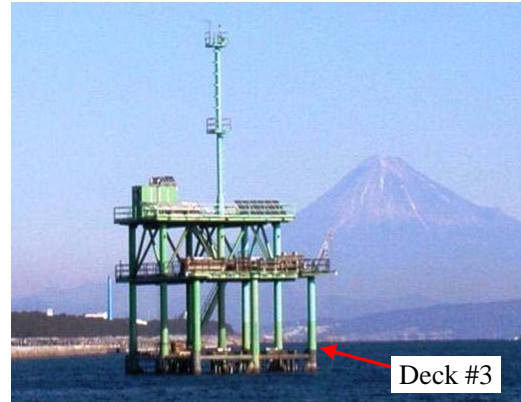
Photo 1 Exposure Site

Covering depth of rebars was 25mm. Various coating materials shown in Table 4 were applied on the surface of RC or PC beams depending upon each coating material category. Exposure site shown in Photo 1 is located in Shizuoka, Japan

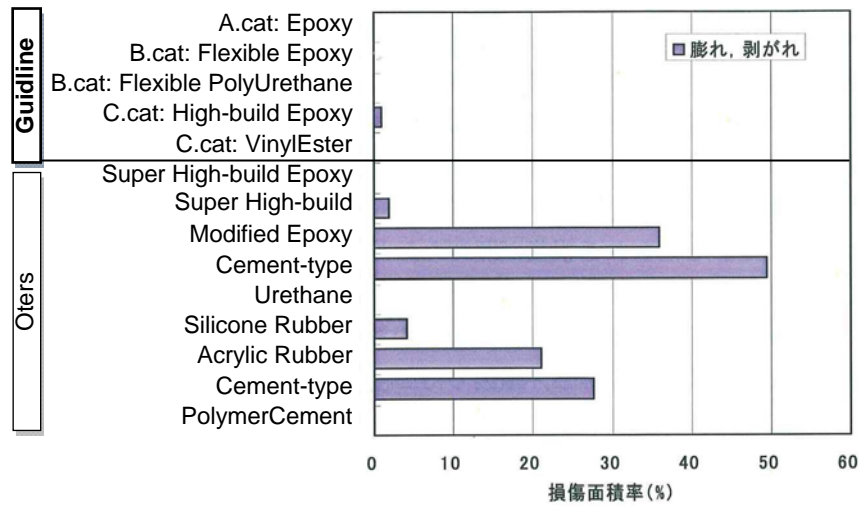
Photo 2 shows typical view of exposed specimens as examples for both healthy and relatively damaged cases. Figure 1 shows damaged ratio that indicates the percentages of damaged area out of entire coating area. All coating systems that meet to the guideline and super high-build coating presented almost no damage. In contrast, modified epoxy, cement type, acrylic rubber, and inorganic coating materials showed certain damages. No rebar in concrete corroded for all coating systems.

Figure 1 Damage Ratio of Surface Coat

Chloride ion content of concrete in the coating systems that meet to the guideline is shown in Figure 3. These coating materials indicate fairly good barrier performance against salinity intrusion. The other coating materials show also good performance as shown in Figure 4. However, as shown in Figure 1, some of coatings were damaged after a long period; therefore, rebars in those concrete specimens may corrode in the future.

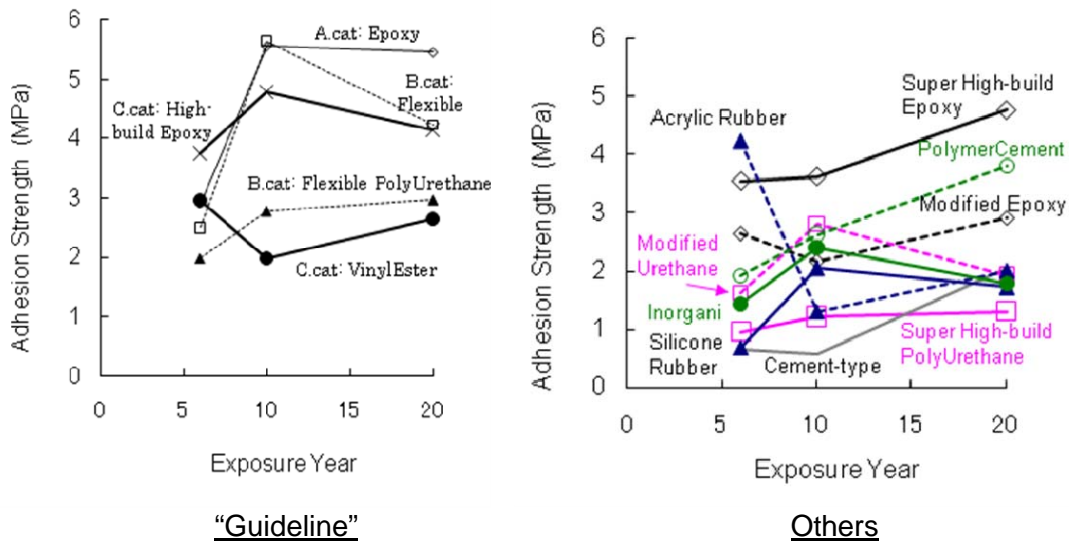
Figure 2 shows the change in adhesion strength during 20years exposure. All coating materials suggested slightly increasing trend except for acrylic rubber. These coating materials likely have enough adhesive performance, because failure mode of pull-off testing was tensile fracture of base concrete.

Figure 2 Change in the Adhesion Strength of Coating during Exposure Test

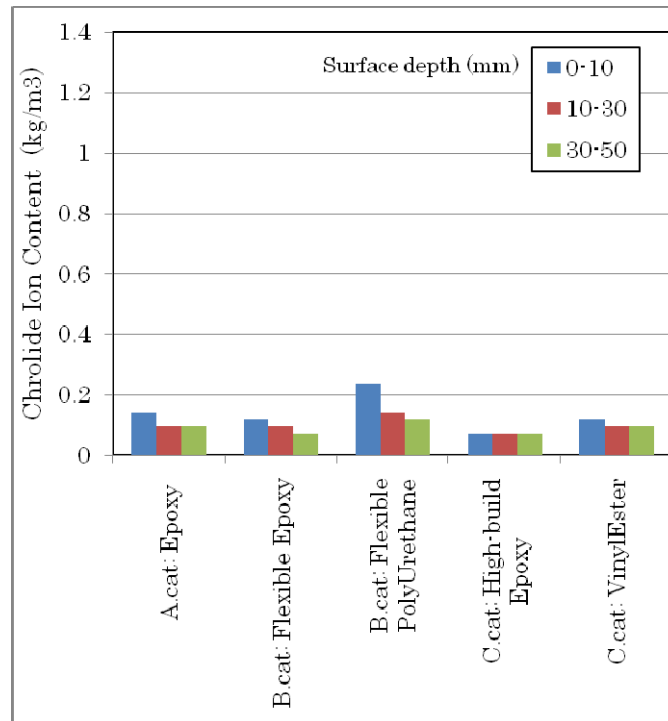
“Guideline”

Figure 3 Chloride Ion Distribution after 20years Exposure Test

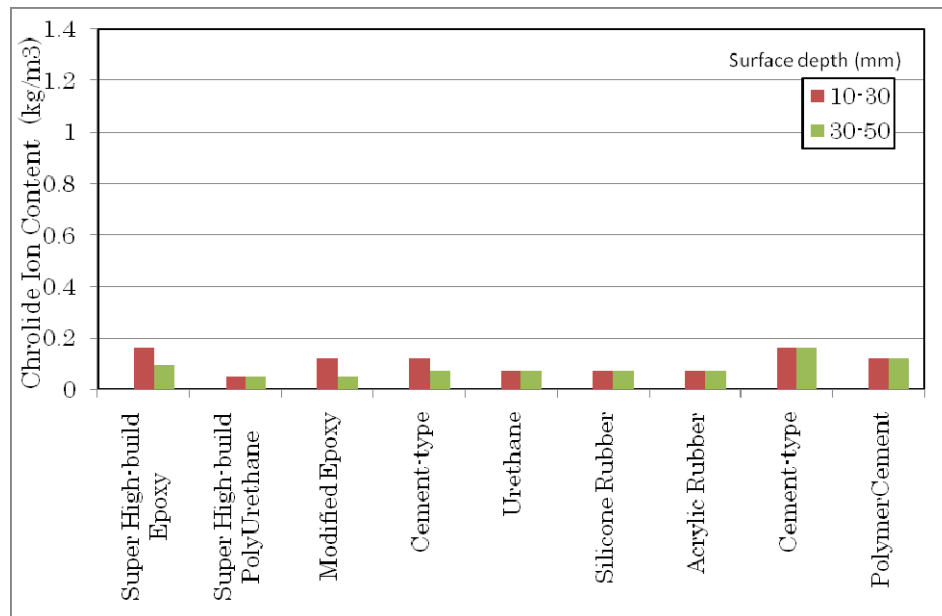
Others

Figure 4 Chloride Ion Distribution after 20years Exposure Test

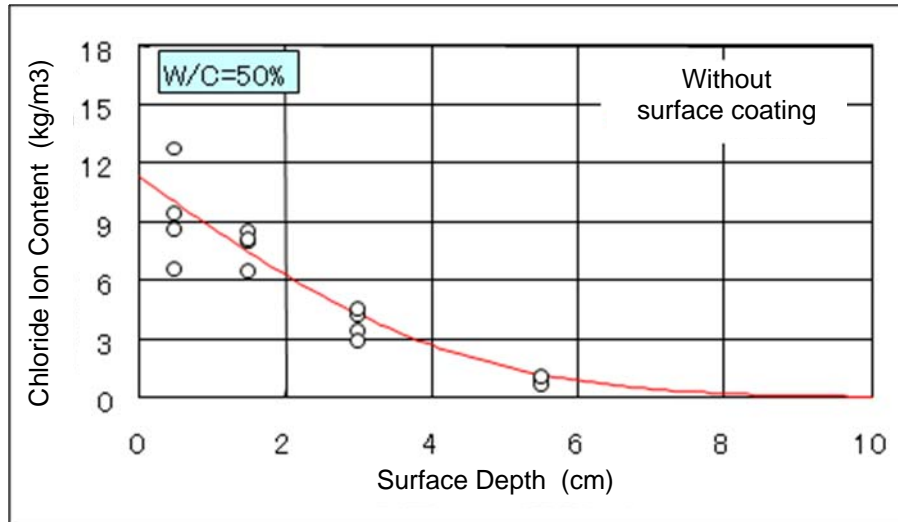
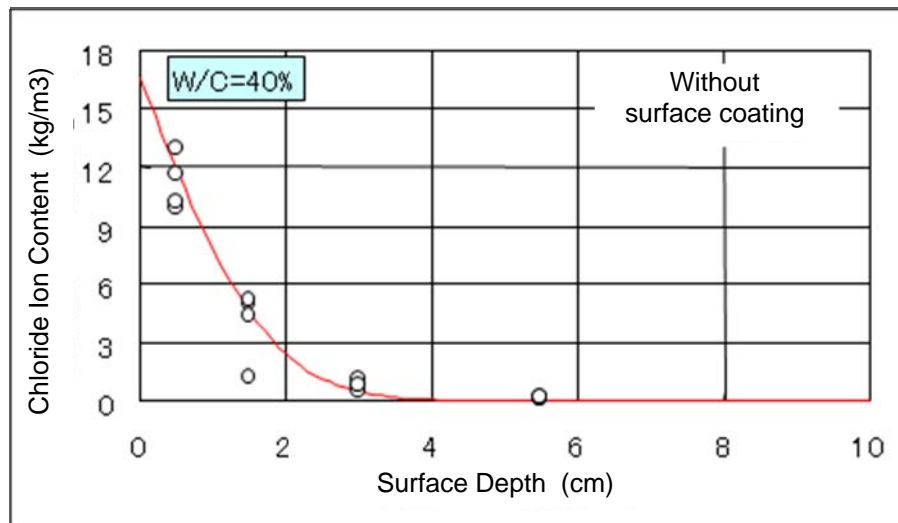
In contrast, specimens without coating showed quite high chloride ion content. In any cases, more than 10kg/m^3 in the near surface part as shown in Figure 5 and 6. Chloride permeation depth is different; the larger W/C, the deeper chloride permeation. The amount of chloride ion can be quite high around rebars.

Figure 5 Chloride Ion Distribution after 20years Exposure Test

Figure 6 Chloride Ion Distribution after 20years Exposure Test

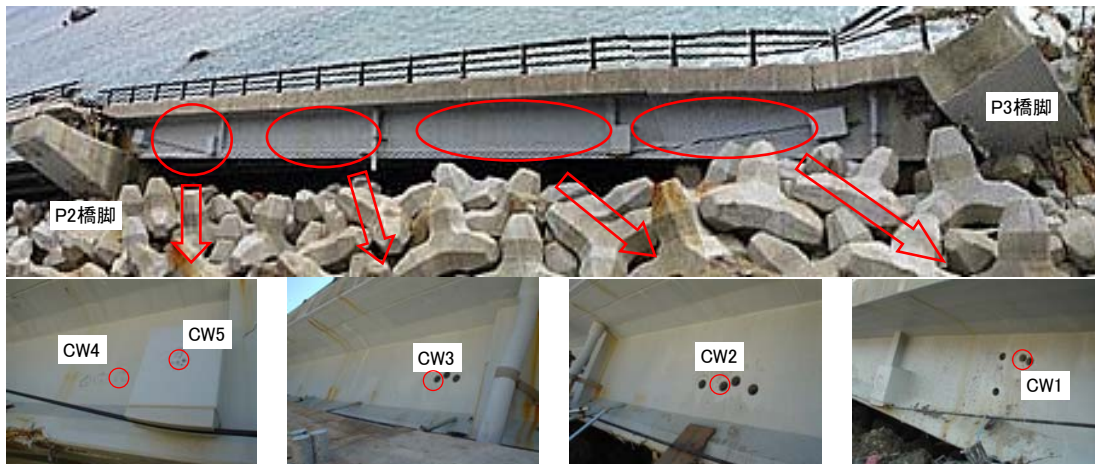
Photo 3 Bridge 1: Overview (after typhoon disaster)

Table 5 shows the bridges tested in this study, their coating systems, and service life. As shown in Photo 3 and 4, two of the bridges had been repaired due to salt damage, but broke down by typhoon natural disaster (not by structural failure reasons).

Bridge 1: slightly rusting dots and blistering, rust stain on above flange (without coating)

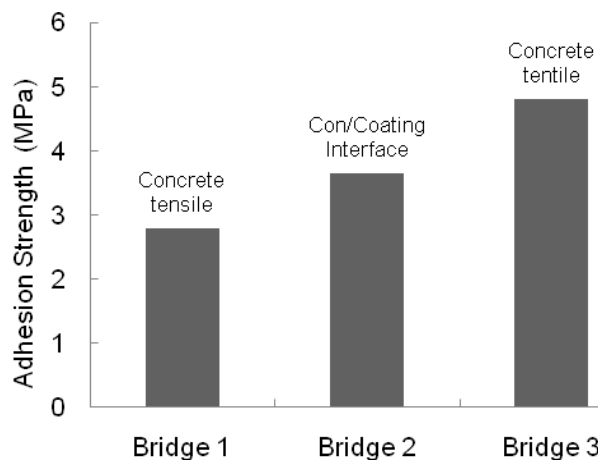
Figure 7 shows adhesion strength of coating on the bridges. The strength about 2.8N/mm² of Bridge 1 appears relatively small, but it is same as the initial value at 7years ago and failure mode was concrete tensile fracture. Failure mode of pull-of testing was interface peeling between basecoat and concrete for Bridge 2. Furthermore, all adhesion strength values meet the JSCE's reference value ⁶⁾, 1N/mm². Therefore, these coating materials have enough adhesion performance after long time servicing.

Figure 7 Adhesion Strength and Failure Mode of Surface Coating

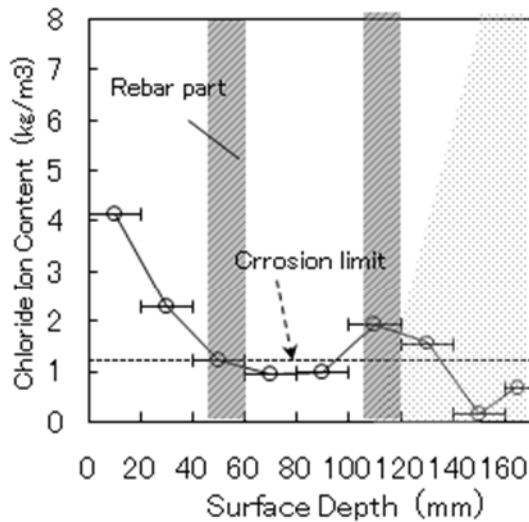
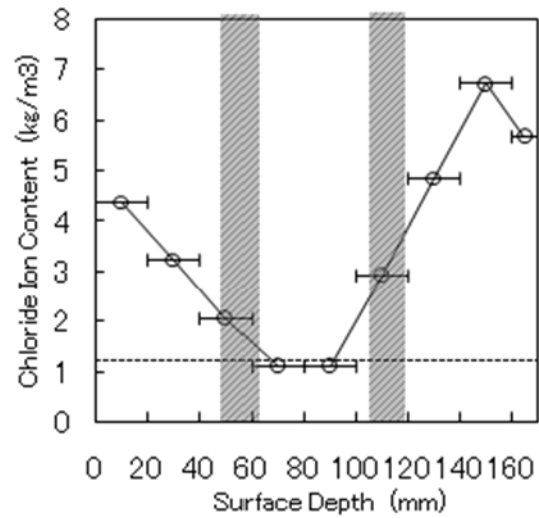
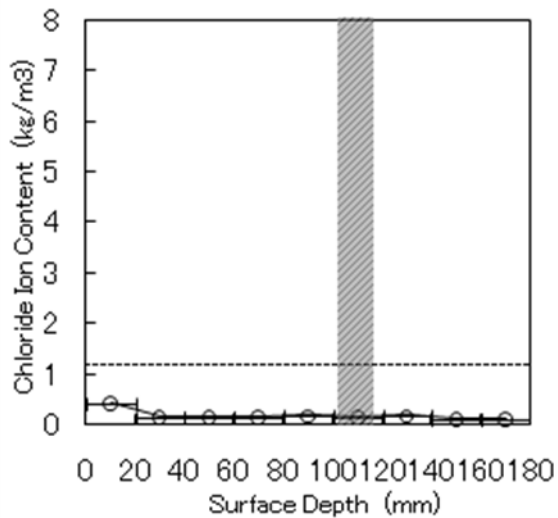
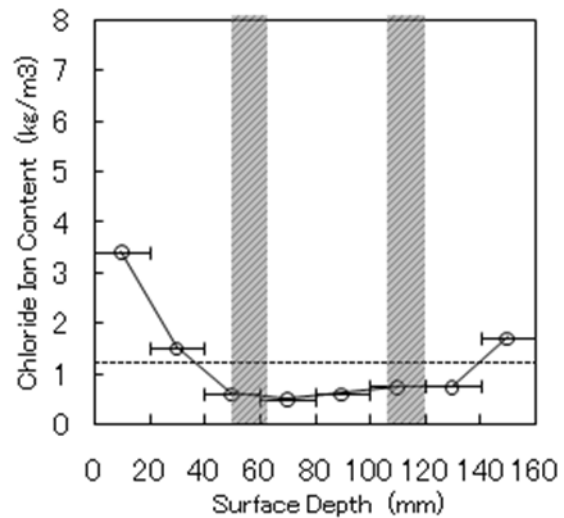
Figure 8 shows chloride ion content distribution in Bridge 1. At around rebars, the chloride ion content was about 1.2kg/m³ that is the rebar corrosion limit. It can be considered that rebars in the girder probably get rust in the near future. The figures prove that coating works a good

barrier for 7 years because of the low content in patching (a) and repaired new concrete (c), although originally contained salinity in concrete was still trapped inside the surface coat by repair works. The contained chloride in concrete may not move because the content distribution (a)(b) indicate almost similar to the one at repair work (R).

(a) CW1 (Patching: 120mm-)

(b) CW3

(c) CW5 (Newly constructed in repair,
No sea-sand used)

(R) Measured at repair work: 7 years ago
(P3-A2: girder, web, land-side)

Figure 8 Chloride Ion Content Distribution in Bridge 1
