# STUDY FOR SECURING SOUNDNESS OF PC STRUCTURES

## - Approach to Establish Method of Applying Nondestructive Inspection for Advanced Management of Highway Structures -

Takashi TAMAKOSHI<sup>1</sup>, Toshiaki NANAZAWA<sup>2</sup> and Koichi IKUTA<sup>3</sup>

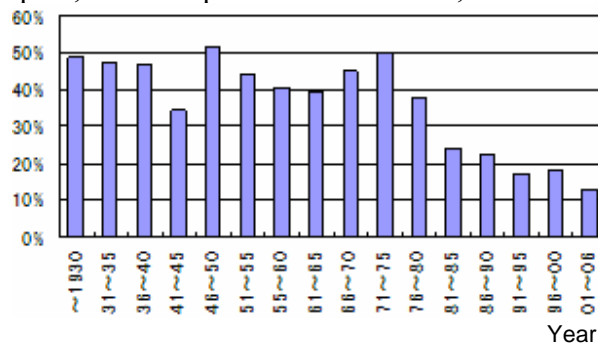
\*Rate of bridges by age for which repair of main members has been determined to be necessary as a result of the major routine inspection of national highways managed by the national government.

**Figure1 Rate of bridges which need early repairs in ages**

Road network has been developed in Japan from around the high economic growth period. Presently there are approximately 150,000 road bridges above 15m in length. Due to aging of them, the rate of road bridges over 50 years or more, which is about 6% currently, will increase rapidly and be estimated at 50% approximately 20 years later. Figure1 shows the rate of bridges which needs early repair or another measure in respective ages that was estimated from the result of the major routine inspection for highway bridges managed by the national government. It clearly indicates the correlation of damage occurrence with age despite the cause of occurrence and propagation of deterioration are complex, which depend on its structure, environment and other matters.

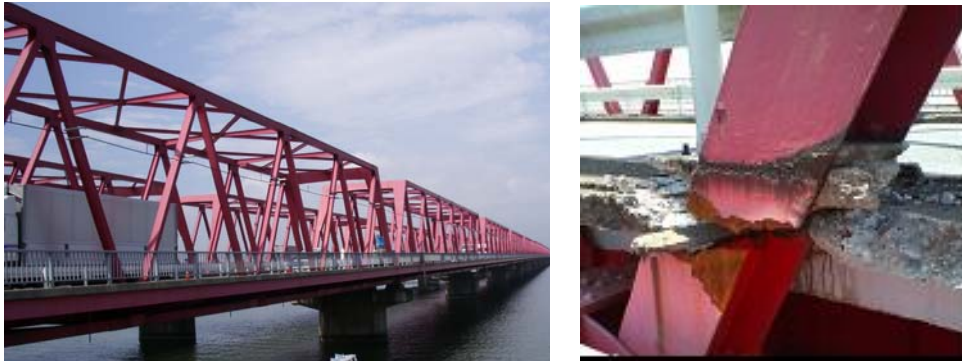
**Figure2 Failure of diagonal member of truss bridge**

In Japan, failures of diagonal members of truss bridges managed by the national government, which could lead to collapse, occurred last year. However those damages or sign of the accidents had not been detected in previous major routine inspections (refer to Figure2). In Canada, as collapse of a concrete Gerber bridge had occurred in 2006, deterioration of both concrete and re-bars inside a Gerber hinge, in which they could not inspect visually, was pointed as one of the causes of the failure of the hinge which led to the collapse (refer to Figure3)<sup>1)</sup>.

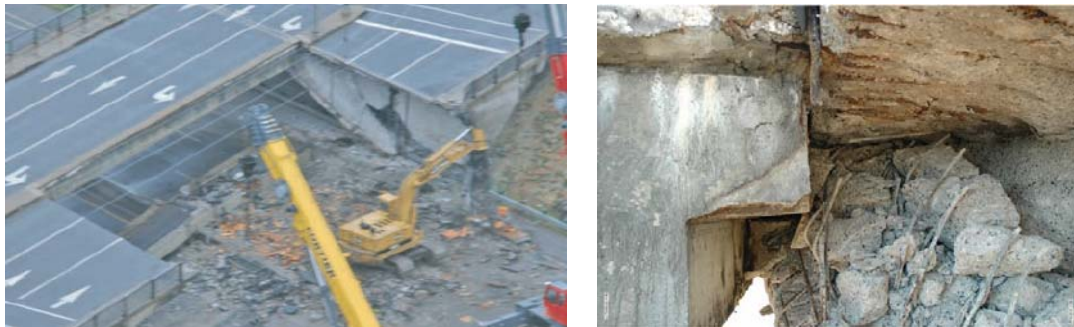
**Figure3 Collapse of de la Concorde Bridge and inside of Gerber hinge<sup>1)</sup>**

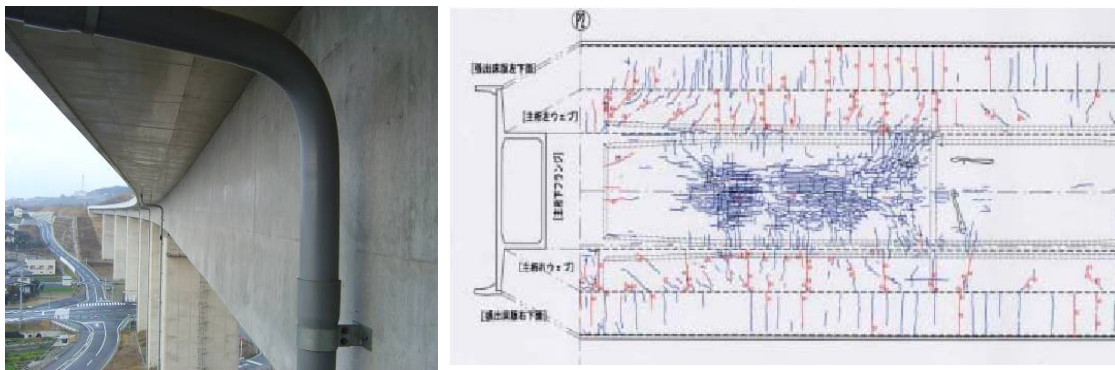
**Figure4 Cracks on a partial prestressed concrete bridge**

That is more severe problem than that on detection of invisible deterioration because it might fail to perform as designed against assumed loads such as seismicity just after completion of construction and more difficult to identify. In Japan, damage such as many cracks and displacement occurred in a partial prestressed concrete bridge before service several years ago. It was repaired and is being monitored despite unclearness of causes and its soundness (refer Figure4). In the US, though the cause of the collapse of I-35W bridge has not been identified, insufficient thickness of gusset plates was reported<sup>2)</sup>.

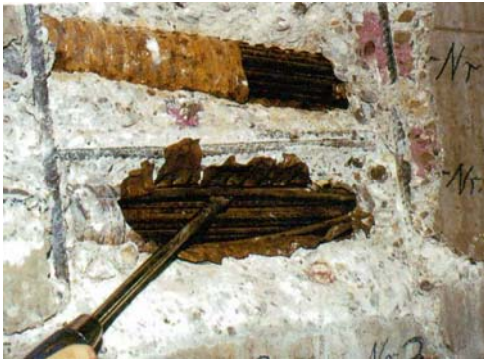
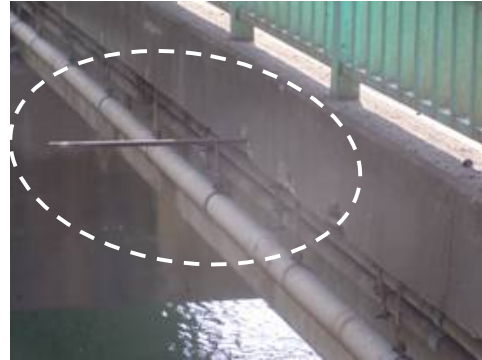
**Figure5 Corrosion of prestressing steels<sup>3)</sup> Figure6 Falling out of prestressing steel**

Decrease or loss of prestress occurs by various causes such as improper constructing works, corrosion or fire (refer to Figure5 to 7). Though it might be presumed by occurrence of cracks, crack occurrence is not usually allowed in PC structures. Therefore when cracks are observed on a PC structure, it might not satisfy performance required already.

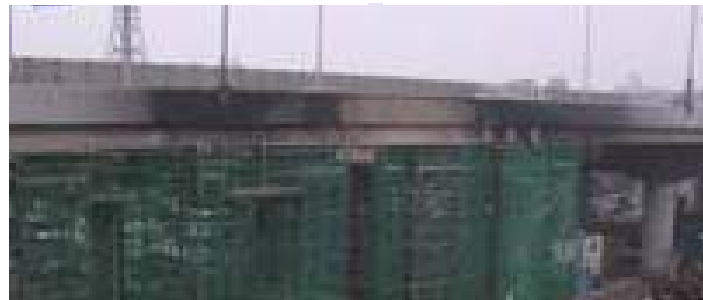
**Figure7 PC beam suffered from fire**

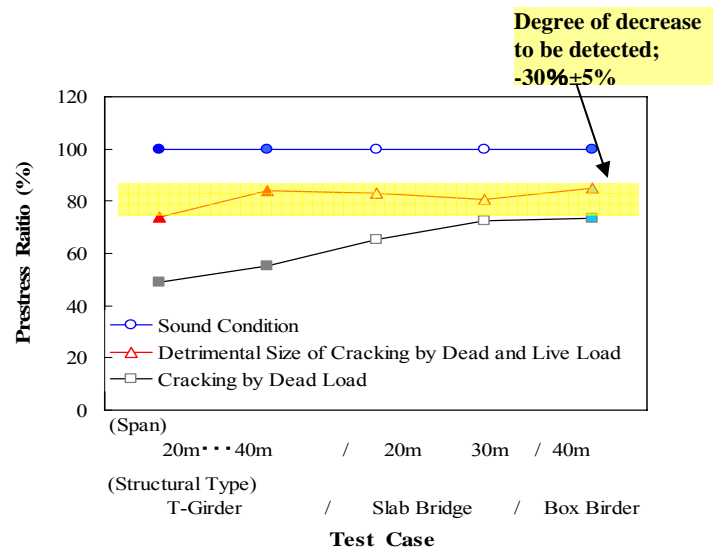
Relation between degree of prestress and condition of the structure is shown in Figure8. It was found that there is no sufficient difference among them in terms of degree of prestress decrease. For example, it is estimated that 35% of prestress decrease causes occurrence of detrimental size of cracks and possibility of reducing strength in long terms for T-girders with post-tensioning system.

**Figure8 Degree of prestress and condition of PC girders**

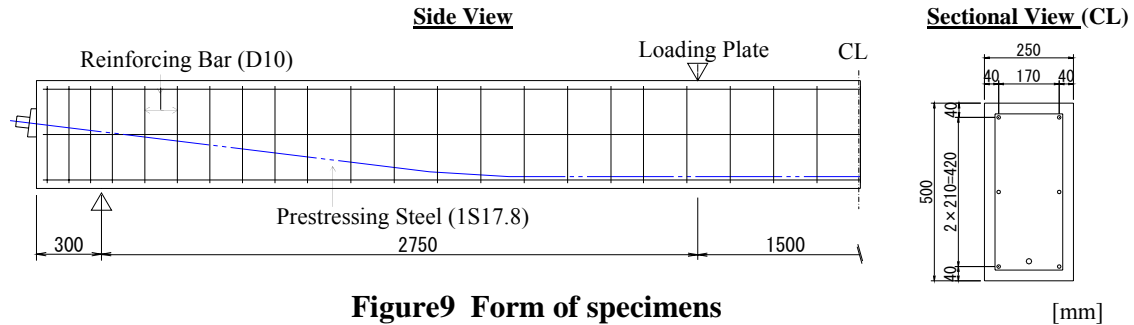
Loading tests of beam-shaped specimens with different prestressing of 100%, 50% and 10% of the prestress designed was carried out. The form of the specimens is shown in Figure9.

**Figure9 Form of specimens**

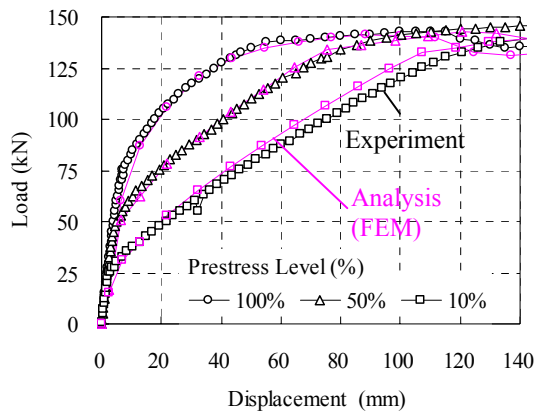
While respective tests resulted in almost same loading capacities due to the same steel volume which relates to strength, the relation between load and displacement and the appearance of cracks were distinctly different (shown in Figure10 and 11). As shown in

**Figure10 Load and Displacement**

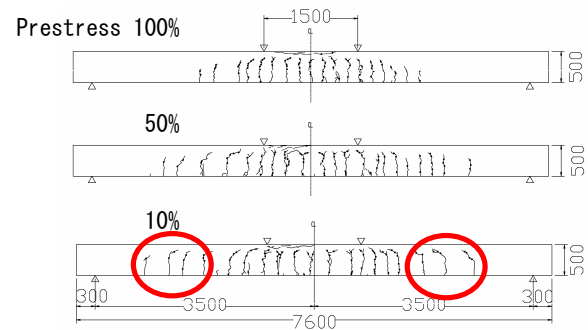
Figure11, the location and dispersion of cracks deeply depended on degree of prestress.

**Figure11 Crack Dispersion before Failure**

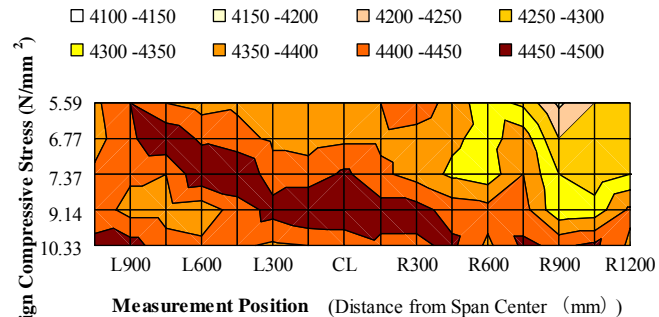
Influence of inner stress state over propagation velocity of ultra sonic wave transmitted through the web was examined by measuring propagation time from one side to the other side of the web. The applied voltage was 1200V and resonant frequency was 40kHz. The distribution of the transmission propagation velocity measured is shown in Figure12. It shows a tendency that the transmission propagation velocity was varied in accordance with the height of a measuring position on the web. That indicates the correlation between the transmission propagation velocity of ultra sonic wave and the

**Figure12 Distribution of Transmission Propagation Velocity of Ultra Sonic Wave**

inner stress by prestressing which would be estimated by the nondestructive inspection using ultra sonic wave.

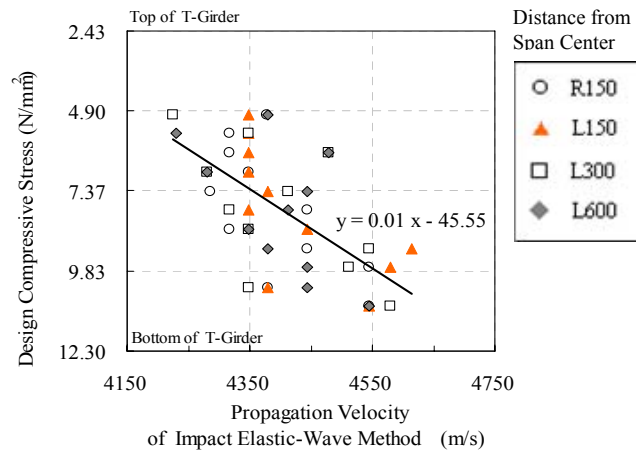
Impact waves by a steel sphere ( $\phi 9.6\text{mm}$ ) were received at two places and surface propagation velocities were estimated by the difference of the two arrival times. Horizontal surface propagation velocities were measured in each height on the web in order to evaluate difference of stress degree. The relation between the stress degree estimated and the horizontal surface propagation velocity is shown in Figure13. The stress degree is obviously correlated with the propagation velocity. That indicates to be able to detect relative difference in stress degree at least.

**Figure13 Relation between Propagation Velocity and Design Stress**
