# **FAILURE INVESTIGATION AND RETROFIT STRATEGIES OF A 22-SPAN STEEL GIRDER BRIDGE DURING THE 2010 CHILE EARTHQUAKE**

Zuocai Wang<sup>1</sup>, Genda Chen<sup>2</sup>, Phillip W. Yen<sup>3</sup>, and Ian Buckle<sup>4</sup>

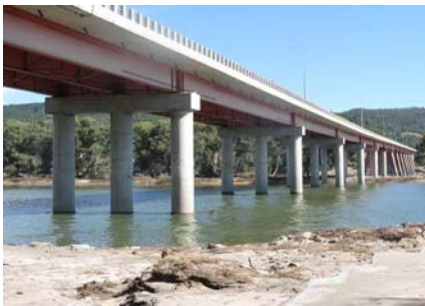
Fig. 1 Cardenal Raúl Silva Henríquez Bridge

Built in 2002, Cardenal Raúl Silva Henríquez Bridge is a 22-span, steel-girder structure crossing the Maule River near Constitución in the NE-SW direction. Each span length is 41.5 m. The bridge is supported by two seat-type abutments and twenty-one intermediate bents. As partially shown in Fig. 1, the first five bents from the NE abutment are supported on two reinforced concrete (RC) columns and drilled shafts. The next six bents are supported on three RC columns and drilled shafts. The following eight bents are steel pile bents with three legs (one vertical and two inclined) with horizontal struts and diagonal braces interconnecting the legs in each bent. The last two bents are supported on three RC columns that rest on footings. The bridge superstructure is comprised of two continuous 11-span-long segments with three expansion joints at the two ends and in the middle of the bridge. It is connected to the bridge substructure by elastomeric pads at all piers to allow for longitudinal movement except for two abutments. At each abutment, three girders were welded to their bearing masonry plates that are anchored into the abutment.

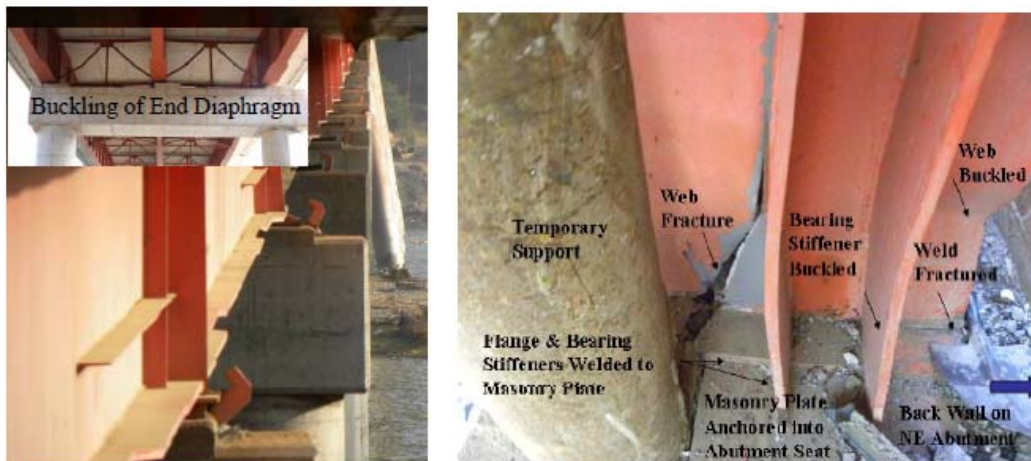
Fig. 3 Superstructure Damage at the NE Portion

During the earthquake, the NE portion of the bridge moved transversely from west to east as shown in Fig. 3(a). All steel stoppers were deformed and girders were displaced from their elastomeric pads, resulting in the web and flange bending of the exterior girder about its weak axis. At the NE abutment, the webs and bottom flanges were fractured in all three girders, and both bearing stiffener and web buckled as illustrated in Fig. 3(b). The cause of this type of damage is indicative of excessive longitudinal loads in the superstructure that was resisted by the weld bearing connection at the abutment. At the SW abutment, the welds from the girder bottom flanges to the masonry plates were fractured [Chen et al., 2010].

(a) Girder offset and cross frame buckling      (b) Girder fracture at the north abutment
