Maintenance of ASR-affected Structures in Hokuriku Expressway, Japan

Abstract

Increasing amounts of deicing salts have been used to ensure the safety of road surfaces in Hokuriku district, Japan. Sodium chloride, which accounts for the majority of deicers, has been causing damage to road concrete structures due to alkali-silica reaction. This report describes the current state of maintenance and repair techniques of these road structures affected by deicer-related alkali-silica reaction.

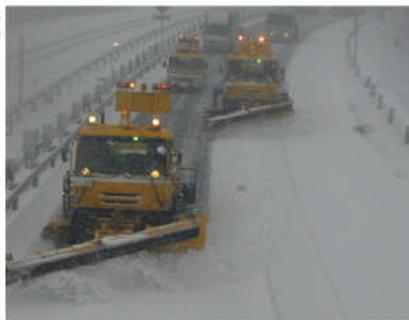
Fig.2 Highway snow removal work in winter

The Hokuriku district is located approximately in the center part of the Japan Sea coastline and is characterized by severe weather conditions: hot and humid summers and cold and snowy winters (see Fig. 1~Fig. 3).

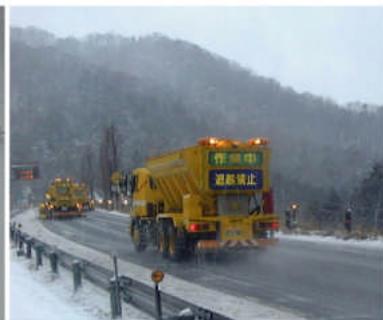
Fig.3 Scattering of deicing salts

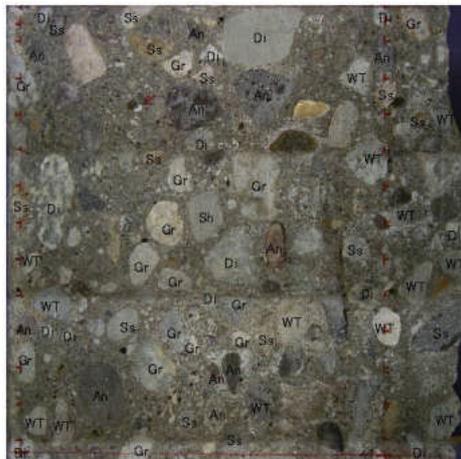
Fig.7 Lithological composition of gravel

Lithological composition of gravel	In regard to particles 5mm or more in diameter visible on the surfaces of concrete cores, the lithological composition is calculated by the point count method using a 5mm mesh.
Alkali-silica reactivity:	Alkali-silica reactivity is judged by the presence of rims and/or alkali-silica gel around aggregate particles. Thin sections are prepared from some specimens for polarization microscopy observation.
Alkali content of concrete:	A 10-g sample ground to particles less than 150 μ m in diameter is added to 100ml of distilled water at 40°C and agitated for 30 min. The mixture is then filtered, and the alkali concentration of the filtrate is measured by atomic absorption photometry, to calculate the Na ₂ O equivalent (Na ₂ O + 0.658 K ₂ O).

Detailed ASR investigation includes the mineralogical composition of coarse aggregates, thin section observation with a polarizing microscope, alkali and chloride contents in concrete, and the residual expansion of concrete cores drilled from the structures. In particular, considering the feature of Hokuriku district, the residual expansion test of concrete cores, which is a technique that conforms with the alkali external supply, has been adopted. The test method is described in Table 1 and shown through Fig.7~Fig. 11.

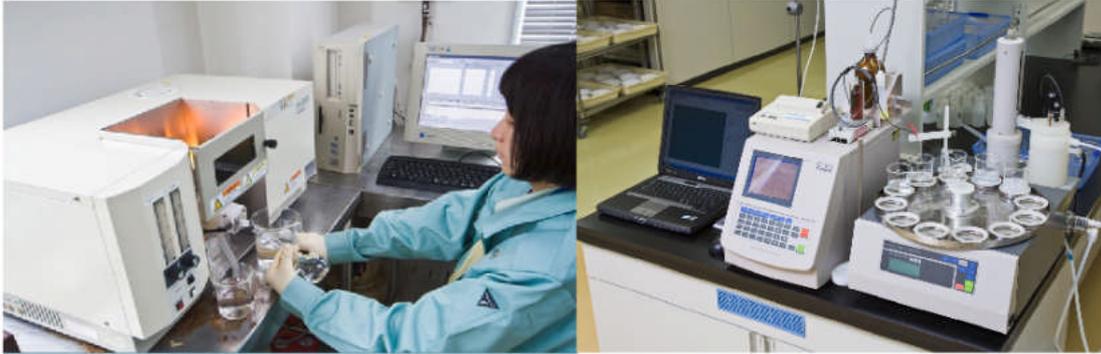
Chloride ion content:	A 20-g sample ground to between 150 and 300 μ m particle size is dissolved in a 2N HNO ₃ solution and boiled for 5 min. The chloride ion (Cl ⁻) concentration of the filtrate is then measured by potentiometric titration.
Residual expansion (Canadian method, ASTM C 1260)	The time-related changes in the expansion of drilled concrete cores (ϕ 55mm) are measured while being immersed in a 1N NaOH solution at 80°C.
Residual expansion (Danish method):	The time-related changes in the expansion of drilled concrete cores (ϕ 55mm) are measured while being immersed in a saturated NaCl solution at 50°C.

Fig.9 Alkali content of concrete by Atomic Absorption Spectroscopy Apparatus

Fig.10 Chloride ion content by Potentiometric Titration Apparatus

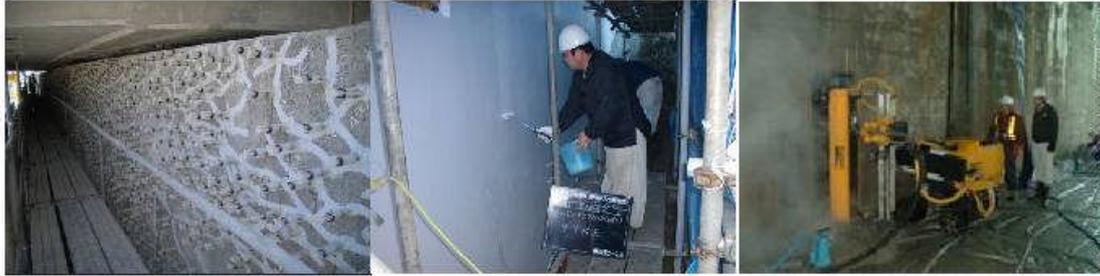
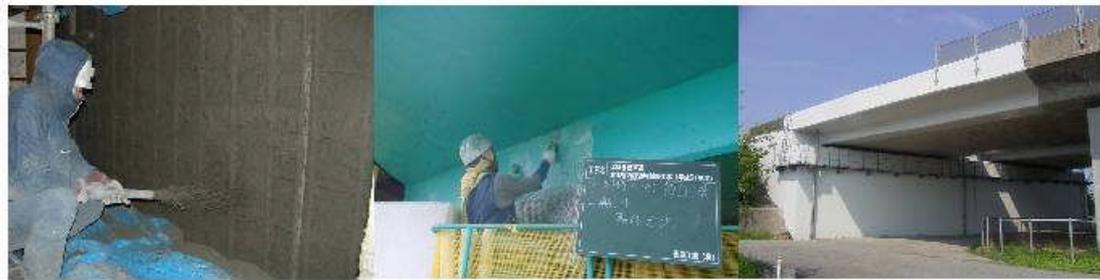
Fig.13 Maintenance of ASR-affected bridges

Crack injection

Surface coating

Water jet

Section repair with shotcrete

Execution of fiber sheet coating

Completion of repairing works

ranking “A” structures, crack injection and surface coating is applied, including the time reference results of residual expansivity tests of concrete cores. For ranking “B or C” structures, the road surface drainage countermeasures are applied, followed by close observation of the improvements. Repair rankings are priority for important intersections (such as national road and railway) and the areas affected by concrete spalling or peeling off, works include section repair and coating with fiber sheets. In addition, due to the severe environment conditions in the Hokuriku region, the rehabilitation period has been set to about one or two year long to ensure quality control.

After the repairing is concluded, monitoring is applied for inspection purposes. Focus point is the effect of road surface drainage. Also, a special attention is paid to bridge abutment front, where the water absorption from the back part often leads to swelling of the surface coating. The effective countermeasures for stopping water migration from the back part of bridge abutments are a matter of serious concern.
