INTRODUCTION OF NON-DESTRUCTIVE HIGHWAY INSPECTION METHODS USING HIGH DEFINITION VIDEO AND INFRARED TECHNOLOGY

Koji Mitani¹ and Masato Matsumoto²

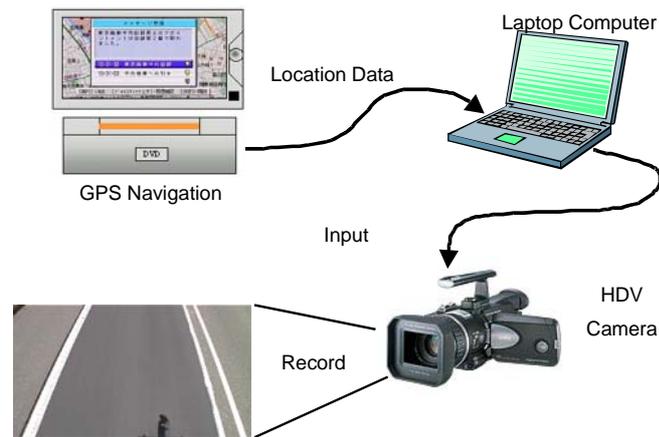
FIGURE 1 shows the mechanism of pavement crack detection using HDV. The technology is the combination of GPS, GIS and HDV image pictures. The GPS navigation system, HDV and laptop computer are included inside the inspection vehicle. The HDV camera is attached on top of the inspection vehicle to record the surface condition (FIGURE 2). The recorded data is analyzed by image processing to determine an individual structure's current condition as related to crack size, location and distribution. The detected cracks are identified in a digital crack map. The crack size and length are determined by computer software, and these quantitative characteristics are also summarized in spreadsheet format. The obtained crack maps and related data are provided to engineers for their subsequent structural diagnosis and rehabilitation planning.

FIGURE 1 - HDV RECORDING FOR PAVEMENT CRACK DETECTION

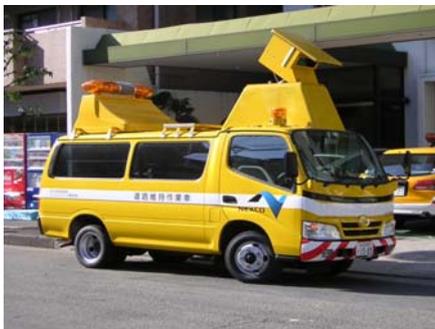
FIGURE 2 - HDV-EQUIPPED INSPECTION VEHICLE (LEFT)

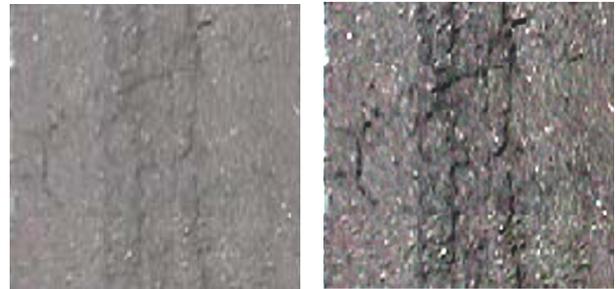
A special advantage of HDV technology, with respect to crack identification and measurement, is the ease of maintaining a historical record of bridge cracks for use in monitoring crack propagation over time. The image processing includes a two-gradation analysis and line featuring analysis. The first step of the two-gradation analysis converts the digital picture into binary (black-and-white) data by analyzing the degree of color transition from the nearby pixels, enabling our computer program to differentiate the spectrum and identify individual cracks. The second step then identifies the lines of black pixels in order to confirm the existence of cracks (see FIGURE 3).

FIGURE 3 - IMAGE PROCESSING (RIGHT)

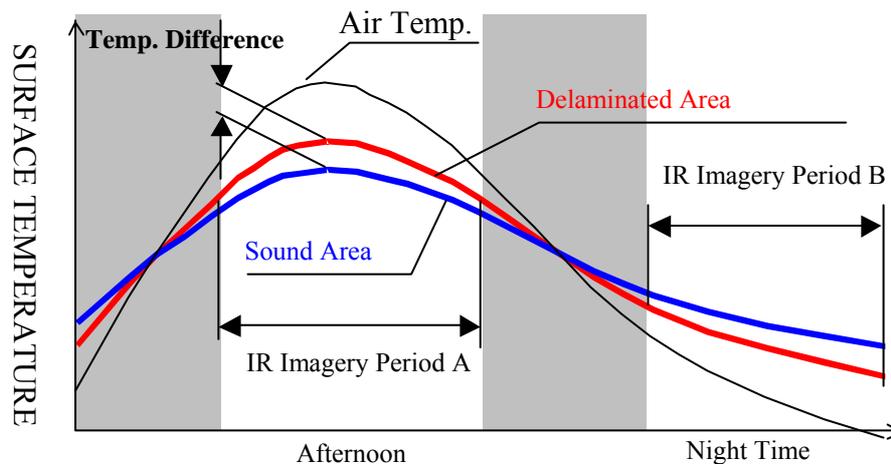
FIGURE 4 shows the mechanism of infrared thermography method. The red line shows daily temperature variation for delaminated concrete, while the blue line shows the daily temperature variation for concrete in good condition. The delaminated concrete surface shows different temperature variation (see FIGURE 5). Infrared imagery technology is applicable during the periods when temperature differentials are

detectable over time (IR imagery period A and B in FIGURE 4). It is not always possible to detect delamination of concrete only from the color variation of infrared imagery since the concrete structure itself tends to have a temperature gradient depending on location and orientation with respect to the sun. Akashi et al. (2009) performed the statistical and analytical study on the relationship between characteristics of temperature variation and inherent damage of the concrete, and developed an automatic damage classification system (J-System) that can classify the damage rate into three categories; the classification categories being “Critical” (crack exists on concrete surface and immediate attention is required), “Caution” (crack exists within 2cm from the concrete surface and close monitoring is recommended) and “Observation” (currently satisfactory) (see FIGURE 6). In Japan, spalling of concrete debris from expressway bridges has become a serious issue. In order to prevent hazards to the third parties, comprehensive sounding tests have been performed on all potentially hazardous concrete surfaces exposed to motorist and pedestrian traffic. Using IR thermography technology, engineers can check the delamination and/or spalling of concrete about three times faster than they can by conducting conventional sounding tests because IR technology applications require significantly less staging to secure adequate site access and correspondingly less traffic control to collect the required field data. Concurrently IR versus traditional sounding tests offer a 40% cost savings.

FIGURE 4 - TEMPERATURE VARIATION DURING THE DAY

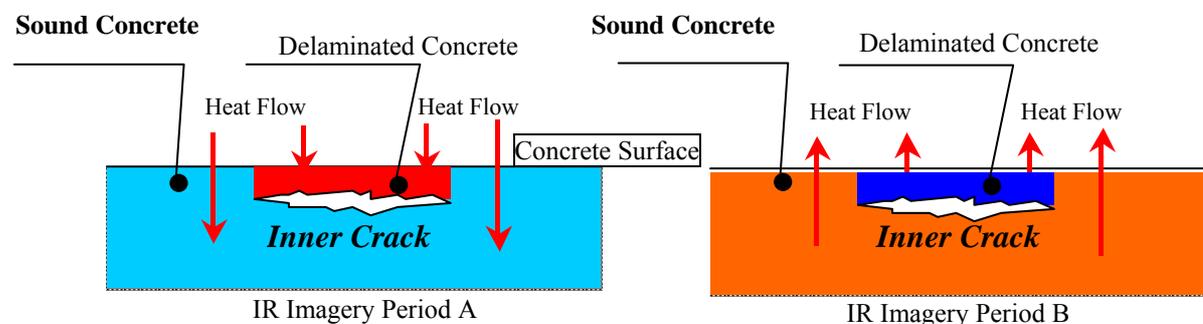
FIGURE 5 - MECHANISM OF INFRARED IMAGERY TECHNOLOGY

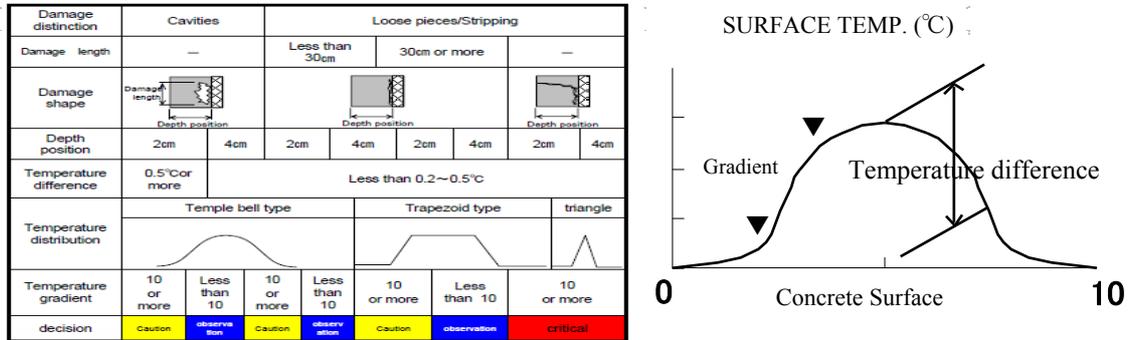
FIGURE 6 - DAMAGE RATING BY INFRARED IMAGERY TECHNOLOGY

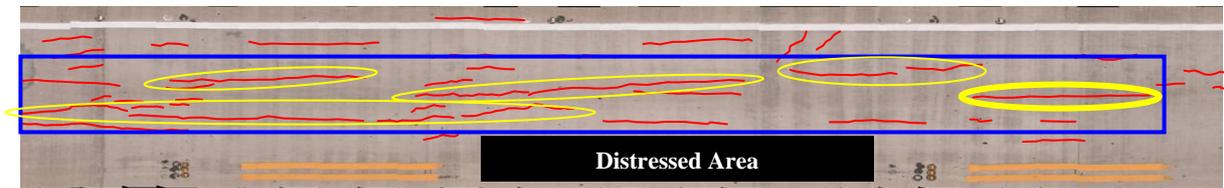
FIGURE 8 shows an example of a crack map for a concrete deck surface. Cracks of 3mm or greater were detected by a software supported automatic crack detection program, followed by supplemental manual crack checking by an experienced engineer. Manual crack checking successfully detected cracks of 0.8mm or greater. According to the Bridge Inspectors Field Guide (Florida Department of Transportation (2008)), cracks should be classified into three categories as shown in Table 2, and the NBI (National Bridge Inventory) specified “Distressed Area” is calculated for the rectangular area including “Significant,” “Moderate,” or “Severe” cracks. Inspectors are responsible for proposing priorities on rehabilitation to the bridge owners by comparing the “Distressed Area” for each span or bridge. The results of pilot area bridge deck surface inspections proved the accuracy of crack detection using HDV technology to be satisfactory for routine in-service deck inspections. The new inspection technology provides additional benefits by increasing the level of safety for both inspectors and motorists and storing position recorded historical inspection data for monitoring of crack propagation. The digital crack map database can be a powerful tool for supporting those engineers responsible for maintenance plan preparation and work task priority decision-making.

FIGURE 8 - AN EXAMPLE OF CRACK MAP FOR CONCRETE DECK TOP

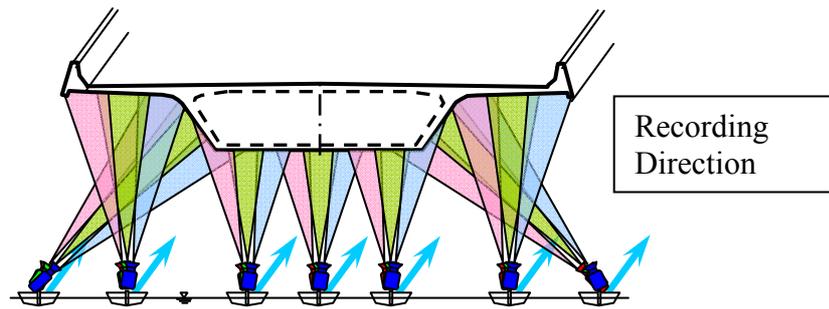
The underside of the bridge superstructure was photographed by HDV from a boat. Due to the boat's motion from wave action, the allowable recording range needs to be addressed by using three HDV cameras with a combined 1.56 million pixel image, a resolution that enables the user to include a 2-meter wide targeted object within a 3600 wide pixel image. This approach enabled identification of cracks in the 0.2mm to 0.5mm range through an analysis of the relative grey tone of the pixels denoting the cracks. The pilot project section consists of seven continuous spans of a post tensioned segmental box girder bridge. HDV photography involved seven separate passes of the boat beneath the bridge as shown in FIGURE 9 in order to capture all of the required HDV images. The time required to record HDV images for the lower surface of all seven spans was about 2.5 hours. The recorded data obtained by the three cameras were combined automatically using proprietary computer software. By magnifying the digital image on the computer, existing cracks were visually detected by an experienced engineer trained to interpret HDV images.

FIGURE 9 - RECORDING OF CONCRETE BRIDGE SUPERSTRUCTURE SURFACE BY THREE HDV CAMERAS

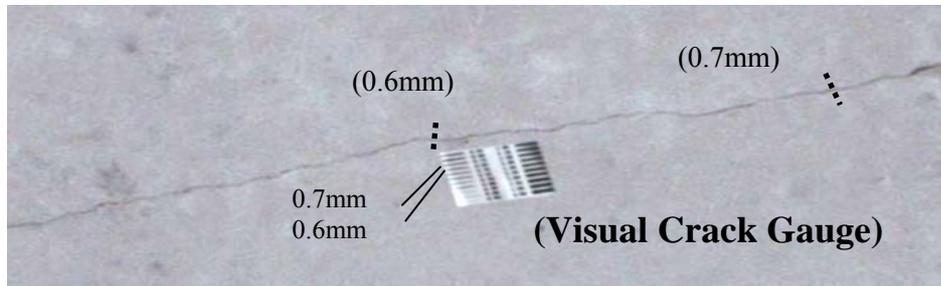
To validate the results of the computer generated HDV crack detection assessment and to perform more detailed crack detection, an 'electronic crack gauge' is superimposed onto the HDV image. Engineers can maneuver the gauge on the HDV image and manually validate computer based crack width measurements. The detected cracks are categorized into three ranks (Rank 1: $\leq 0.5\text{mm}$, Rank 2: $>0.5\text{mm}$ to 0.7mm , Rank 3: 0.7mm or greater). The crack width, length and location data developed by using HDV applications can provide powerful decision making support information for engineers with bridge maintenance planning responsibilities.

FIGURE 10 - ENLARGED IMAGE OF DETECTED CRACKS (EXAMPLE)

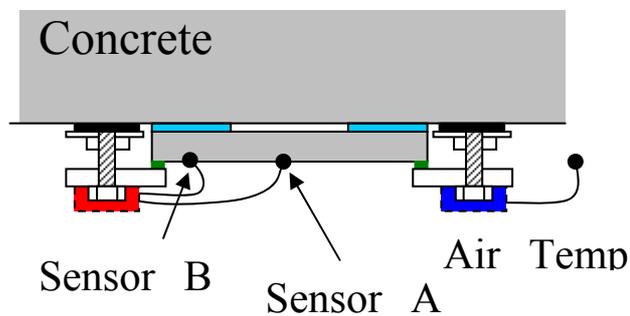
Since the accuracy of damage identification using infrared imagery is greatly affected by daily temperature variation, accurate monitoring of the infrared (IR) photographing environment is mandatory. FIGURE 11 shows the equipment used for monitoring the temperature condition on the concrete surface. Three concrete test pieces with artificial flaws were attached to the bridge's underside surface. Taking infrared images of the concrete 'set-up' test pieces enabled the field infrared imaging team to see if there was sufficient temperature difference between damaged and non-damaged areas at any given time to permit further diagnostic IR imaging of the test area. Based on analysis of a 24 hour time-temperature record, it was concluded that the best available time period to apply infrared technology was from 9pm to 2am. During the photographing process, the infrared images of set-up test pieces were periodically checked in order to make sure that the field infrared imaging team was always in proper IR imaging environment. Figure 12 (a)(b)(c) shows an example of test results using IR imagery technology. The result of damage rating in FIGURE 12(c) shows three clusters of red spots indicating "Critical" condition. However, by checking the digital

FIGURE 11 - THE “SET-UP TEST PIECE”

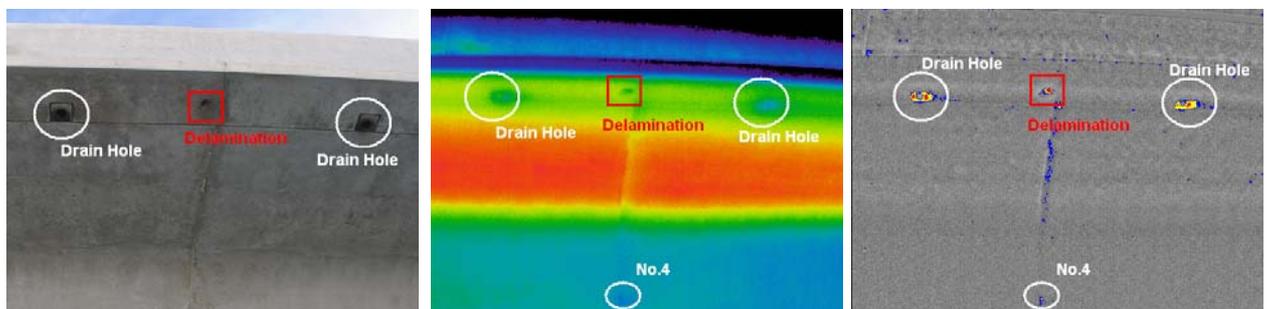
photo in FIGURE 12 (a), we can easily recognize that the spots at both sides are for drainage outlets. Using the output from the damage classification system, we can estimate the approximate spall area surrounded by red rectangle in Figure 12(c). Calculating the total spall area for each span or bridge provides engineers a quantified basis for prioritizing alternatives in a bridge structure rehabilitation plan.

FIGURE 12 - RESULTS OF THE INSPECTION USING IR IMAGERY TECHNOLOGY - (A) PHOTOGRAPH (LEFT), (B) IR IMAGERY (CENTER), (C) DAMAGE RATING (RIGHT)

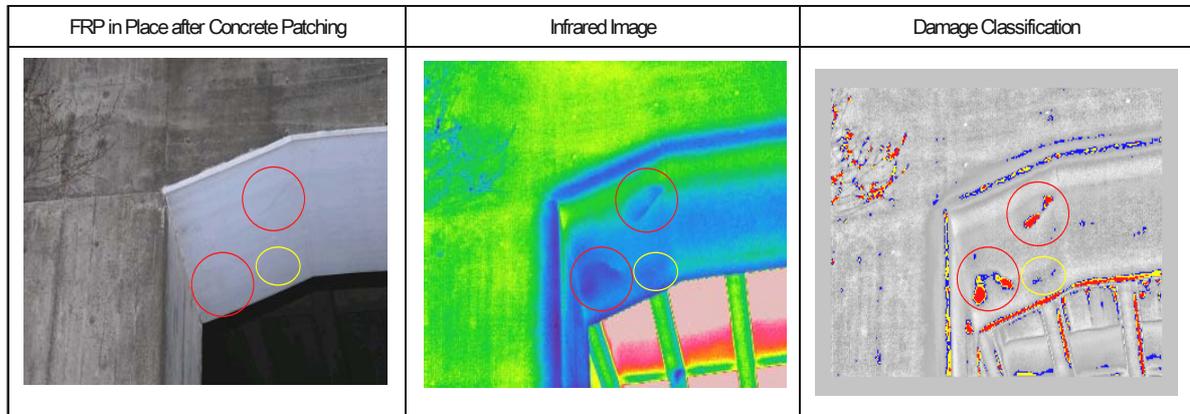
HDV and IR imagery technology can be applied for both in-service bridge inspection and checking new structures for specification compliance (in terms of crack area percentage) at the time of construction acceptance. HDV technology has also been used successfully for supporting night time striping reflectivity tests. IR imagery technology has many other uses as well. Among applications relevant to maintenance and rehabilitation is the ability to use IR imaging to monitor areas of structural distress

that have been covered with fiber reinforced polymer (FRP) materials (see FIGURE 13). Another application is to identify subsurface irregularities (grout covered rock pockets) in new construction structure immediately after the removal of form work.

FIGURE 13 DETECTING POTENTIAL SPALL BENEATH THE FRP COVER
