# **BRIDGE ASSESSMENT METHODS USING IMAGE PROCESSING AND INFRARED THERMOGRAPHY TECHNOLOGY**

Masato Matsumoto<sup>1</sup>

Koji Mitani<sup>2</sup>

F. Necati Catbas<sup>3</sup>

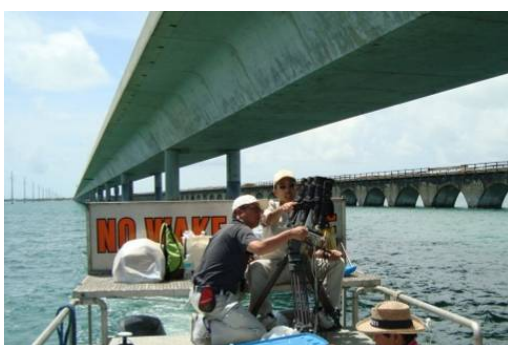
FIG. 2: FIELD DATA COLLECTION BY HIGH DEFINITION VIDEO

Recently, significant progress has been made in the research and development of crack detection methodologies for efficient highway bridge inspection using high resolution digital imaging, HRDI, of the structures. In the past, conventional inspection techniques using digital image processing had not been widely applied for practical use due to its limited image quality. The equipment was typically expensive and the application was limited primarily to technical research applications and special forensic professional services and often limited to situations under controlled conditions. However, recent innovations and improvements in image quality and data processing technology have contributed greatly to the technical viability of these new inspection methods. NEXCO-West has developed a concrete crack detection technology using high quality digital image and image processing software (MATSUMOTO et. al.(2009) ). Sections of the concrete bridge elements are photographed by a motion-controlled digital camera from the fixed locations, or high definition video cameras through mobile carriers such as the inspectors, vehicles, or boats. Fig.1 shows the automatic photographing system used for photographing from a fixed location. The digital camera is attached to the computer-controlled platform mounted on the tripod. Based on accurate matching between pre-photographed image and scanned drawings, the software automatically prepares a photographing plan shown as the grid in Fig. 1. Each grid represents one snapshot for the high resolution frame. Once the photographing plan is completed, the software controls the motion of the platform, enabling the camera to automatically pan and tilt, and adjust the zoom for each high resolution frame. Fig. 2 shows the field data collection by high definition video cameras through mobile carriers. Once the field data collection process is

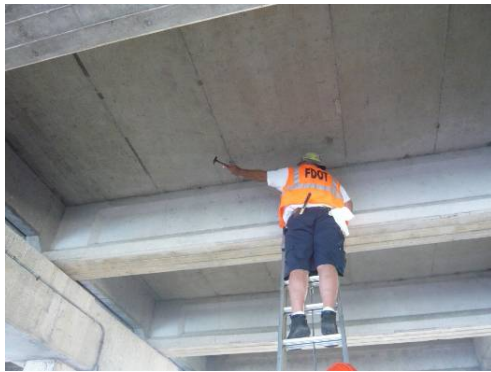
FIG. 16: HAMMER SOUNDING BY  
FDOT CERTIFIED BRIDGE INSPECTOR

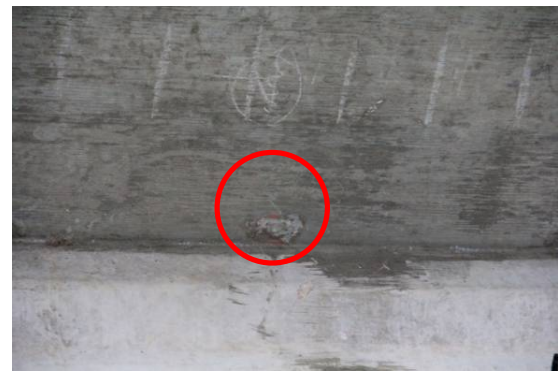
FIG. 17: AFTER HAMMER SOUNDING
