# EXPERIMENTAL RESEARCHES ON BEHAVIOR OF BEARING SUPPORTS IN HIGHWAY BRIDGES UNDER TSUNAMI-INDUCED FORCE

Jun-ichi Hoshikuma<sup>1</sup>, Guangfeng Zhang<sup>2</sup>, Hisashi Nakao<sup>3</sup> and Toru Sumimura<sup>4</sup>

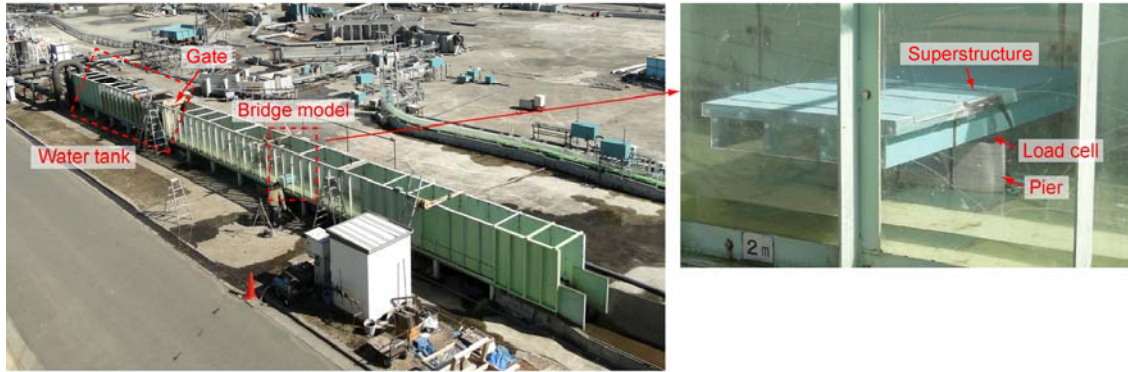
**Fig. 2** Setup of flume tests

(a) Setup of flume test (Left: Elevation, right: Cross-section)

(b) Photo of flume test

A series of flume tests on bridge model were conducted for investigating the effect of the configuration of the superstructure on tsunami effect on behavior of bridges, particularly bearing supports. The tests were designed for modeling a bridge with 2 m clearance attacked by tsunami with a wave height reaching to the top surface of the bridge deck. Figure 2 shows the setup of flume tests. In this research, tsunami waves were generated by opening the gate of the water tank. Tsunami wave height was controlled by

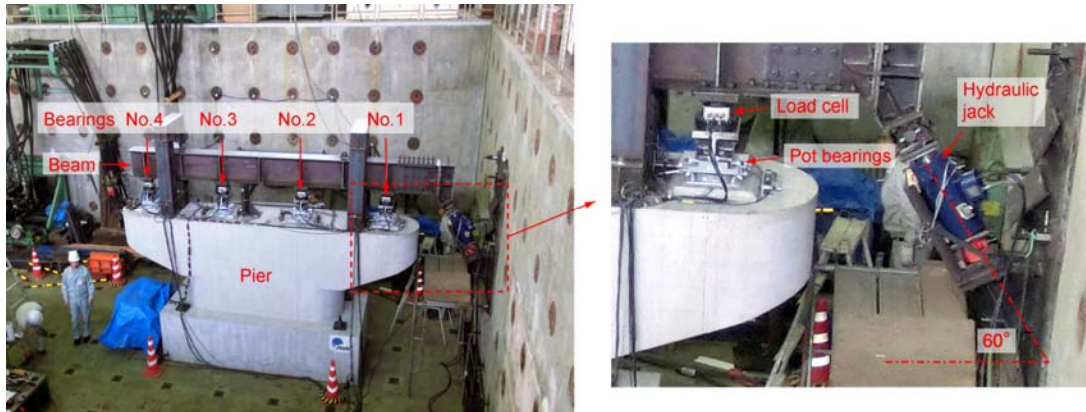
**Fig. 6** Setup of loading test on large-scale bridge model

A 1/2 scale existing bridge model with pot bearing supports, designed prior to 1980, was loaded with the purpose to investigate the capacity of bridge for resisting the tsunami-induced force. Figure 6 shows the setup of the loading test. The test unit is a 1/2 scaled model of pier P3 in Koizumi Bridge that the superstructures were washed away due to the tsunami in the 2011 Great East Japan Earthquake. The superstructure was supported by four pot bearings based on a figure of Koizumi Bridge. Figure 7 shows the details of the pot bearings. Resistance of this type of bearings in horizontal direction and vertical direction are provided by the stopper and the side block, respectively. Design capacity can be evaluated based on the allowable stress design method. In this test, the load was applied in a direction as shown in Fig.6, where this loading method was one of the loading case for simulating the case that the resultant of the horizontal force and vertical force acted on the side of the superstructure was about 60 degree to the horizontal direction.
