EFFECT OF DECK PLATE THICKNESS OF ORTHOTROPIC STEEL DECK ON FATIGUE DURABILITY

Jun Murakoshi¹, Shu-ichi Hirano², Hideaki Harada³

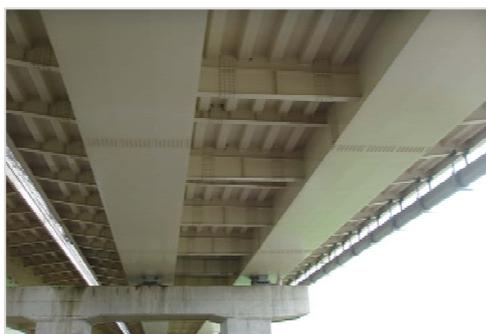
Fig. 1 View of orthotropic steel deck box girder bridge

Orthotropic steel deck (OSD) bridges have been widely used for long-span bridge and urban viaducts for reducing dead load. OSDs consist of many thin steel plates, stiffened by a series of closely spaced longitudinal ribs supported by transverse floorbeams (see Fig. 1). As they support vehicle wheel loads directly as deck system, considerations for fatigue has to be supposed to be required in the design of OSDs. With rapid increase of vehicle weight and traffic volume in Japan, various types of fatigue cracks shown in Fig. 2 have recently been observed in existing OSDs under severe traffic condition, resulting from the complicated welded details combined with local stresses that can be difficult to quantify in the design. Among such fatigue damages, two types of severe cracks have been observed at the rib-to-deck welded joints. They initiate at the root of the one-sided fillet weld. One type of them propagates into the deck plate and finally reaches its surface (deck plate cracks), while the other propagates through the weld (bead cracks). Among them, the deck plate cracks have potential to threaten safety of traffic due to cave-in of road surfaces if they reach a certain length. Focusing on the two types of cracks, especially the deck plate cracks, the research projects have been conducted for the following objectives:

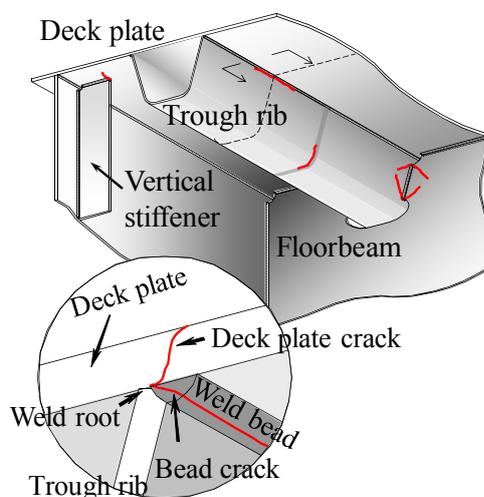
【Section of the rib-to-deck weld connection】

Fig. 2 Major fatigue cracks observed in OSDs

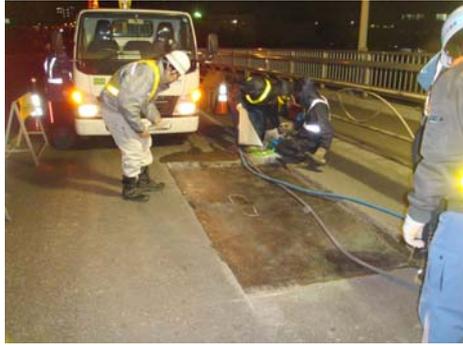
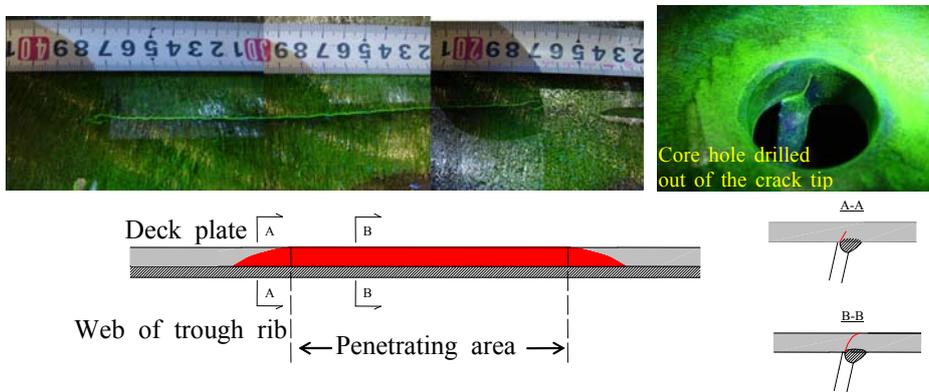
(a) Visual observation of deck surface after removal of asphalt layer

(b) Description of observed crack

Fig. 3 Detailed inspection for deck plate crack

Fig. 3 shows detailed inspection for a deck plate crack. According to investigation of existing damaged OSDs, the tendencies of deck plate cracking are listed below.

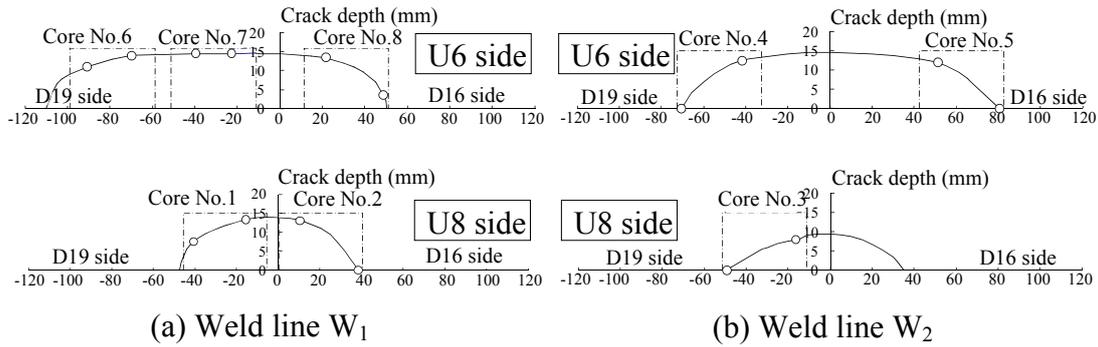
Fig. 6 Shapes of deck cracks in the weld root at the rib-to-floorbeam connections(D19)

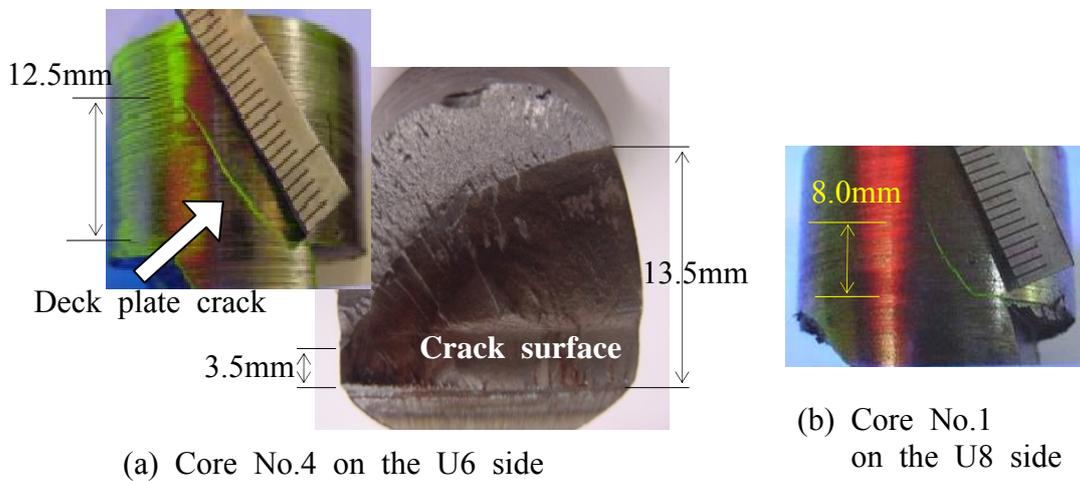
Fig. 7 Cracks observed on the core surfaces

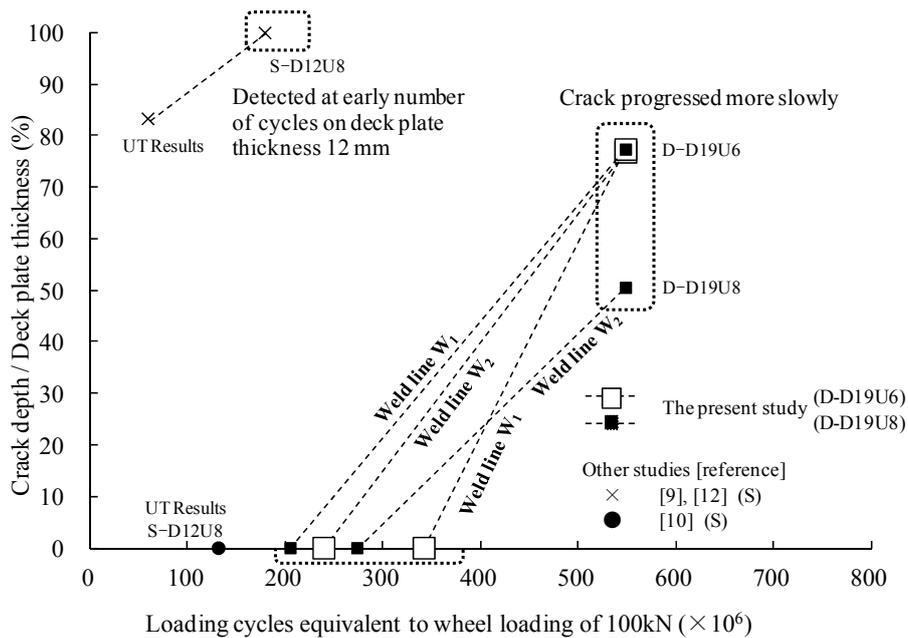
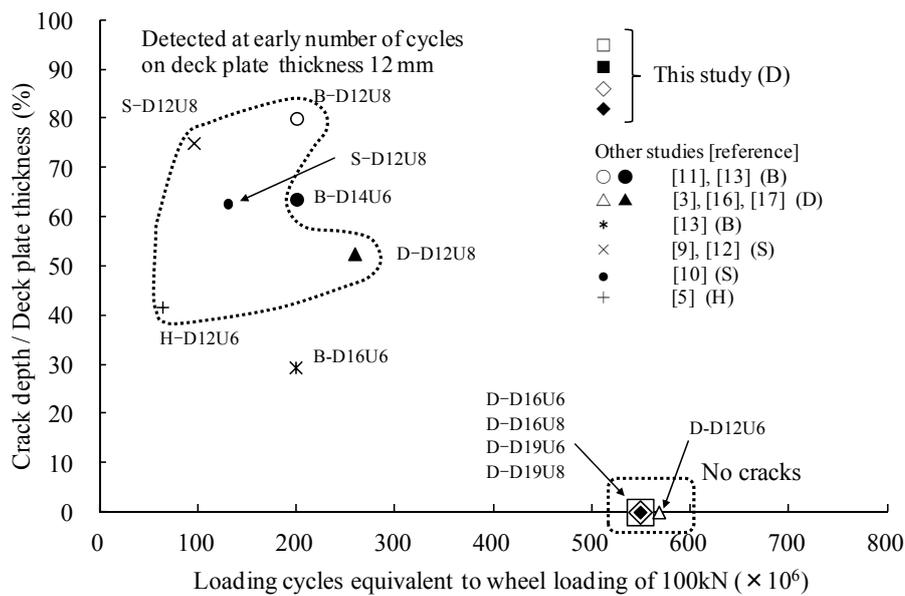
(a) Cracks in weld parts of RD connections at rib-to-deck weld

(b) Cracks in other parts at rib-to-deck weld

Fig. 8 Ratio of crack depth to deck thickness versus loading cycles equivalent to 100kN wheel load

Fig. 8 shows the relation between the ratio of crack depth to deck thickness and the number of loading cycle equivalent to 100kN wheel load. The results by the authors and those by other studies are plotted in the figure. The equivalent loading cycles were calculated based on the linear cumulative damage rule ($m=3$). Crack depths estimated from UT are also plotted. Although the variation in data is large, crack growth tended to progress relatively slowly with increase of the deck thickness.

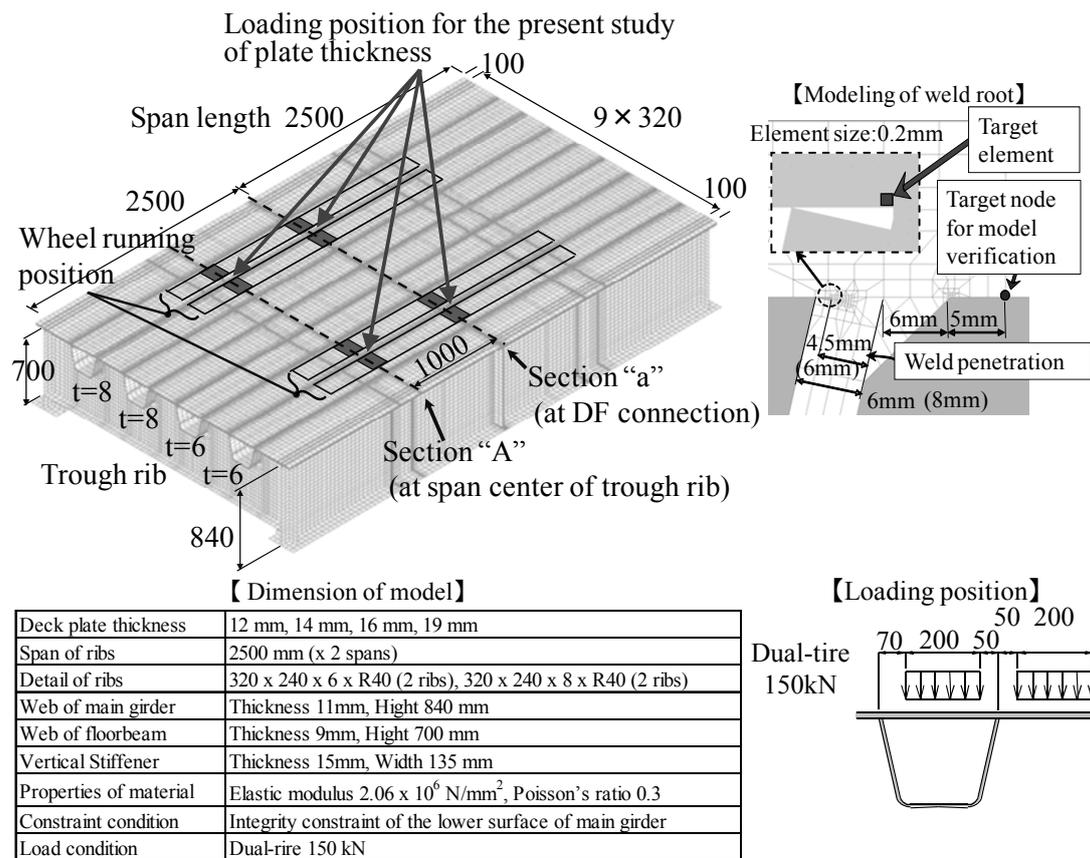
Fig. 9 Analysis model of test specimen

FE analyses were conducted for the full-scale test specimen focusing on the local stresses in the weld root where cracks initiated. Fig. 9 shows outline of the analysis model. In modeling, the minimum dimensions of elements of the target weld root were set to $0.2\text{mm} \times 0.2\text{mm} \times 0.5\text{mm}$. Although local stresses of the weld root are affected by element dimensions in the analysis model, relative comparison of local stresses by using the same detail modeling is considered to be appropriate. The elastic modulus of E and Poisson's ratio ν for steel material were set as $E=206,000\text{N/mm}^2$ and $\nu=0.3$, respectively. The contact point between the bottom surface of deck and the inner surface of rib at the RD connection was modeled as separated node. Dual-tire wheel loads of 150kN were applied above RD weld line, same as that in the wheel running test. Especially in this paper, the results of loading patterns at section "a" at DF connection and section "A" at span center of trough rib were discussed.

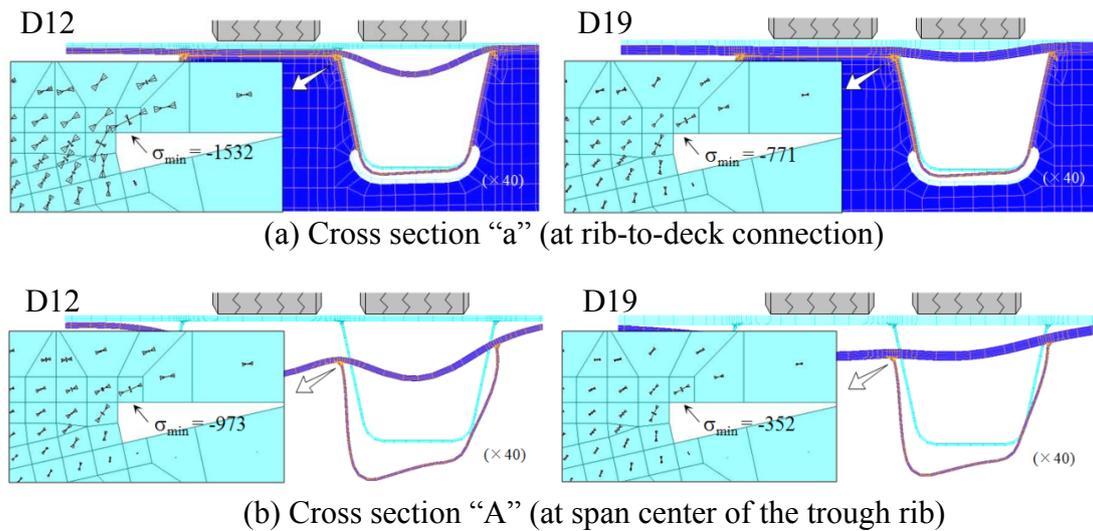
Fig. 10 Deformation and principal stress vector diagrams for D12U6 and D19U6

Fig. 10 shows the deformation and the principal stress vector diagrams for the combination of D12U6 and D19U6 at cross section of "a" (rib-to-deck connection)" and "A" (span center of the trough-rib). Relative high peak compressive stresses occurred at the weld root due to local bending of deck plate. Deformation of the deck and the rib and local stress of target element in the weld root decreased with increase of the deck thickness. Absolute values of the minimum principal stress are larger than those of the maximum principal stress in the weld root. As to target element, the direction of minimum (compressive) principal stress corresponds almost perpendicularly to the direction of crack propagation.

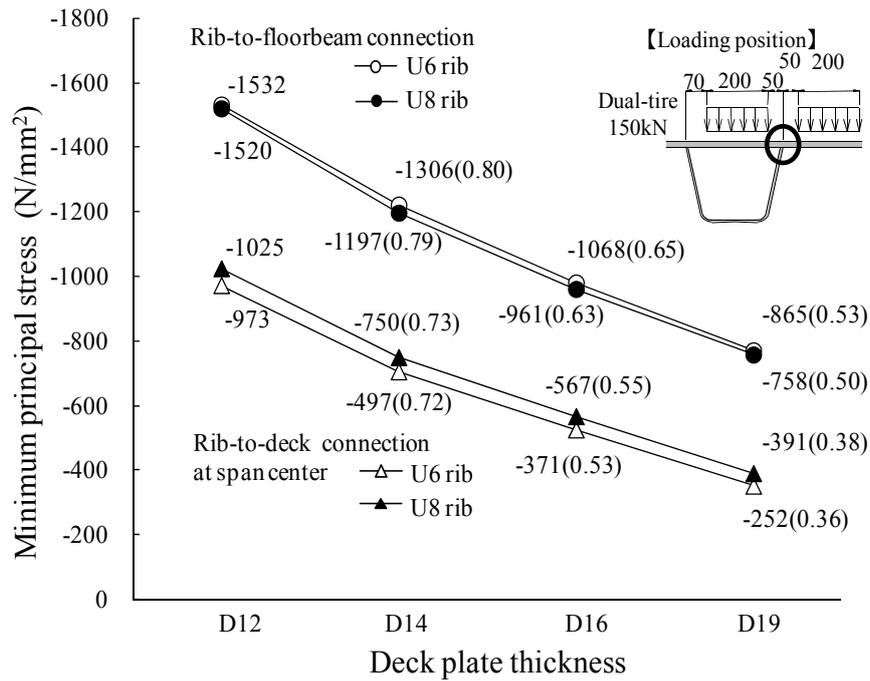
Fig. 11 Minimum principal stress versus deck plate thickness

Fig. 11 shows the minimum principal stress for the target element in the weld root by deck thickness. The ratios to the stresses for D12 are indicated in parentheses. The effect on fatigue durability of deck thickness was evaluated on the basis of relative comparison of minimum principal stress since compressive principal stress is dominant in the local stresses at the weld root under wheel loading. Increase of deck thickness can significantly reduce the minimum principal stress. The minimum principal stress at RF connection part for D19 is larger than that at RD connection part at the span center of the trough rib for D16 and D19, which corresponds to tendency

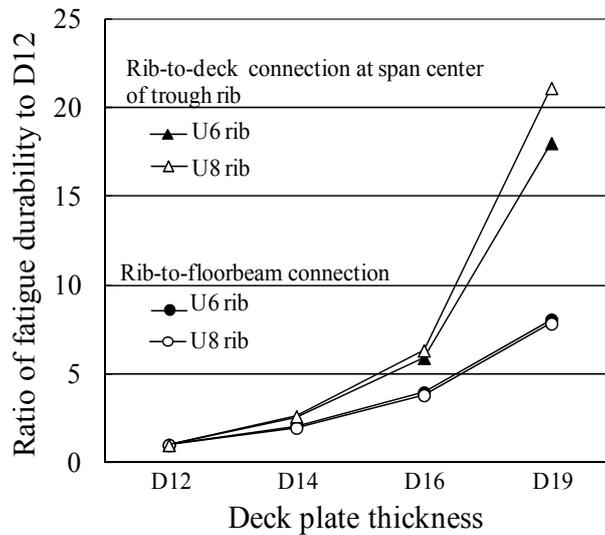
Fig. 12 Ratio of Fatigue durability to D12 versus deck plate thickness

Fig. 12 shows the relative comparison of fatigue durability by deck plate thickness. Fatigue durability was assessed based on the local stresses in the weld root by cumulative damage rule. As to the weld root at RF connection, where is under more severe fatigue condition, estimated fatigue durability for OSD with D14, D16 and D19 against local stress are about 2, 4 and 8 times as long as that with D12, respectively.
