# RECENT RESEARCHES ON PROPERTIES OF LAMINATED ELASTOMERIC RUBBER BEARINGS UNDER CYCLIC LOADING

Jun-ichi Hoshikuma<sup>1</sup>, Masatsugu Shinohara<sup>2</sup> and Takao Okada<sup>3</sup>

## **Abstract**

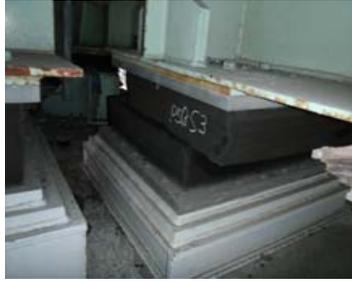
**Photo 1** Rupture of Laminated Elastomeric Rubber Bearing

Laminated elastomeric rubber bearings have been widely employed since the 1995 Kobe Earthquake, and severe damage have never been observed before the 2011 Great East Japan Earthquake. However, some of laminated elastomeric rubber bearings, including those designed with the post-1995 design specifications, suffered rupture or deep cracking into rubber due to the 2011 earthquake as shown in Photos 1 and 2 (J. Hoshikuma, 2011). Details and the mechanism of the damage to the laminated elastomeric rubber bearings are discussed in references listed in the end of this paper (T. Hirose, 2012, K. Kawashima, 2013). Based on the discussion, possible contributing factors of the damage are supposed to be: 1) effect of the seismic response of complicate structural girders; 2) effect of creep and shrinkage of PC girder; 3) effect of unexpected dispersion; and 4) effect of an aging change of the mechanical properties.

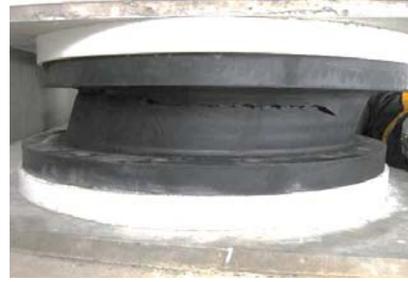
**Photo 2** Crack in Lead Rubber Bearing

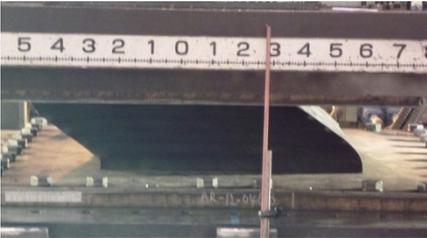
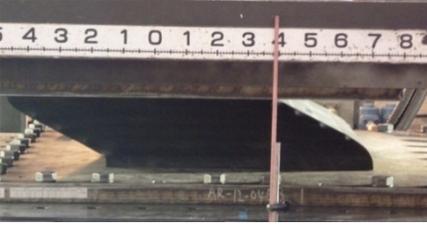
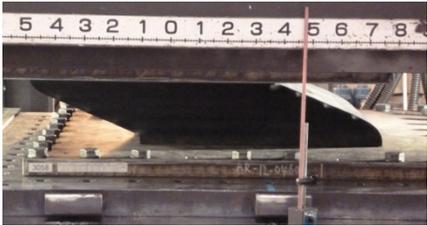
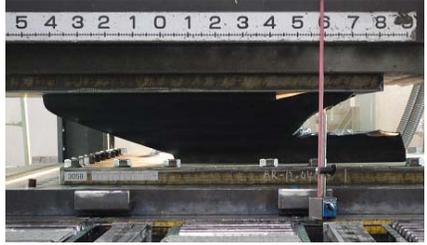
**Table 3** Shear Force Versus Displacement Relation at Each Displacement

Loading Step	Force versus displacement relation	Photo at peak displacement
Step 1  Effective design displacement 175% 11times

Step 2  Design limit displacement 250% 6times

Step 3  Ultimate limit displacement 300% 2times

Step 4  Rupture Displacement 370% Monotonic loading

Table 3 exemplifies a hysteresis loop of the relation between the shear force and the lateral displacement given to a test specimen of LRB and photographs taken at peak shear strain in each loading step. The final failure of this test specimen was caused by rupture of rubber at the shear strain of 370%. It is, however, noted for a few other specimens that the rupture was observed around an adhesive section between the inside steel plate and the rubber.
