FINITE ELEMENT-LEVEL BRIDGE INSPECTION DATA ANALYSIS AND EXPERIMENTS ON THE DURABILITY OF RC DECKS

Takashi Tamakoshi¹, Mari Ishio², Fumi Miyahara³,
Yoshiteru Yokoi³, and Masahiro Shirato⁴

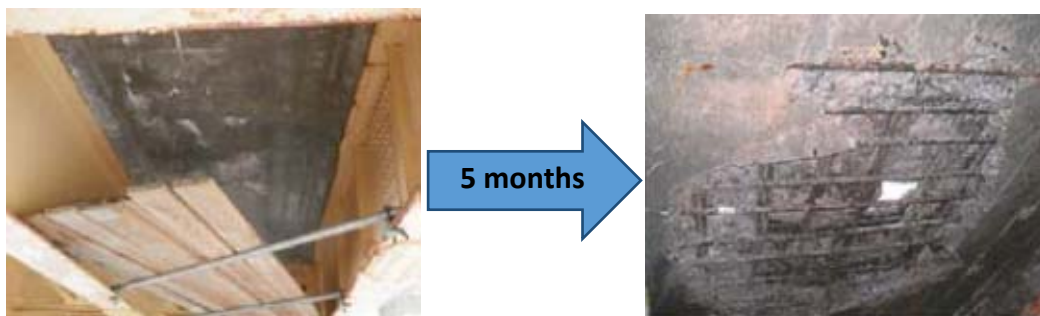
However, case histories have indicated that decks not having dense two-directional cracks sometimes seem to abruptly collapse. Figure 1 shows an example, in which a deck having minor two-directional cracks and subtle effloresces collapsed in five months. This kind of deterioration process did not seem to follow the typical crack development pattern, leading a diagnosis of RC deck durability to an unsafe side in bridge inspections.

FIGURE 1 An example of the collapse of an RC deck having only minor cracks

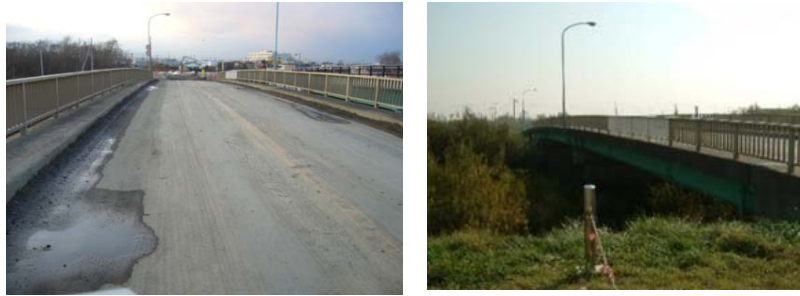
Plan view

Deck span = 2.0 m, Deck thickness = 170 mm		
Main reinforcement	Top	D16@250
	Bottom	D16@125
Distribution reinforcement	Top	D16@300
	Bottom	D16@150

Figure 4 RC deck specimens cut out of the decommissioned bridge (Specimens no. 1 and no. 25 were finally employed.)

3. The samples were cut out of the same lane because loading histories were considered similar to each other, where the positions of presumed axel loading and the sampled specimens are also drawn in Figure 4.

The deck thickness was 170 mm and it did not have waterproof work. No repair was conducted in the past for the RC deck. The reinforcement arrangement of the deck is also summarized in Figure 4.

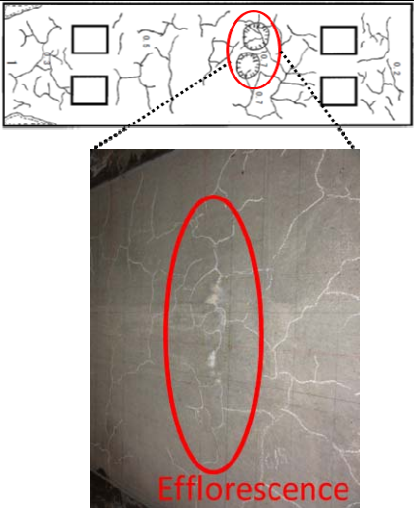
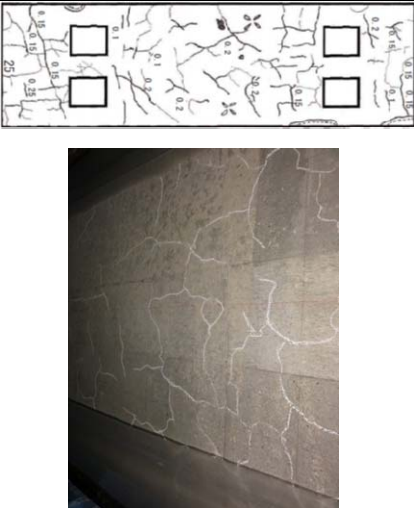
TABLE 4 Observed crack widths and spacing in the sampled specimens

Specimen no. 1 (w/ through-thickness crack)	Specimen no. 25 (w/o through-thickness crack).
Bottom surface appearance

Crack width	0.10 mm to 0.25 mm	0.10 to 0.20 mm
Crack spacing	0.2 m to 0.3 m	0.2 m to 0.3 m

Crack widths and distances in both specimens were measured and compared in Table 4, with photos of the bottom surface appearance, for both specimens. Except for the fact that subtle efflorescence locally appeared as shown in the specimen no. 1, crack patterns, widths and densities were found out similar to each other when comparing the specimens. After removing asphalt pavement, the water permeability was tested, proving that the specimen no. 1 had through-thickness cracks and the specimen no. 25 had none of them. Concrete and reinforcement were sampled from both specimens and tested, as summarized in Table 5. Both specimens have similar material properties. The sampled specimen dimensions were 1.4 m wide perpendicular to traffic and 3.85 m long parallel to traffic and these widths and lengths were too short to place the specimens on the
