**Case Study on Risk Factor Analysis
of 1991 Cyclone Disaster
in Hatiya Island, Bangladesh**

**International Centre for Water Hazard
and Risk Management (ICHARM)**

PUBLIC WORKS RESEARCH INSTITUTE

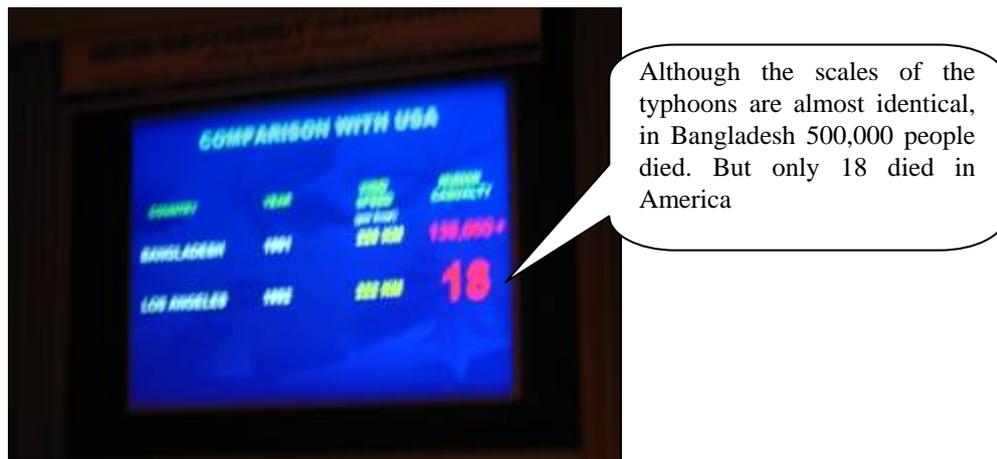
Figure 3. Comparison of Hurricane Disaster in America with Cyclone Disaster in Bangladesh

Figure 3 shows a comparison between the hurricane disasters in the United States of America and the cyclone disaster in Bangladesh.

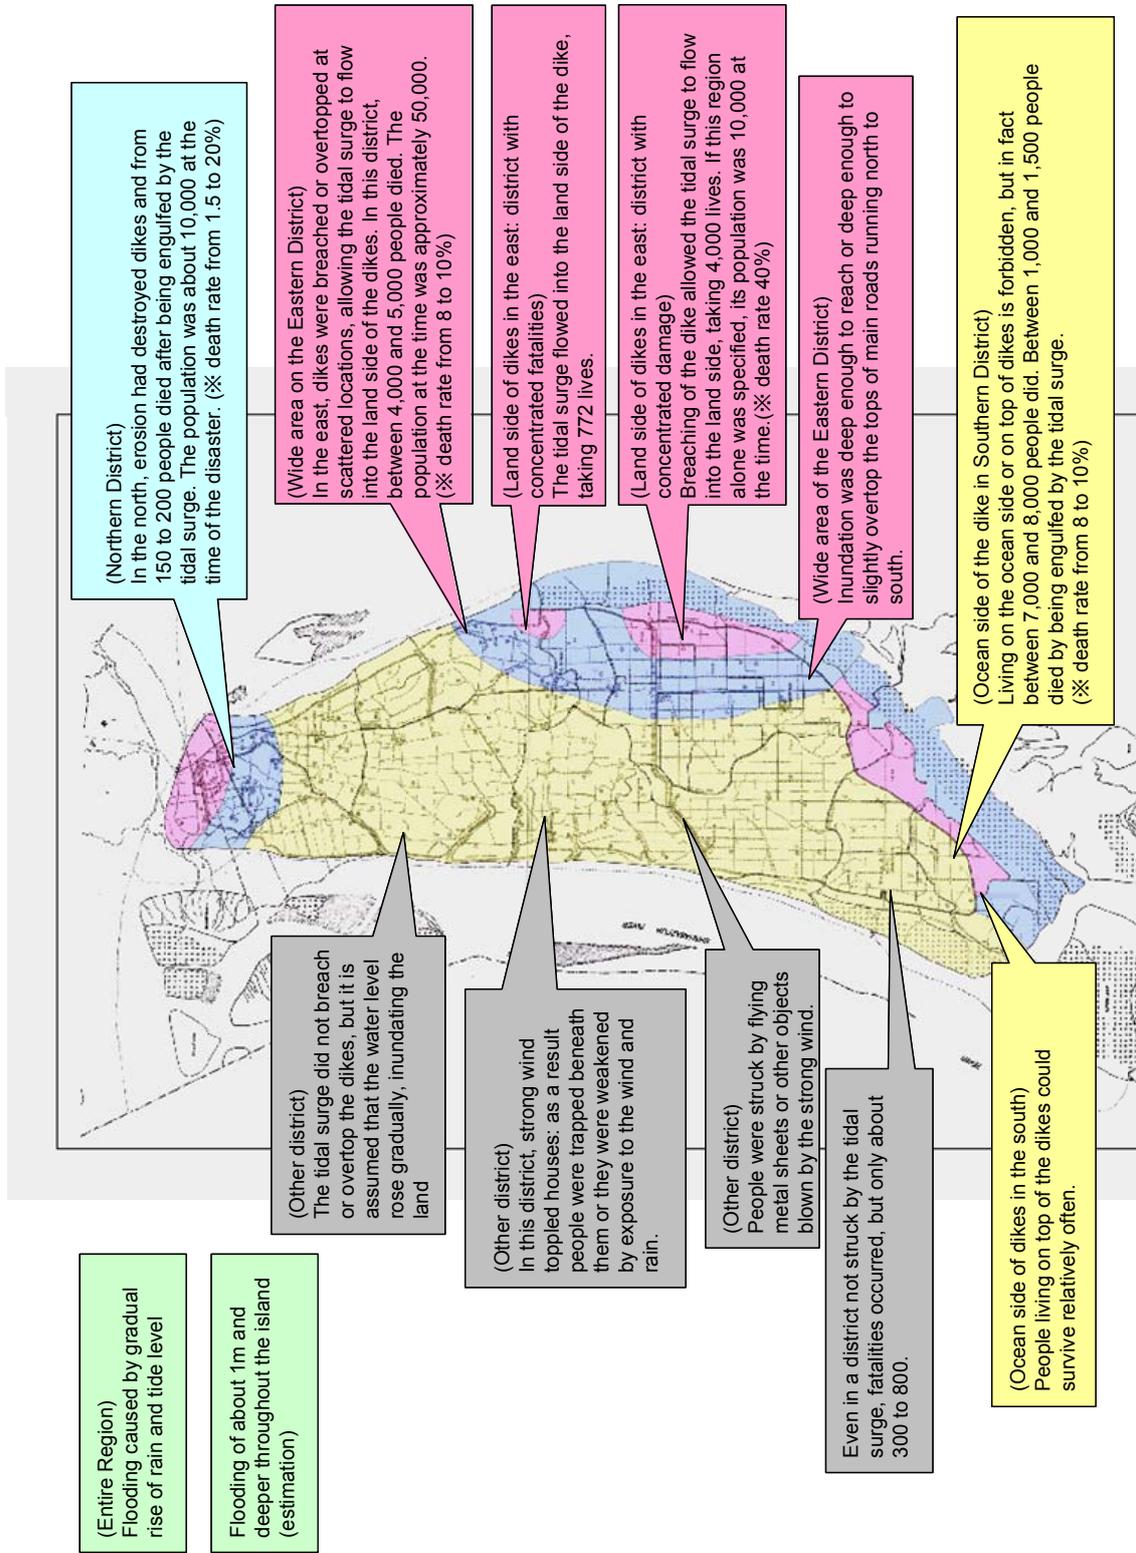
Figure 6. 1991 Cyclone Disaster Region (Prepared based on interviews at DUS)

The following table organizes the state of damage in each district, and the details are plotted on Figure 6.

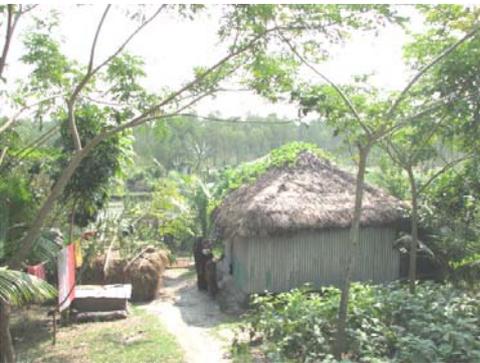
Present dwelling (on the ocean side of the new dike)

It is constructed at the bottom of the slope of the ocean side of the new dike and its roof is made of straw and its walls of galvanized metal sheets. At the time of the 1991 disaster, homes were similarly constructed at the bottom of the ocean side slope of the old dike. The walls were made of bamboo. Although called a house, it is a hut 5m wide and 5m deep.

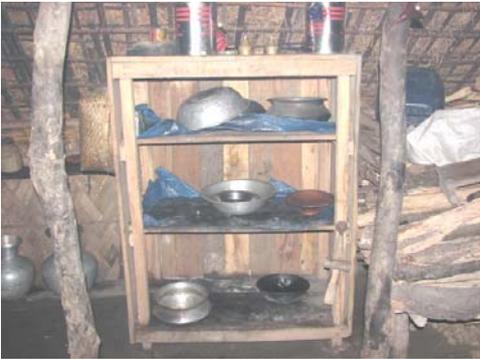
Cooking utensil shelf in her home

There is a cooking utensil shelf opposite the entrance as shown in the photograph. Although it is not shown in the photograph, to the left of the shelf, there is a hearth where she does her cooking. There is no electricity in the hut and it is very dark inside even in the daytime.

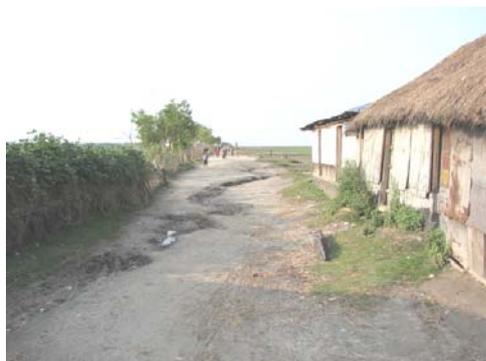
Eastern District (Char Ishwar, Union) dike

At the time of the cyclone in 1991, the tidal surge overtopped and breached the dike at scattered locations. The tidal surge was 1 to 2m higher than the dike crest.

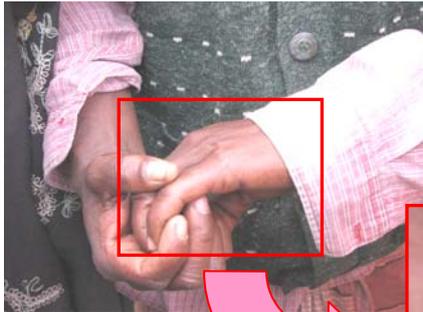
Scar on Ononto Zorodas’s hand

He injured his hand when he was washed away with his house by the cyclone of 1991. His scar is shown in the photograph.

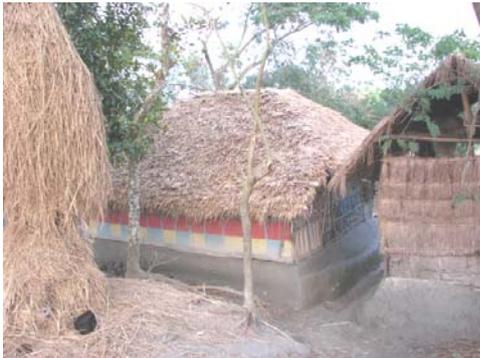
Sheckholido's home (ocean side)

He has lived at the bottom of the slope of a dike (ocean side of the dike) since he was a child. He rebuilt the house because it was damaged by the tidal surge caused by the 1991 cycle.

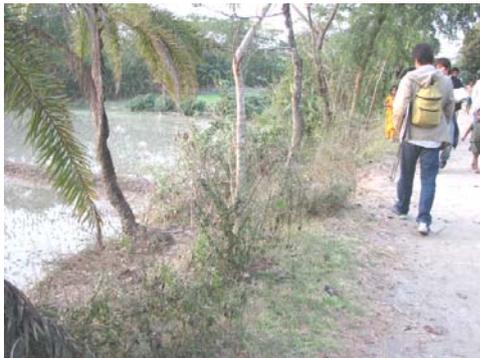
Slope on the land side of the dike

When he evacuated from the cyclone in 1991, the top of the dike was already so muddy because of the strong wind and rain that it was impossible to travel on it. Therefore, he escaped by traveling on the slope on the land side of the dike.

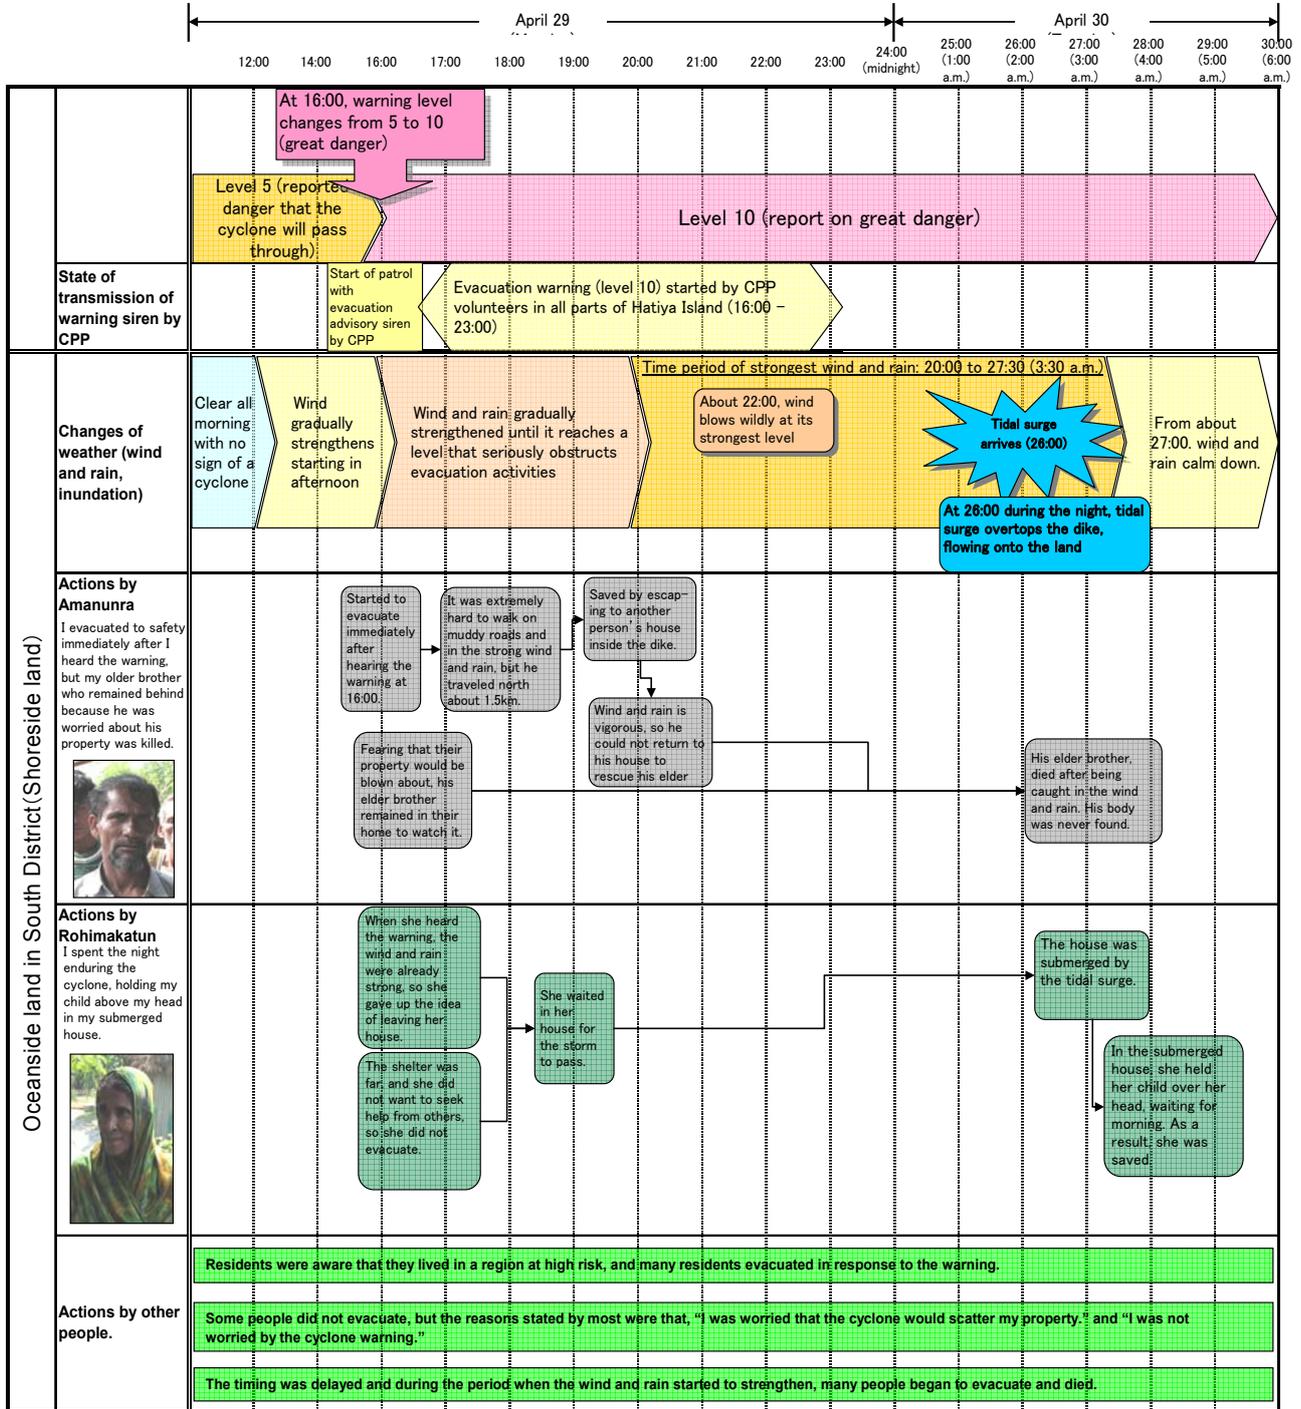
Figure 9 (1): Disaster Scenarios for Hatiya Island during the April 1991 Cyclone (Oceanside of the dikes on the southern coast)

Based on the results of the interview surveys described in 7.2 Interview Survey in Dwip Unnoyan Songstha and in 7.3 Interview Survey of local victims of the disaster, we have organized the disaster process in a time series (See Fig. 9).

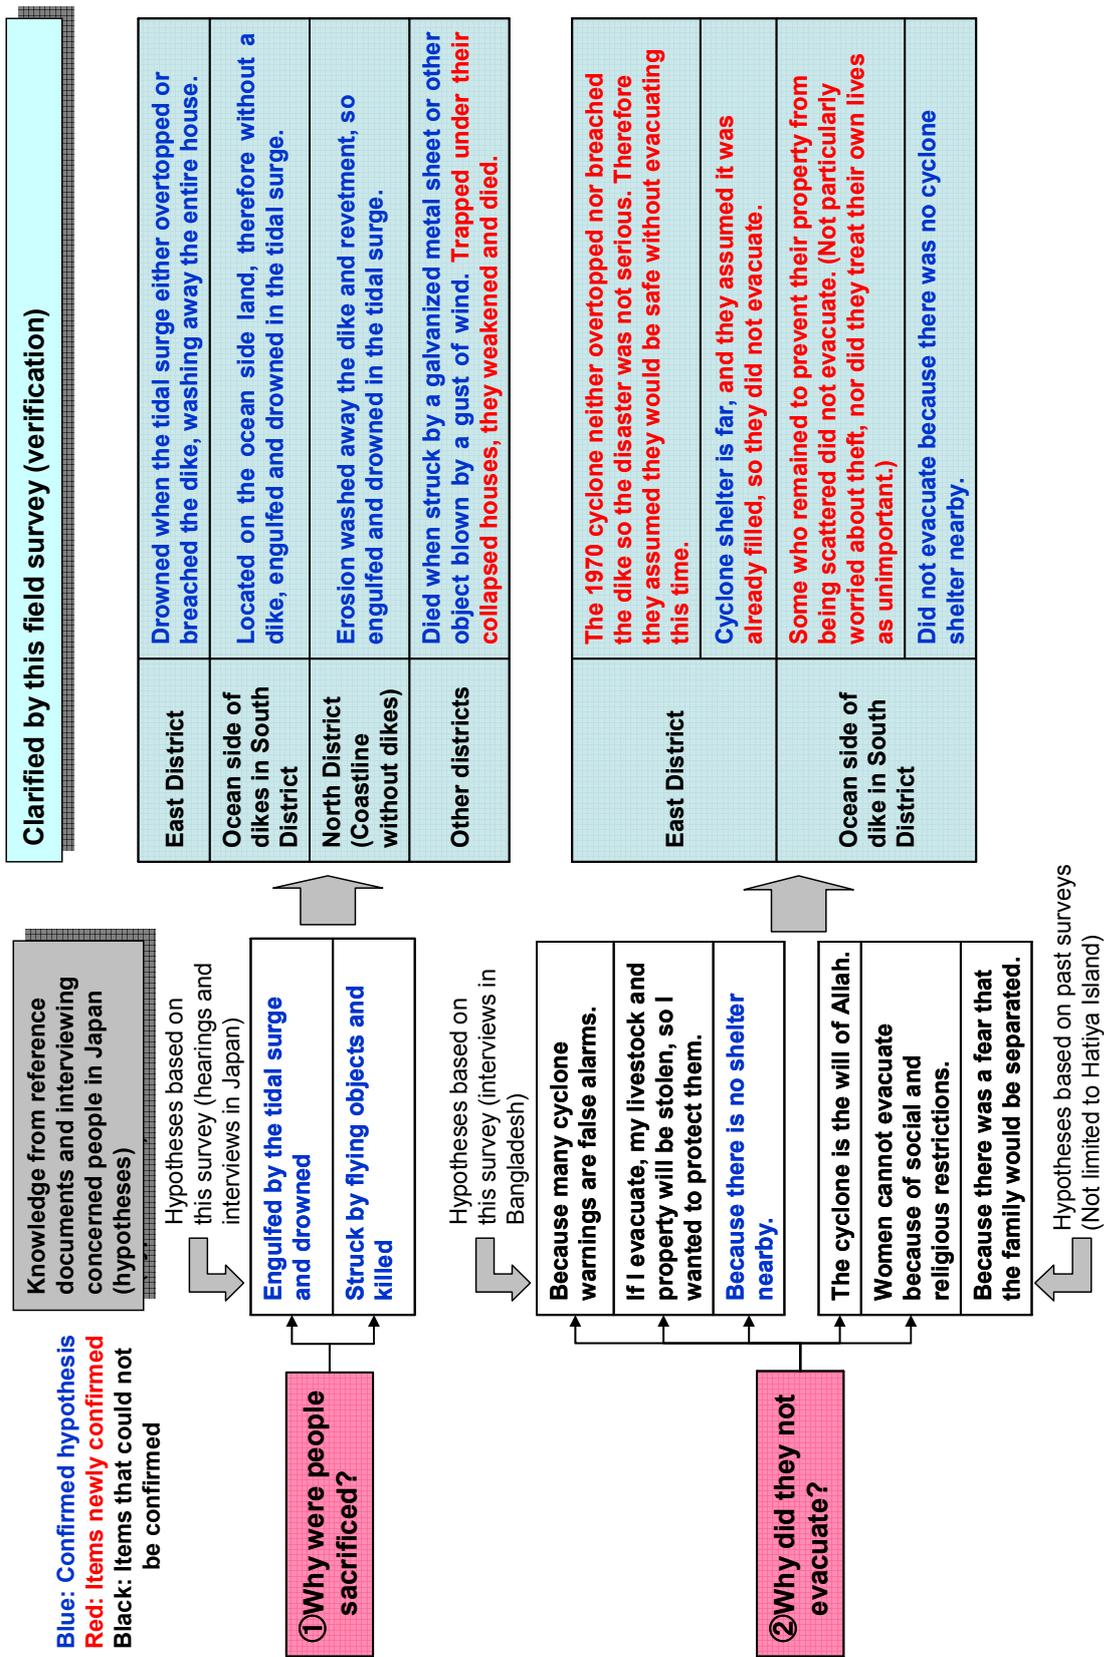
Figure 12. Hypotheses and Survey Results in Each District Based on the Field Survey (1/2)

The hypotheses and results of the surveys in each district (East, South, North, and other districts) based on the field survey are shown in Figures 12 and 13 on the following pages.

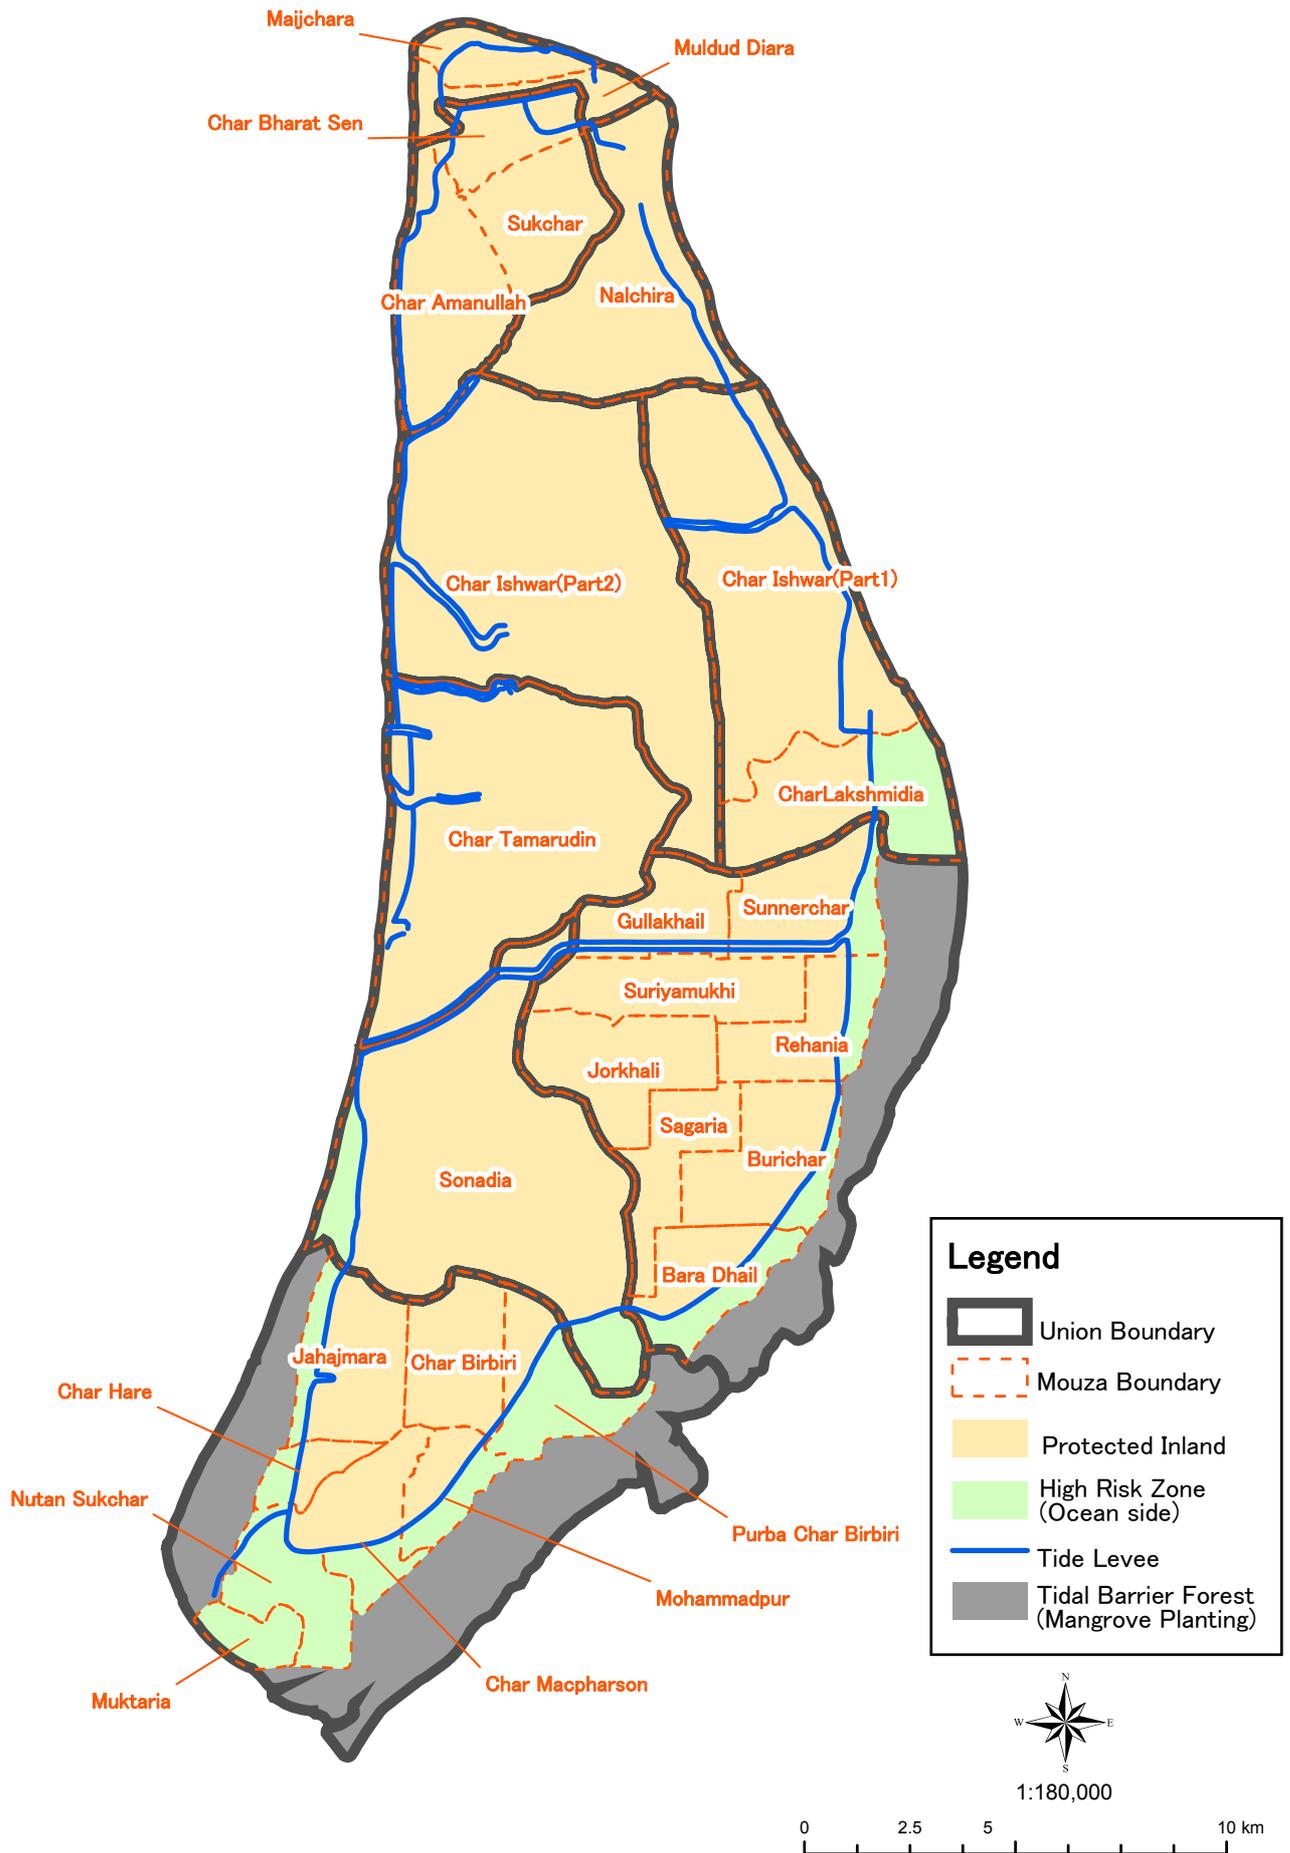
Tide Embankment in Hatiya (1991)

※Because the damages were concentrated in the Southern and Eastern regions, We did not make any distinction in the northern region.

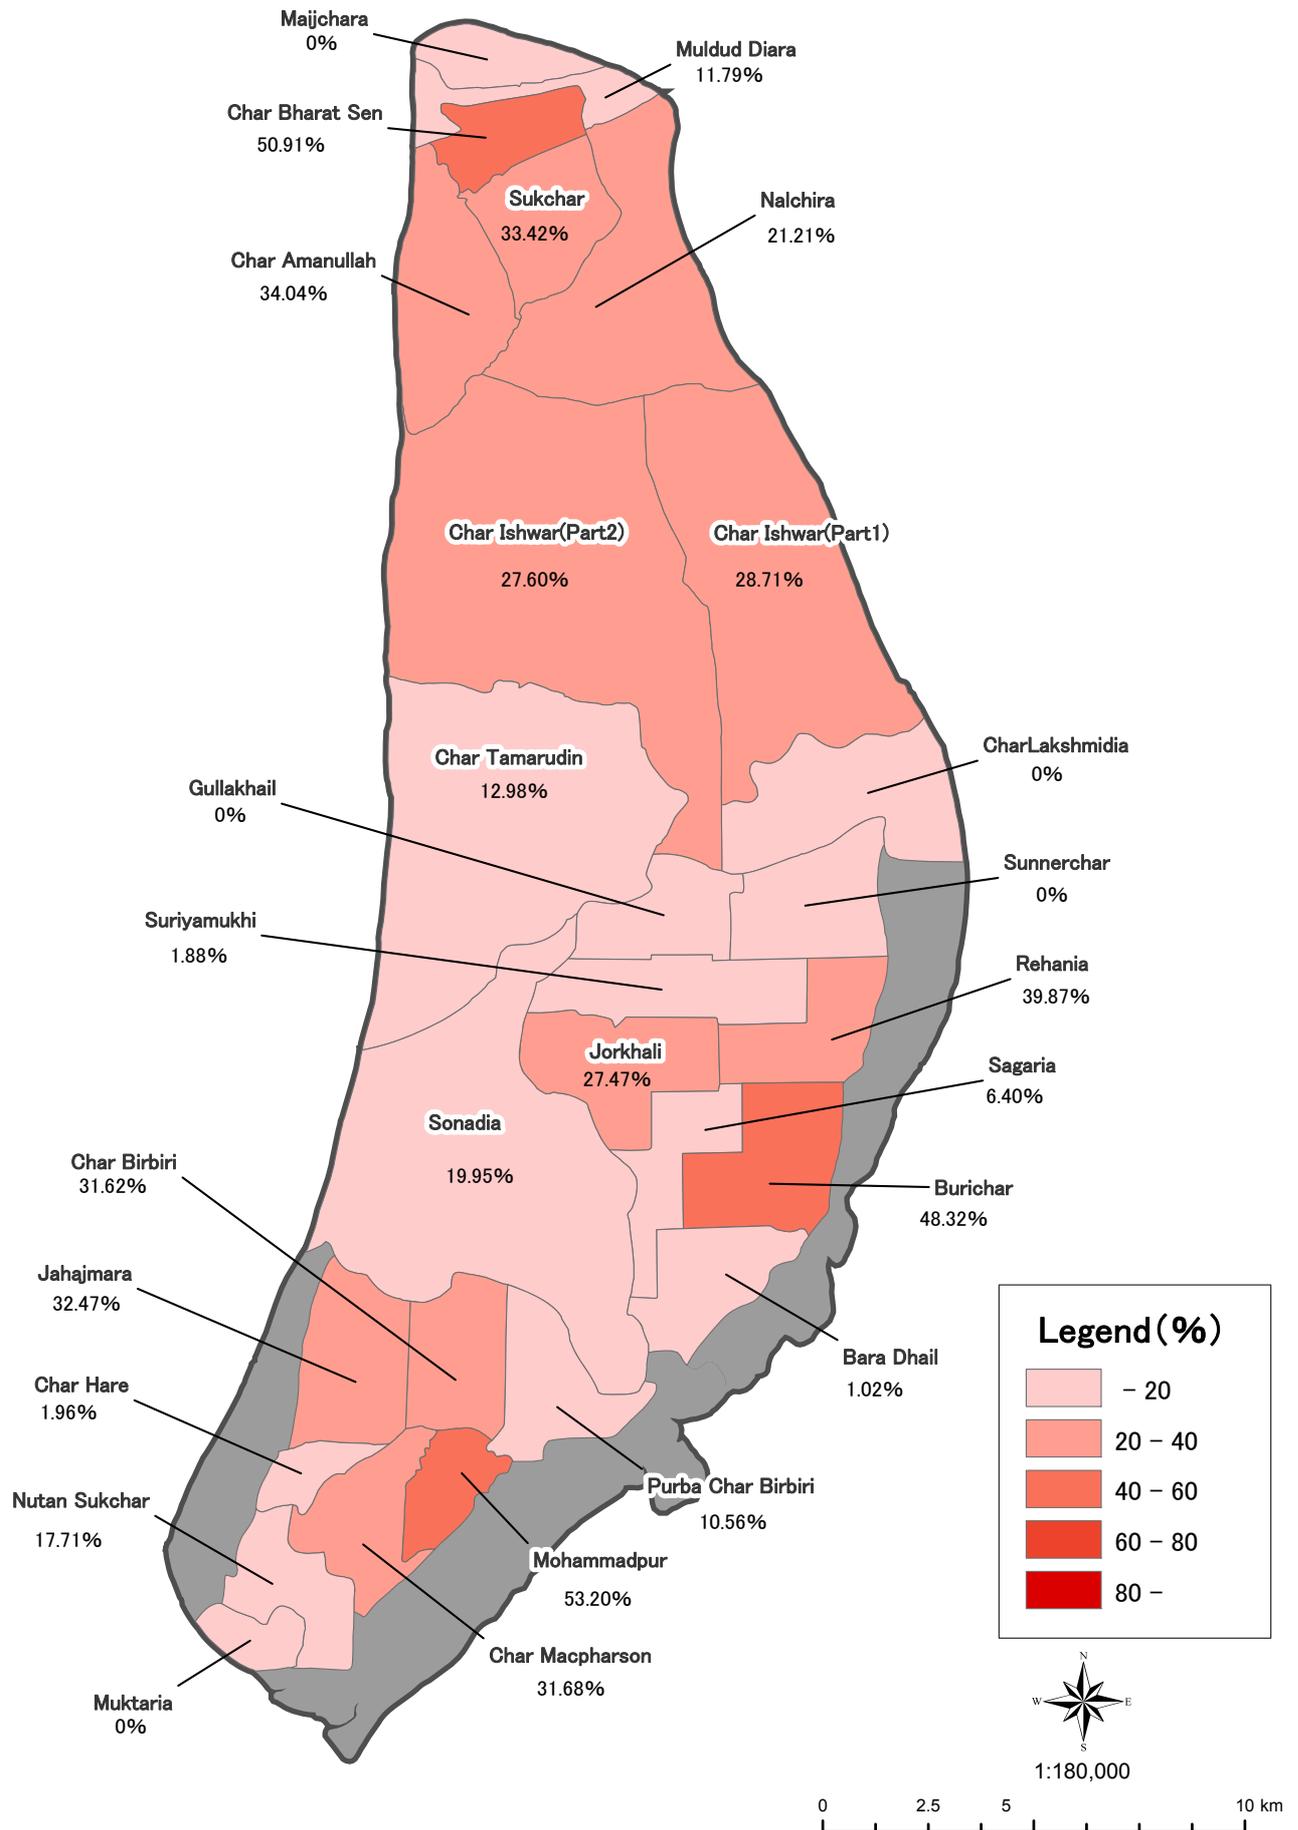
Area Coverage Rate(1991)

= (Area within a radius of 1km from a shelter/Mouza Total Area) × 100%

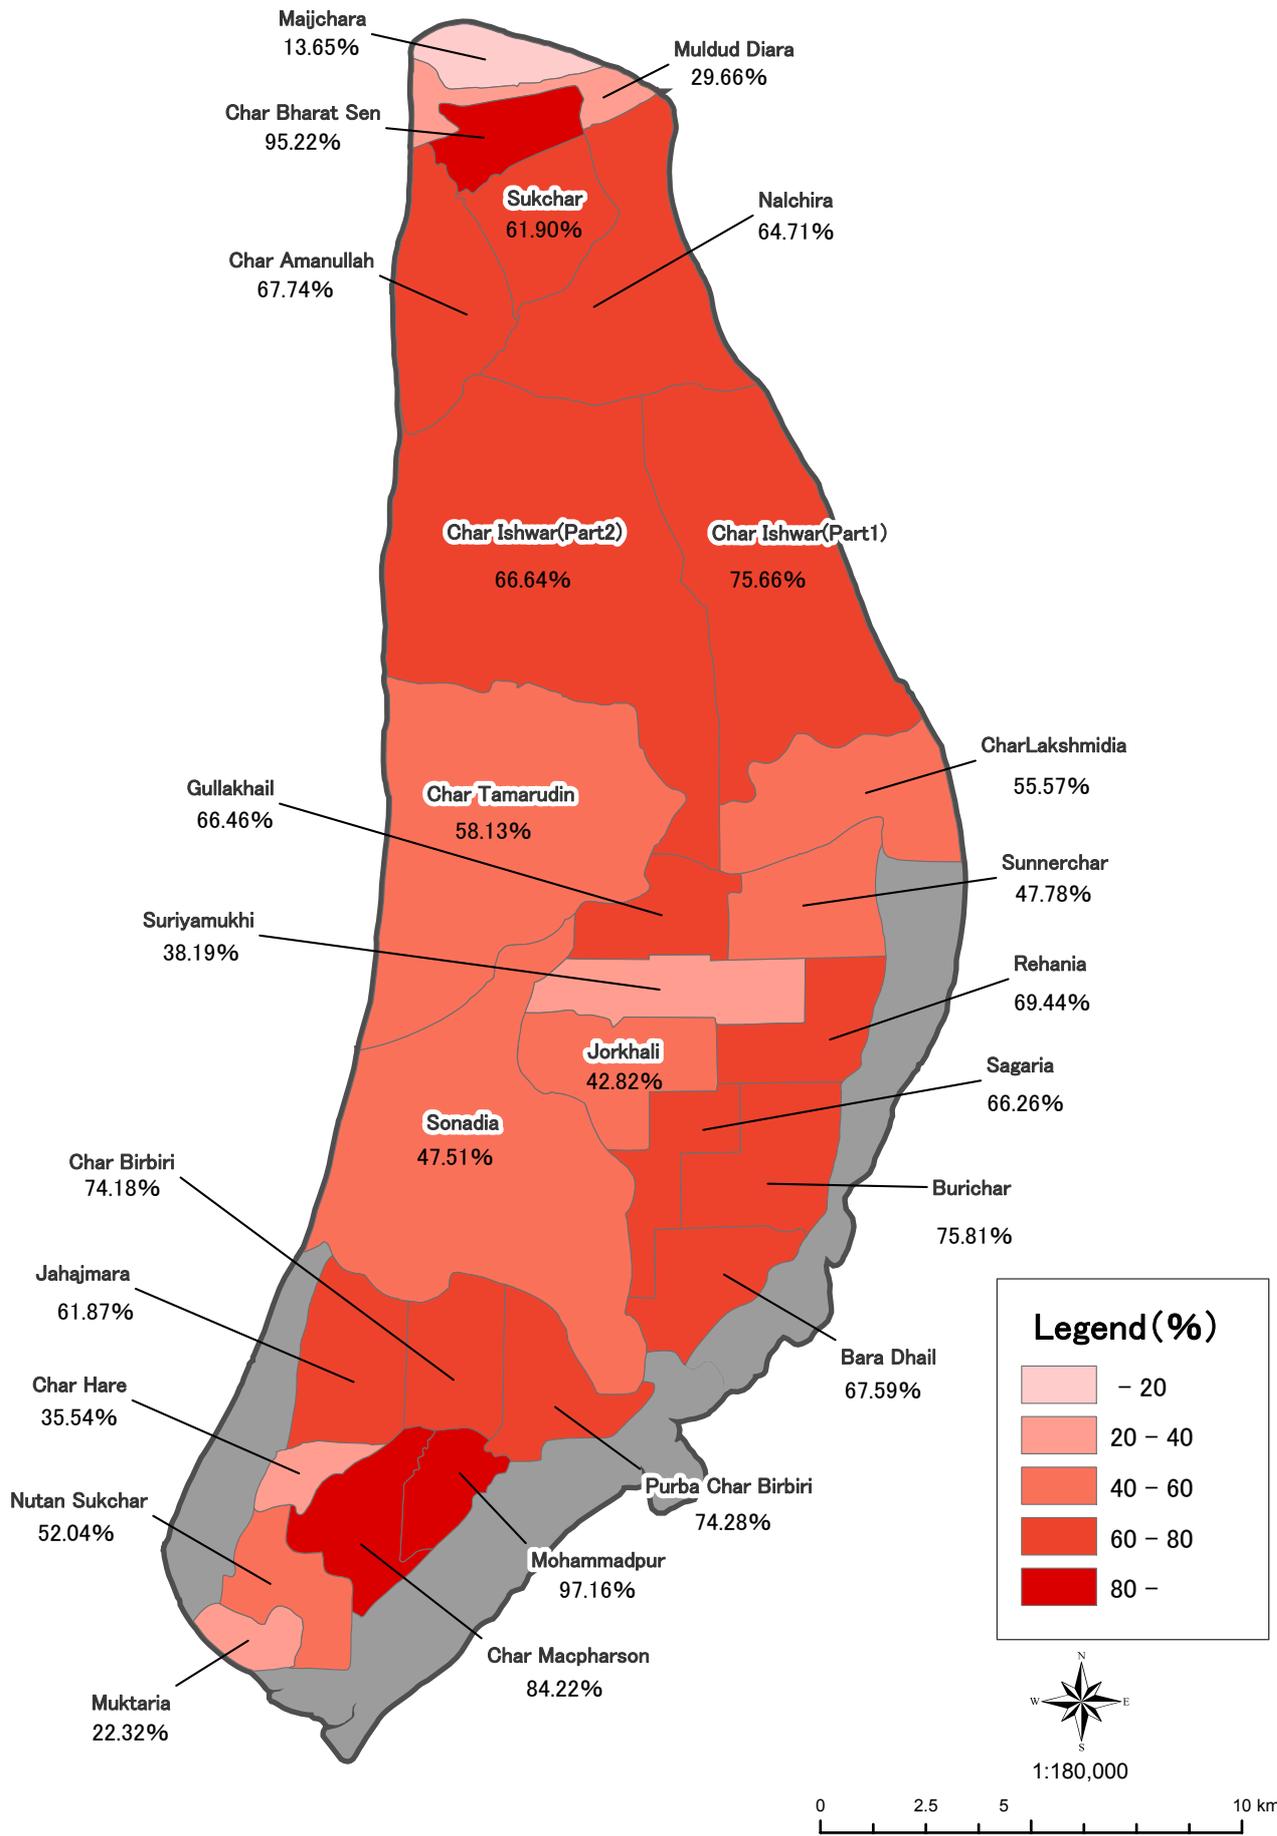
Area Coverage Rate (2007)

= (Area within a radius of 1km from a shelter/Mouza Total Area) × 100%
