Reducing Flood Damage via Met/Hydro Information in Thailand: Case of Bang Saphan Basin

Adisorn Champathong Royal Irrigation Department, Thailand

WORLD BOSAI FORUM, 11 Nov. 2019

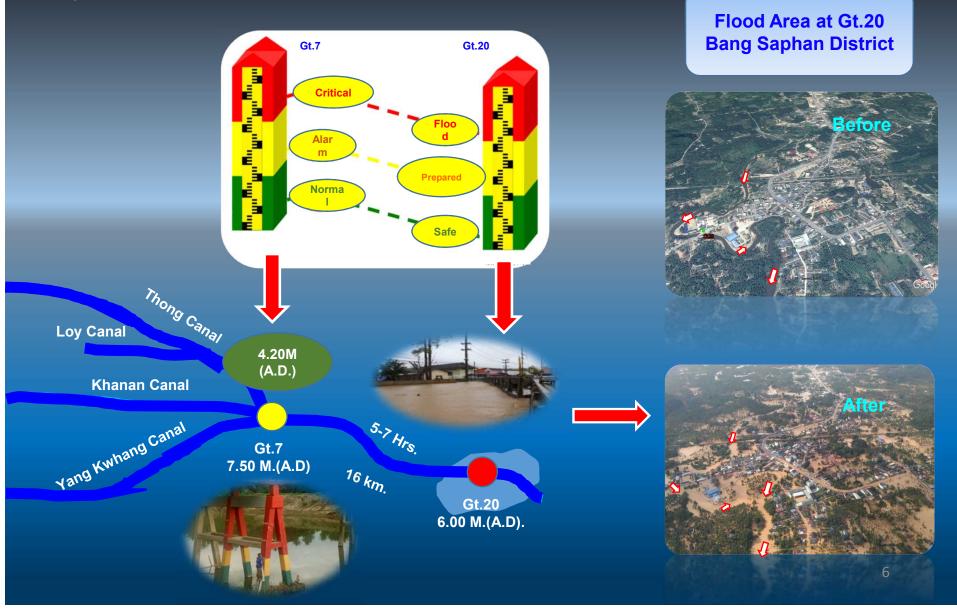
Example of Flood Map in the City (near Gt.20)

Flooding at 9 Jan 2017 At Gt.7 Station WL Peak 8.50 m.(A.D.) River Bank 7.50 m.(A.D.) At Gt.20 Station WL Peak 8.10 m.(A.D.) River Bank 6.00 m.(A.D.)

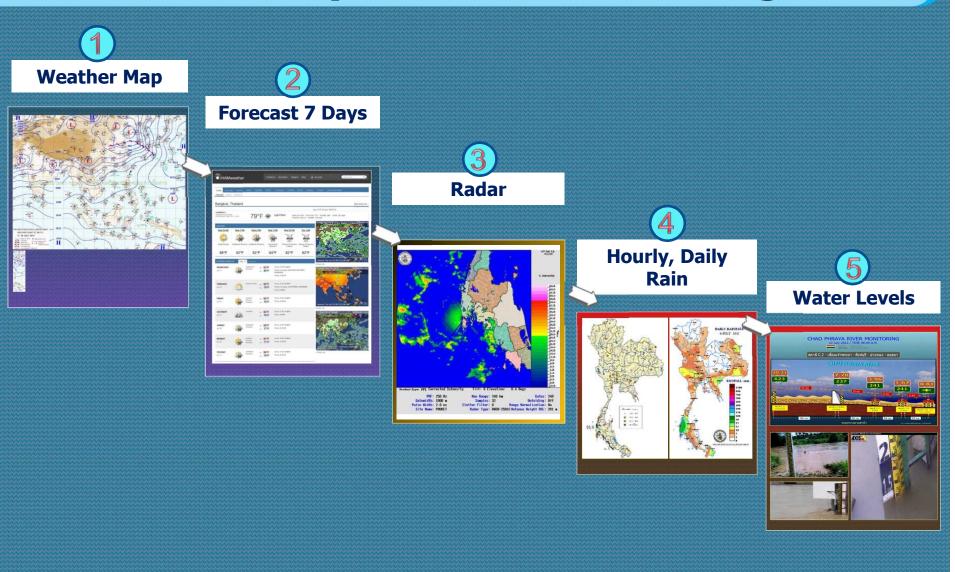
Meteo-Hydro Data Monitoring

Communication with community

Tools

- Hourly Water Level at critical stations via website
- Information board near Community
- LINE (set by Local community)
- FACEBOOK PAGE (set by Local community)

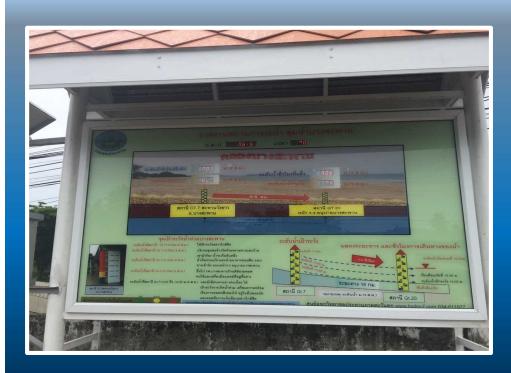
วันที่ 9 พฤศจิกายน 2561									
	КуЗ		0	it.9	Gt10		Gt.7		Gt.20	
	บ้านทุ่งแสก กุยบุรี ประจวบศรีรับธ์		บ้านกลาง ทับสะแก ประจวบศิริชันธ์		บ้านหนองหญ้าปล้อง บางสะพาน ประจวบศีรีชันธ์		บ้านวังอาว บางสะทาน ประจวบศิริชันธ์		สะพานรถยนต์ ร.ร.อนุบาลบ บางสะพาน ประจวบศีรีจันธ์	
			ระดับคลึ่ง 4.00 ม. ZG+6.900 ม.(รหก.)	ปริมาณ 75.00 อบ.ม./วินาที	ระดับคลิ่ง 3.50 ม. ZG+25.400 ม.(รพก.)	ปรีมาณ 210.00 ลบ.ม./วินาที	ระศับคลิ่ง 7.50 ม. ZG+11.800 ม.(รทก.)	บริมาณ 1090.00 ถบ.ม./วินาที

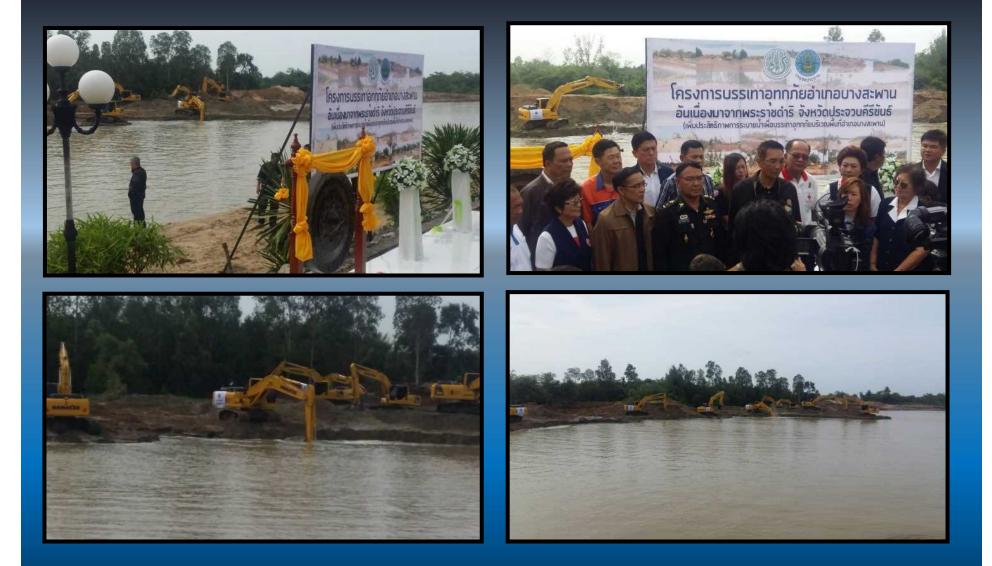
Example: Dredging Bang Saphan Canal, Thailand
