# Damage of Bridge Structures during Recent Earthquakes and the Effectiveness of Seismic Retrofit

## ABSTRACT

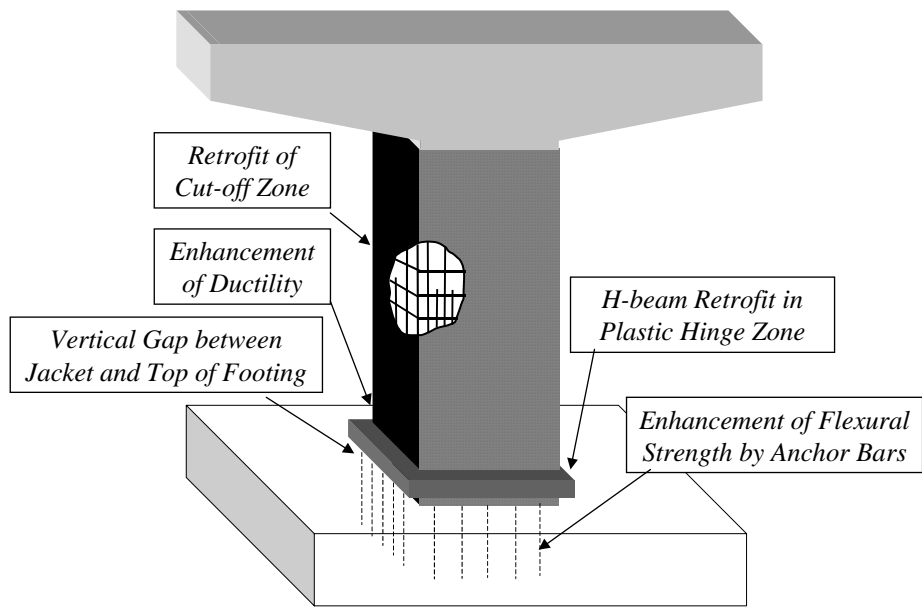
**Fig. 1** Seismic Retrofit Measures for Single RC Columns (Steel Jacketing)

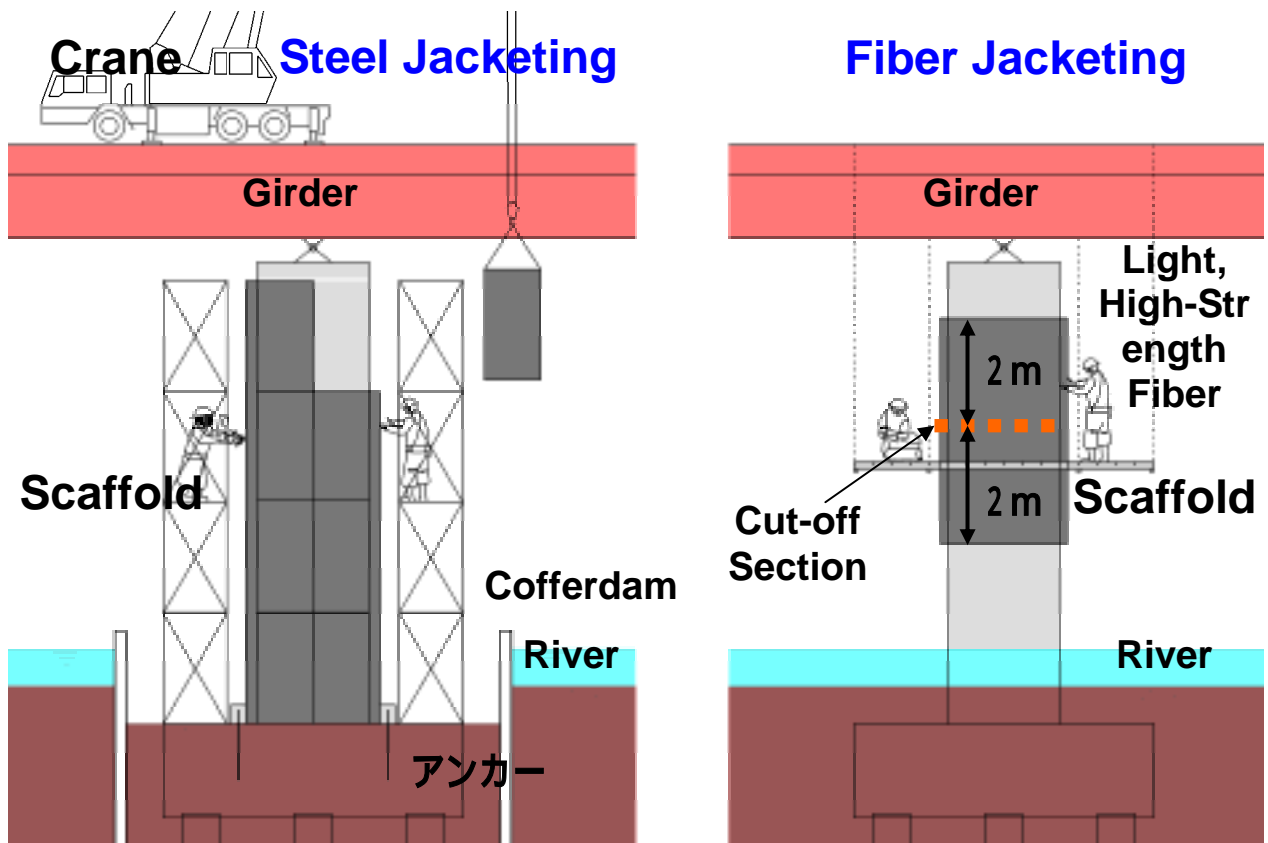
**Fig. 2** Comparison of Construction Methods for Steel Jacketing and Fiber Sheet Jacketing for River Bridges

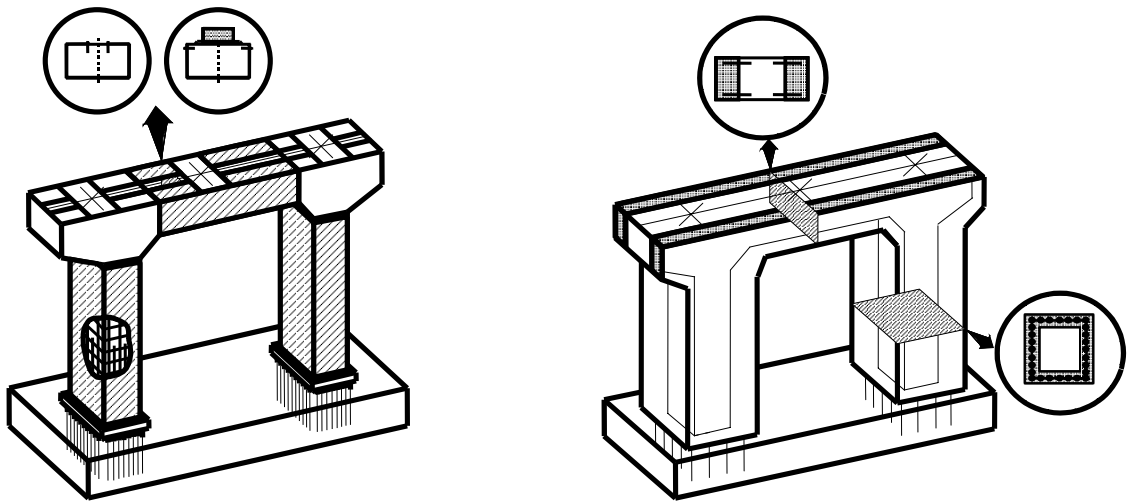
**Fig. 3** Seismic Retrofit Measure for Two Column Bents

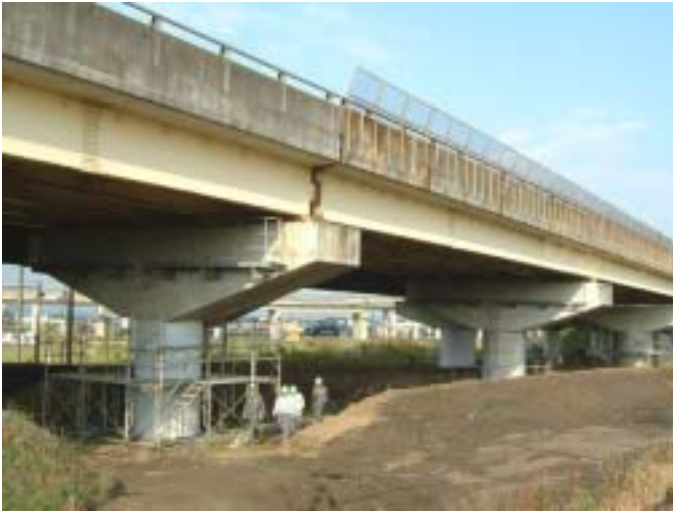
**Photo 6** Shinkumi Bridge

The effectiveness of the seismic retrofit at Shinkumi bridge is shown here. Shinkumi bridge was constructed in 1989 to overpass the railway as shown in **Photo 6**. The superstructures were of 2-span simply-supported steel girders and 3-span continuous steel girder. The substructures were RC columns with a circular section and supported by the pile foundations. Bearings were a steel plate type. The bridge consisted of two same but completely separate bridges, which had two inbound and down bound lanes, respectively. The columns of one bridge were already retrofitted by steel jacketing as shown in **Photo 7**. For the other bridge, the retrofit works were planned to be made in near future.

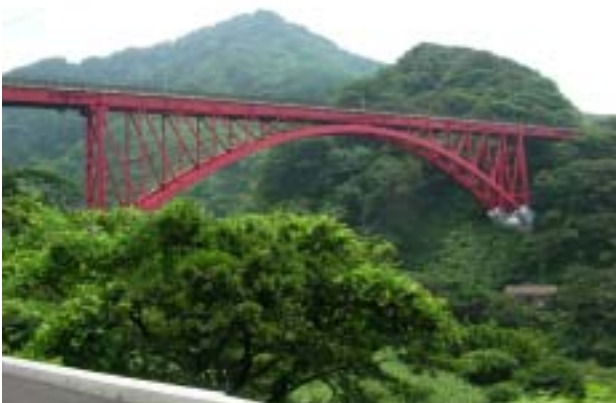
**Photo 9** Agewa Bridge

The Agewa bridge was constructed in 1965. Superstructure was steel arch bridge as shown in **Photo 9**. Simple span steel girder girders were at the both end of the arch section. The bridge length was 197m. The abutments were gravity type and wall type, and the foundations were spread type and pile foundations. Arch abutments were spread type foundation. Both ends were movable type bearing and fixed bearing at the both end of arch section as shown in **Photo 10**.

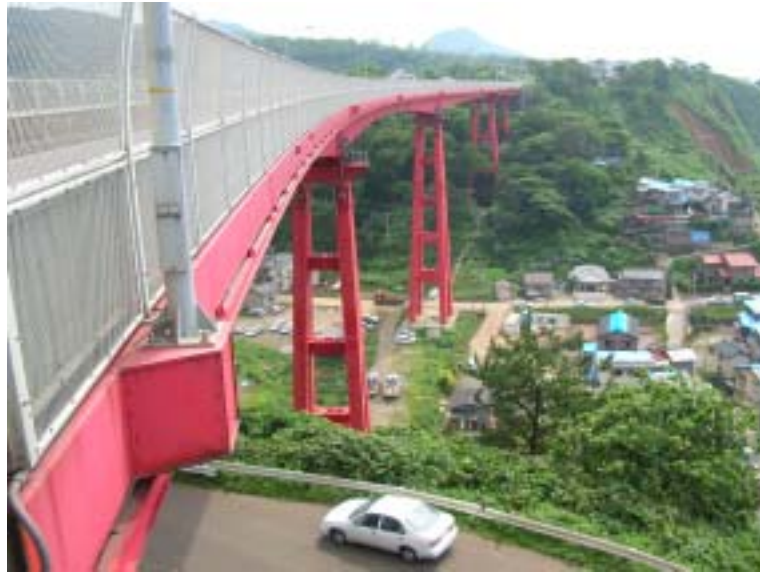
**Photo 11** Yoneyama Bridge

Superstructures were 3-span continuous steel box girder and 2 span continuous steel girder as shown in **Photo 11**. The bridge length was 279m. Abutments are wall type with spread type and caisson foundations. Piers were steel frame structures with height of about 44m. The bridge was retrofitted by the strengthening the bottom of steel piers, concrete infill to the steel columns, and added stiffeners to the lateral beams of piers, and the installation of the unseating prevention devices, were made as shown in **Fig. 5**.
