# Behavior of Dams due to The Western Tottori Prefecture Earthquake in 2000

## ABSTRACT

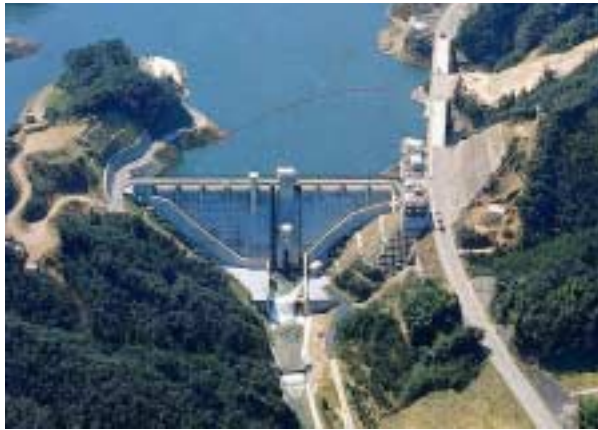
Photograph 1 View of the Kasho Dam

At the Kasho Dam (Photograph 1), the earthquake caused peak accelerations at the lower inspection gallery of 529 gal (north/south direction), 531 gal (east/west direction), and 485 gal (vertical direction). At the elevator tower at the crest elevation (Photograph 2), the peak accelerations were 2,051 gal (north/south direction), 1,406 gal (east/west direction), and 884 gal (vertical

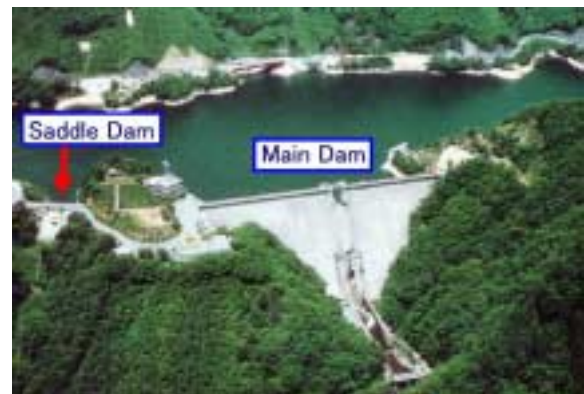
Photograph 4 View of the Sugawara Dam

At the Sugawara Dam (Photograph 4), in the lower inspection gallery of the dam, the peak accelerations were 158 gal (downstream/upstream direction), 126 gal (right bank/left bank direction), and 109 gal (vertical direction). On the walls and the floor of the guard gate house that is a cantilever structure projecting upstream from the dam crest (Photograph 5), there were cracks that appeared to be extensions of the transversal joints of the dam (Photograph 6), and concrete on the dam's downstream surface was partially chipped (Photograph 7), but the no trouble of dam body was observed. Although the drainage from the foundation increased slightly immediately after the earthquake, it later stabilized. Near the dam and in the natural ground surrounding the reservoir, ground deformation caused cracking (Photograph 8). The Chugoku Regional Construction Bureau

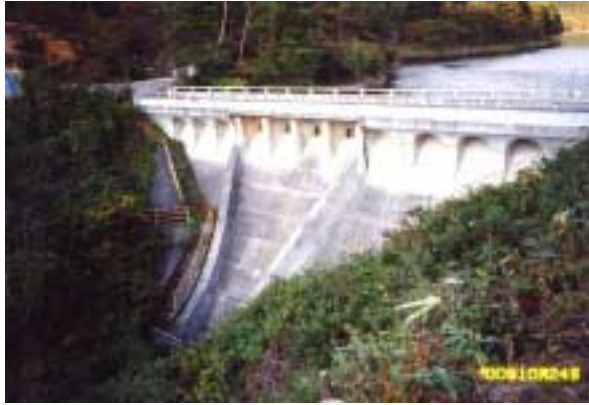
The Uh Dam (Photograph 9) is a regulating reservoir for the Ohmiya Dam that is for power generation and owned by the Chugoku Electric Power Co. and located upstream from the Sugawara Dam. This dam is a concrete gravity dam with a height of 14 m and a crest length of 34 m. Figure 2 shows its standard cross section. It is located about 1 kilometer from the fault estimated by the Geographical Survey Institute, Japan<sup>1)</sup> (hereafter called the "earthquake source fault"). During the earthquake, its reservoir water level was about 2 m below the full water level. The Hino Observation Station of the Digital Strong-Motion Seismograph Network (KiK-net)<sup>2)</sup> owned by the National Research Institute for Earth Science and Disaster Prevention is located 20 m from the Uh Dam. At this location, seismographs installed at the surface (S wave velocity of 210 m/s) and the underground (100 m below the surface, S-wave velocity of 790 m/s) recorded earthquake motion with a peak accelerations (combination of 3 constituents) of 1,135 gal and 607 gal respectively. Although the dam was subjected to this strong earthquake motion, the only damage to the dam was cracking with a width of 1 to 2 cm on the spillway channel near the foot of the downstream slope (Photographs 10). The embankment along the lakeside had slips caused small cracks. In addition, because of damage to the water supply facilities for power generation, after the earthquake, the water supply from the Ohmiya Dam to the Uh Dam was shut off and discharged into the reservoir of the Sugawara Dam.

Photograph 9 Downstream View of the Uh Dam
