# Applicability of Seismic Design in Mitigating Progressive Collapse

## ABSTRACT

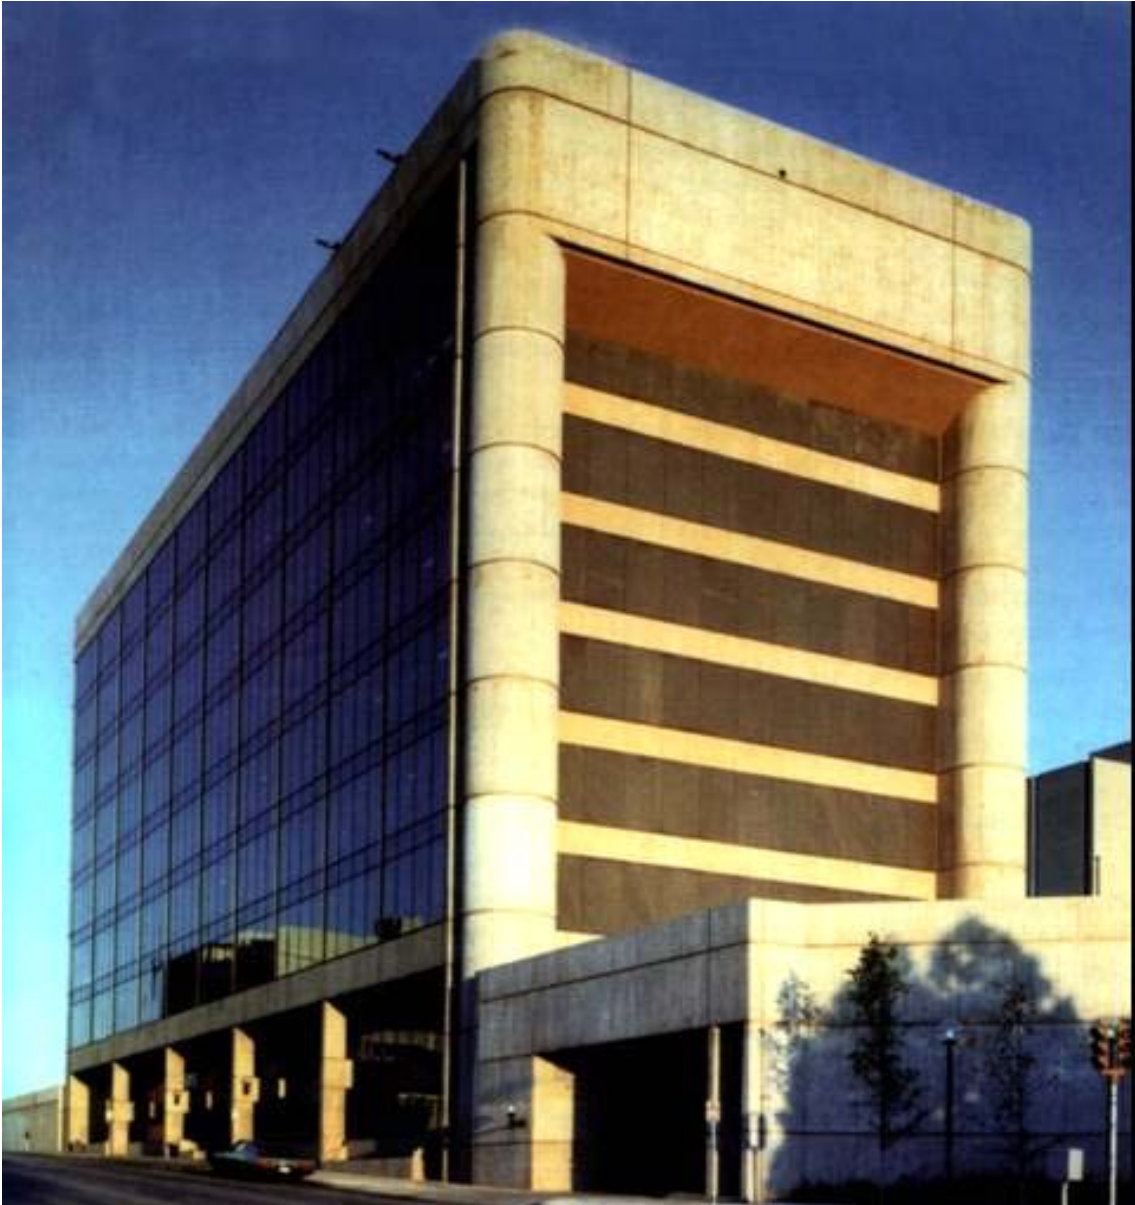
A photo of the Murrah Building prior to the terrorist attack is shown in figure 1. The transfer girder supported on four intermediate columns can be seen just below the glass curtain wall.

Figure 1. Murrah Building Prior to Blast.
