**UJNR Panel on
Wind and
Seismic Effects**

Panel Update

Volume 1, Number 4, December 2003

REPORT ON THE 26 SEPTEMBER 2003 TOKACHI-OKI EARTHQUAKE, JAPAN

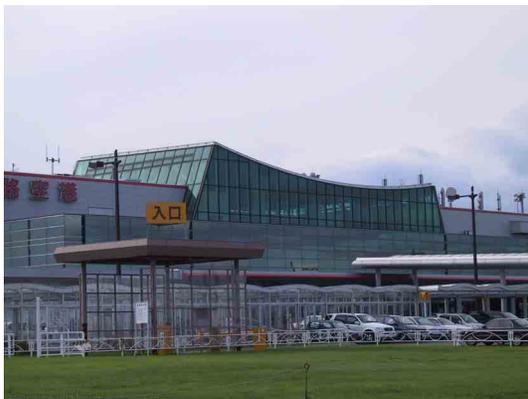
The three edges (north, south and east) of the ceiling were separated from surrounding structural elements and only the west edge was rigidly connected to the structure. Due to the pounding of the ceiling to the west structural frame, a large area of the ceiling fell down. No one was injured due to the early morning shock.

Photo 2 Outside view of airport terminal building
