# **CARBON COMPOSITE SEISMIC RETROFIT OF REINFORCED CONCRETE COLUMNS WITH CORRODED REINFORCEMENT**

**Wilkins Aquino, Assistant Professor, Cornell University, Ithaca, NY**  
**Neil M. Hawkins, Professor Emeritus, University of Illinois at Urbana-Champaign**

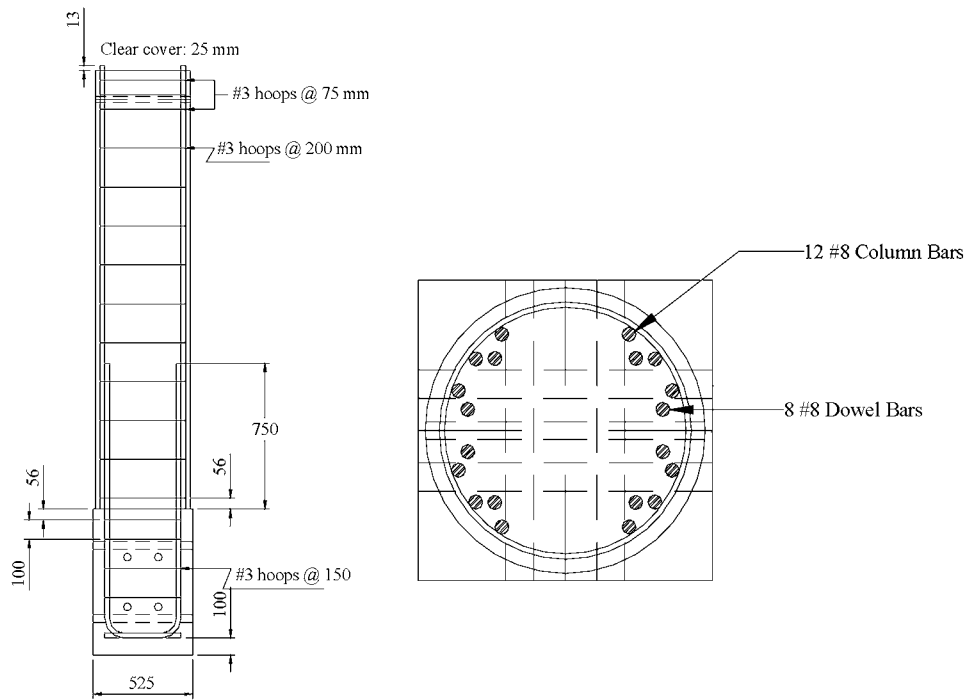
**Figure 1. Column Geometry and Reinforcement. Units =mm**

Six identical reinforced concrete columns 500 mm (20 in) in diameter and 2450 mm (96 in) in height were built in the laboratory. Specimens were 1/3-scale models of field columns located in East St. Louis, IL. Laboratory specimen details are shown in Fig.1. The columns were reinforced longitudinally with 12 #8 steel bars that were spliced to 8 #8 steel bars protruding as dowel bars from a square base. The 750 mm (30 in) extension of the dowel bars above the foundation beam duplicated the 30 bar diameter extension of the same bars in the field columns. In regions of high seismic risk current codes require 40 bar diameter extensions and the aim of this investigation was to see if CFRC retrofits could simultaneously address both corrosion and seismic inadequacies of existing construction. Column lateral reinforcement consisted as #3 steel circular hoops spaced 200 mm (8 in) on centers.

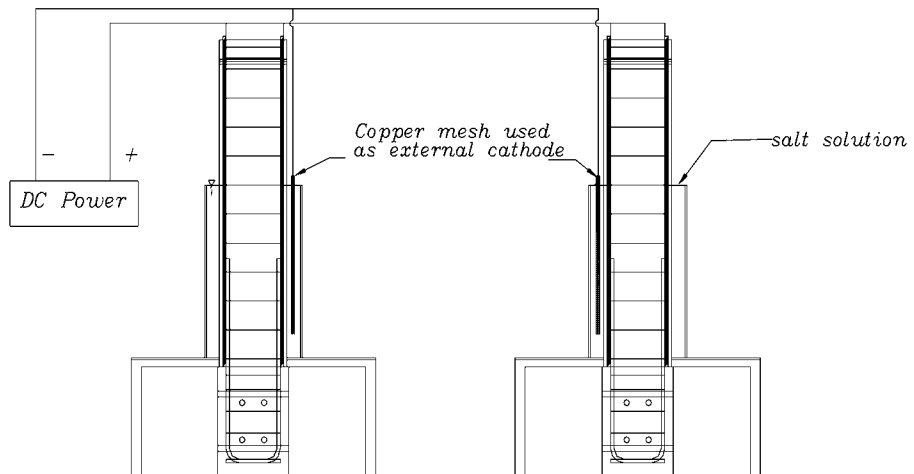
**Figure 2. Parallel Circuit Arrangement for Corrosion**

**Corrosion Process.** External current was used to induce corrosion in the columns. A parallel circuit arrangement was used as shown in Figure 3. Although a series circuit arrangement is preferable for achieving the same level of corrosion in all specimens in a given amount of time, a parallel arrangement was used to reduce the voltage needed to induce the current demand required for these large-scale specimens.

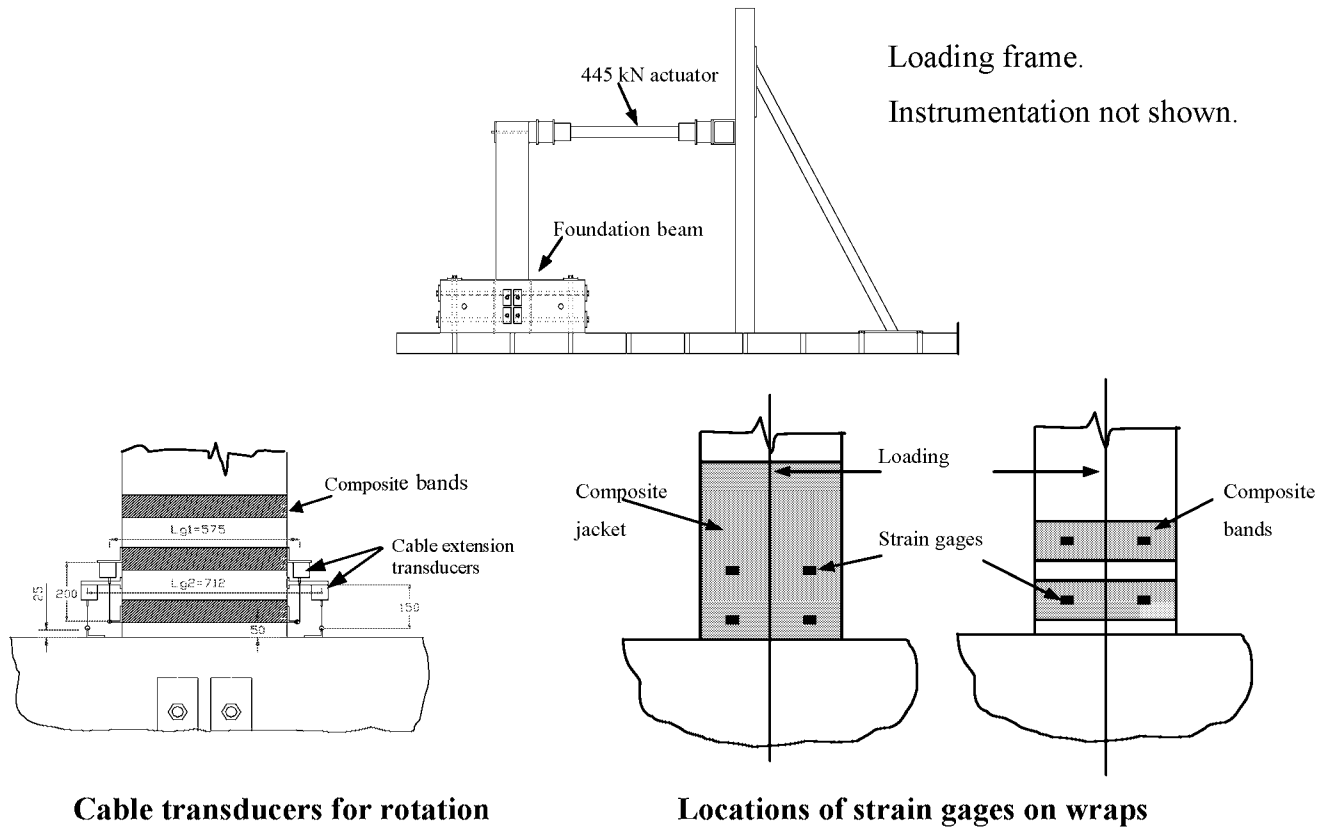
**Figure 3. Lateral Load Test Setup. Unit = mm**

**Loading frame, instrumentation, and data acquisition.** Figure 3 shows the loading frame and instrumentation used for the lateral load tests. Each column was cast with a square base that, for structural testing, was grouted into the central opening of a foundation beam bolted to the laboratory floor. The foundation beam was then post-tensioned in two directions to minimize cracking during testing.
