Recent Studies on Fatigue of Orthotropic Steel Deck at PWRI

Jun Murakoshi¹ and Noriyasu Arima²

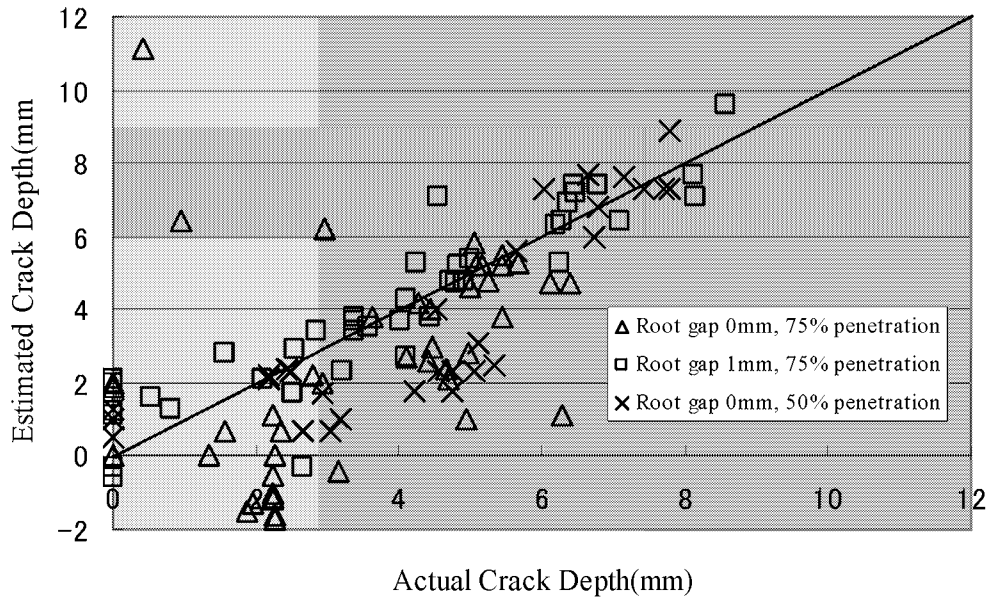
Figure-5 Comparison between Real and Estimated Depths of cracks with Angle Beam Technique

Figure-3 shows images of scanning by three ultrasonic waves: commonly used SV wave (angle beam technique), creeping wave and surface SH wave. Laboratory tests on application of three ultrasonic measurements are being conducted with small specimens that simulate U-rib-deck connection details (Figure-4). Fatigue loading tests were conducted to generate root cracks at the weld root of the specimens, and during the tests, ultrasonic measurements are conducted to investigate the crack detectability for each measurement method, meanwhile their applicabilities to field measurement are being investigated on actual damaged deck (Photo-1). As a result, it has been found so far that with the angle beam technique, we can detect and measure crack depth of more than about 6mm depth (more than half the deck plate) with almost practical accuracy (Figure-5).

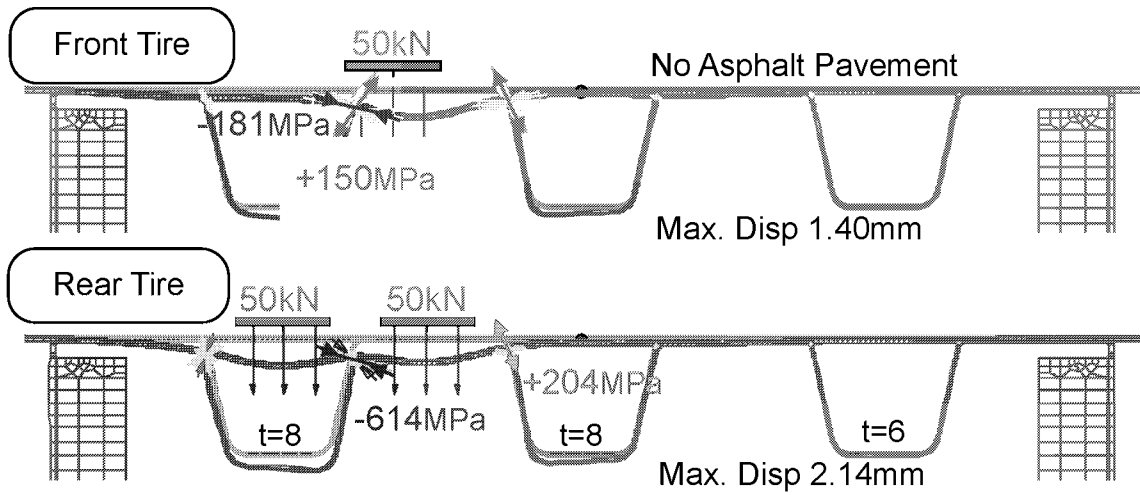
Figure-7 Principal Stresses at the weld root under Loading (L/2 cross section)

Figure-7 shows the principal stresses of the weld root just directly under the wheel load on the center line between the cross-beams (L/2 line). Those wheel load transverse positions in Figure-7 are the same as those estimated in Bridge-B. The front tire gives a tensile stress in the direction that tears the weld bead, and the rear tire gives a high compressive stress in the back surface of the deck plate. It seems that the stress variation created by the front tire and the rear tire is related with the generation of root cracks propagating to the deck plate.

It is considered from these results that the high compressive stress directly under the wheel loads (which is considered to cause severe tensile stress range at weld root with combination of high tensile residual stress) and the variation of stress by repetitive loading of front tire and rear tire generate the crack, and that the local stress behavior when moving wheel load is related to the propagation of the crack.

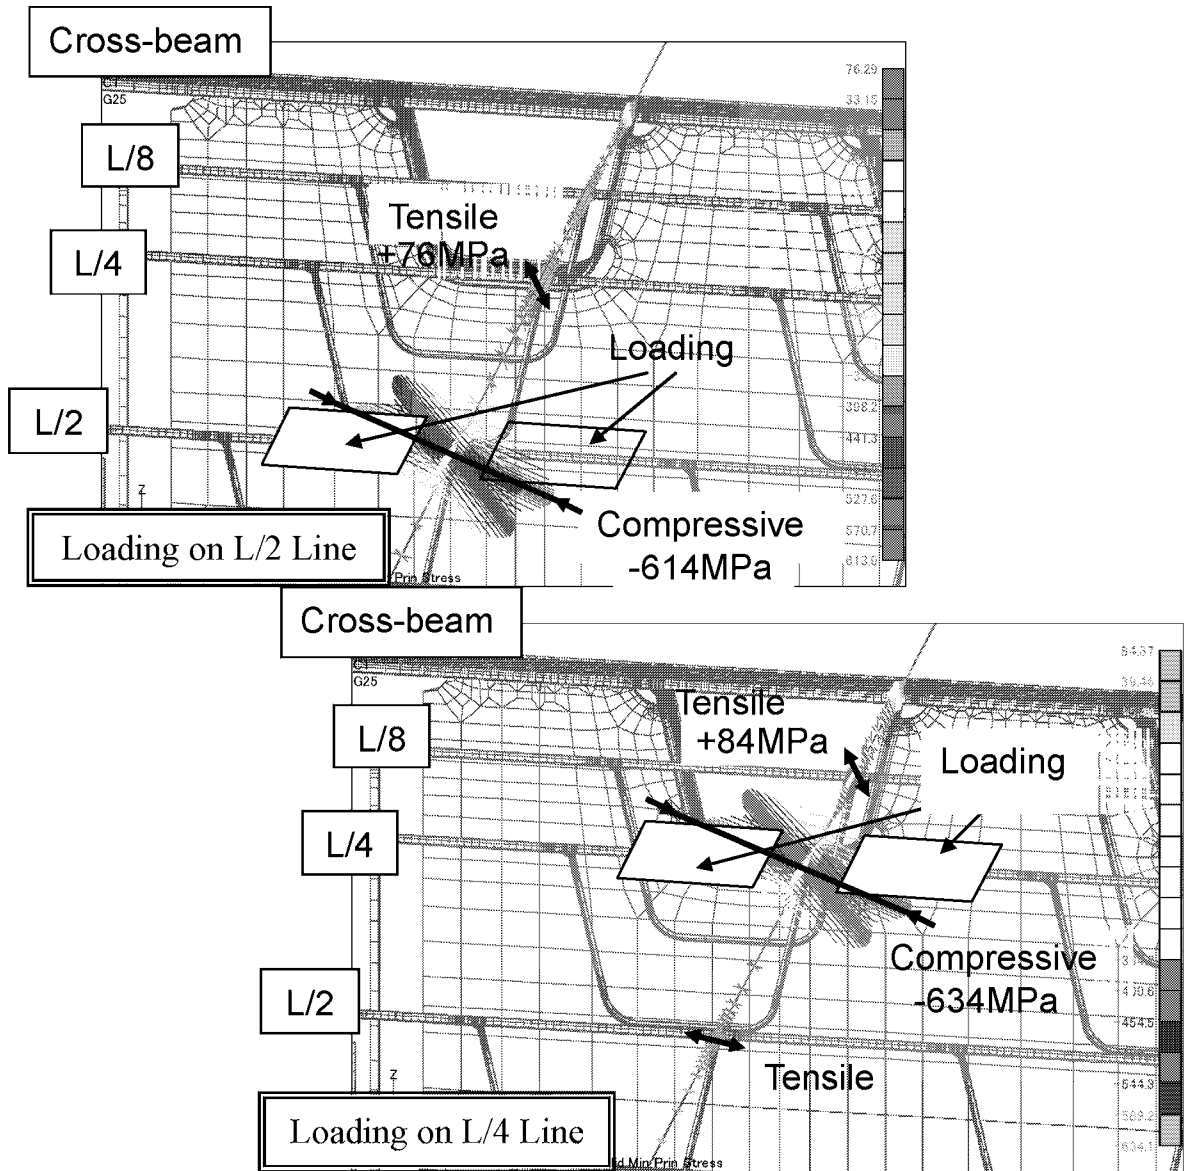
Figure-8 Longitudinal Distribution of Principal Stresses at the Weld Root

Figure-8 shows the longitudinal variation of the principal stress of the weld root under the same rear tire loading as those shown in Figure-7. As mentioned previously, the wheel load gives high compressive stress to transverse direction on the back of deck plate just under the load. But when the wheel load moves to longitudinal direction, it gives low tensile stress, which influences crack propagation to the deck surface to some extent after occurrence of cracking.
