ANALYSIS OF DAMAGE OCCURRING IN STEEL PLATE GIRDER BRIDGES ON NATIONAL ROADS IN JAPAN

Abstract

Data on damage found in steel bridges on national roads in Japan as a result of inspections over a recent approximately ten-year period were collated and analyzed. The subjects of this research were non-composite and composite steel plate girder bridges, which were selected because they are the most common types of bridges in the country. Three types of damage were studied: corrosion, cracks in steel and cracks in concrete decks. The corrosion was remarkable at the ends of girders; cracks in steel were often found at the end of stiffeners in connecting parts of main girders and cross beams, and cracks in concrete decks were most likely to have occurred at the end of main girders and at points one-fourth of the way across on spans.

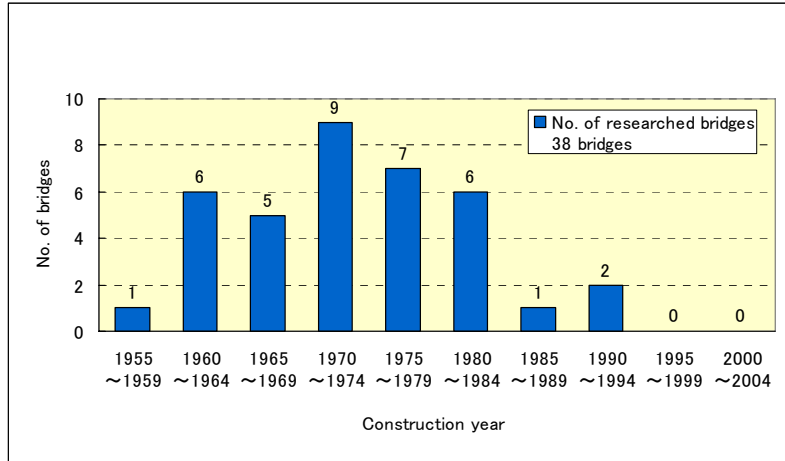
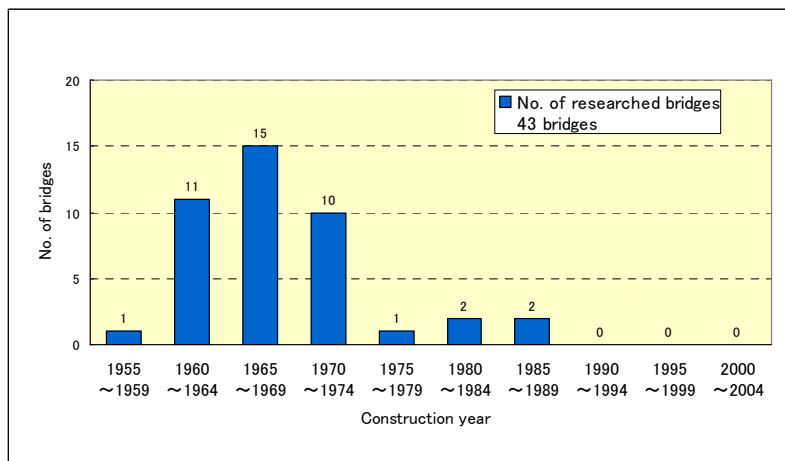
Fig. 3.2: BRIDGE NUMBERS BY CONSTRUCTION YEAR (EVERY FIVE YEARS)

Fig 3.2 shows the relationship between construction year and number of non-composite and composite steel plate girder bridges with corrosion. Many bridges with Class II-1, 2 and 3 damage were of non-composite type and built between 1960 and 1984. In the case of the composite type, many were built in the 1960-1974 period. This rate for the composite type is generally proportionate to all numbers of constructed bridges (see Fig 3.1b). In the case of the non-composite type, however, this wasn't the case (see Fig.3.1a).

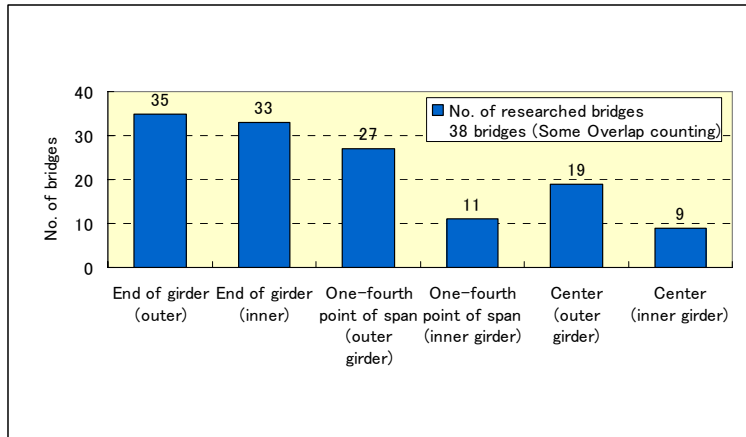
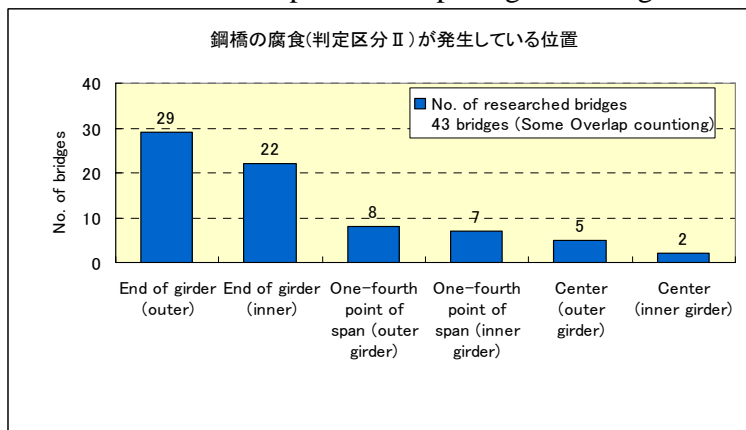
Fig.3.4: LOCATION OF CORROSION (II-1,2,3)

The location of corrosion on non-composite and composite steel plate girder bridges was studied by dividing bridge divisions longitudinally, from the end of girders (included middle support point of continuous girders), one-fourth of span and center of girder as shown in Fig. 3.3. The number of bridges with corrosion on each of these parts is shown in Fig.3.4.

Among the non-composite type, 35 bridges were corroded at the end of a girder. The rate was 92.1 % of all corroded bridges. Among the composite type, 38 bridges, 88.4 %, were the same. Corrosion cases are shown in Fig 3.5 a.

Comparatively older bridges tended to corrode as a whole on the span. Water leaks from expansion joint and drainage, besides water pool and moisture around bearings made girder ends corrode rapidly in many cases.

There were bridges corroded in the middle part of inner girders, the cross part of flanges on outer girders and webs, and splice plates. These were examples of corrosion other than that at the end of girders that had progressed. An example of corroded splice plates is shown in Fig. 3.5 b. There are also cross beams or stringers corroded progressively with cracks. Even among the comparatively recently built bridges, particularly those built using corrosion-resistant steel and to which freeze-resistant coatings were applied had local corrosion. Some bridges held water on its members and the corrosion progressed because of damage of drainage or irrelevant drain hole. Water had leaked through cracks in the deck, and corrosion at upper flanges in main girders was found. However, only two bridges (5.6%) were cases of corrosion being found not at the end of girders, but only at

Among the composite type, a somewhat higher number, 11.6 % of all the bridges, were corroded only in locations other than at the end of girders.

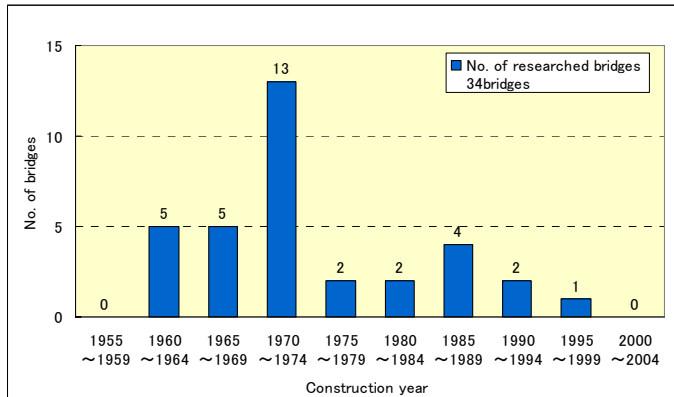
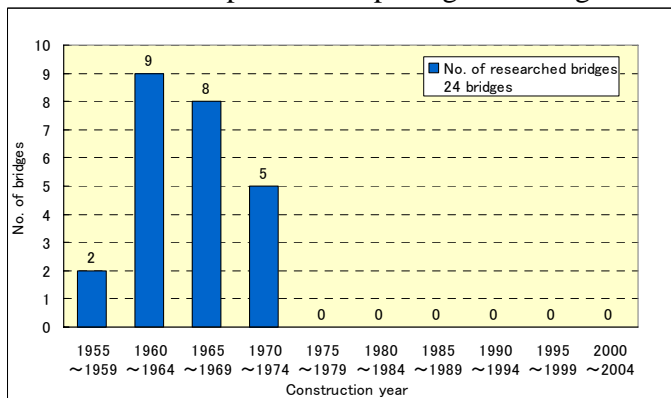
Fig. 3.7: NUMBER OF BRIDGES WITH STEEL CRACKS (II-1-7) AND CONSTRUCTION YEAR

Fig. 3.7 shows the relationship between construction year and number constructed for both non-composite and composite steel plate girder bridges. Many non-composite type bridges constructed in the 1960-1974 period had cracks — 23 of the 34 bridges which had steel cracks bridges, or 67.6 % of that total. Most noteworthy was the fact that bridges constructed between 1970 and 1974 show a high occurrence rate. Composite type built in the 1960-1974 period had a similar occurrence rate.

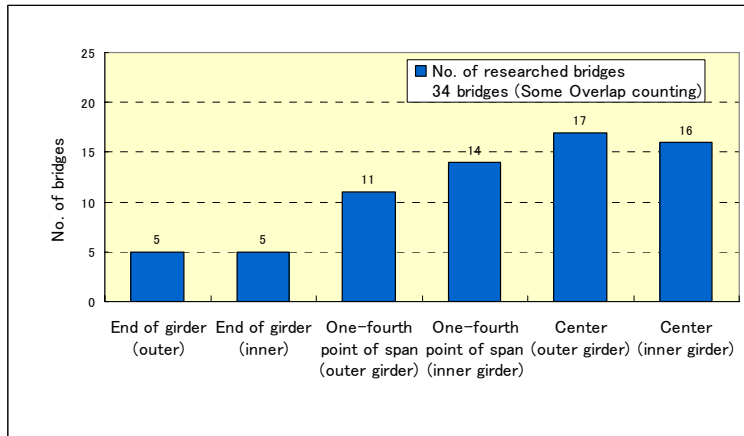
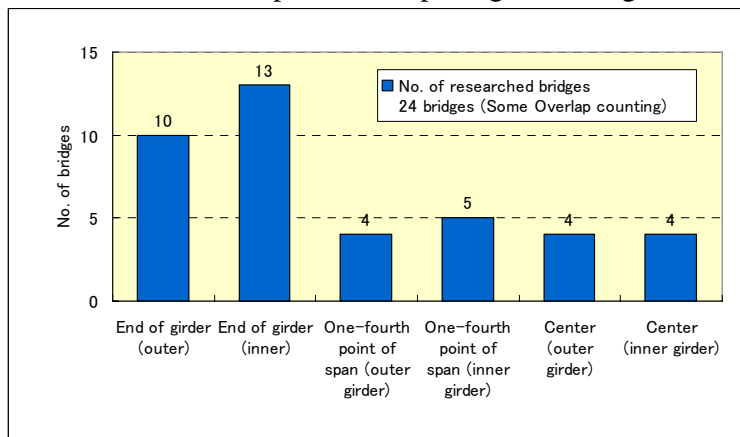
Fig. 3.8: LOCATIONS OF STEEL CRACKS (II-1-7)

Locations where steel cracks were found on girders were researched based on the classifications shown in Figure 3.3. The numbers of bridges in each classification with cracks are shown in Figure 3.8., which includes cracks from the end of a girder that continue to the steel girder middle bearing point.

Among non-composite type bridges, there were five bridges of cracks occurring at ends of exterior girders and also five bridges of cracks occurring at ends of interior girders. This number is less than the number of cases in which cracks had occurred at the center or the one-fourth point of a span. Locations of the cracks included cracks at fillet welding of main girder lower flange and at end parts of vertical stiffeners, and this type of damage was often found on skew bridges.

Among composite types, the number of bridges on which cracks occurred at the

ends of girders included 10 on exterior girders and 13 on interior girders. These numbers were greater than those for cracks at the center or one-fourth point. The locations of cracks were the same as for the non-composite type: 9 bridges had cracks at fillet welding of main girder lower flange and vertical stiffener, 8 bridges at fillet welding of a web and lower flange, next at sole plate, and at the welding of gussets of lateral members. The numbers for these cracks were greater for skew bridges than right bridges.

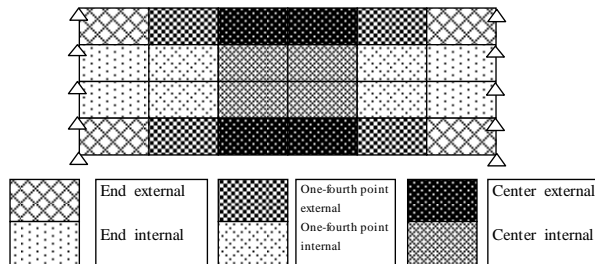
Fig. 3.11: DECK AREAS

The locations of damage are shown in Figure 3.11. This illustration divides the area of the deck of span into the areas at the ends of girders, the area one-fourth across and the central part in the longitudinal direction. The locations are divided according to outer and inner parts in the transverse direction.

Forty-one composite plate girder bridges were investigated. In order of numbers of cases, the locations where deck cracks occurred were at girder ends, points 1/4 across the deck, the center of the span, and intermediate support points.

Cracks at girder ends were generated on 28 bridges; 26 had cracks at the 1/4 points; and 25 had cracks in the central part of the deck span. There was no significant difference between the exterior and interior sides of the deck in the distribution of transverse cracks.
