INSPECTION AND REINFORCEMENT FOR FATIGUE DAMAGES ON ORTHOTROPIC STEEL DECK BRIDGE

Akiko Tabata¹, Yoshihiko Takada¹, Yoshihei Horie¹

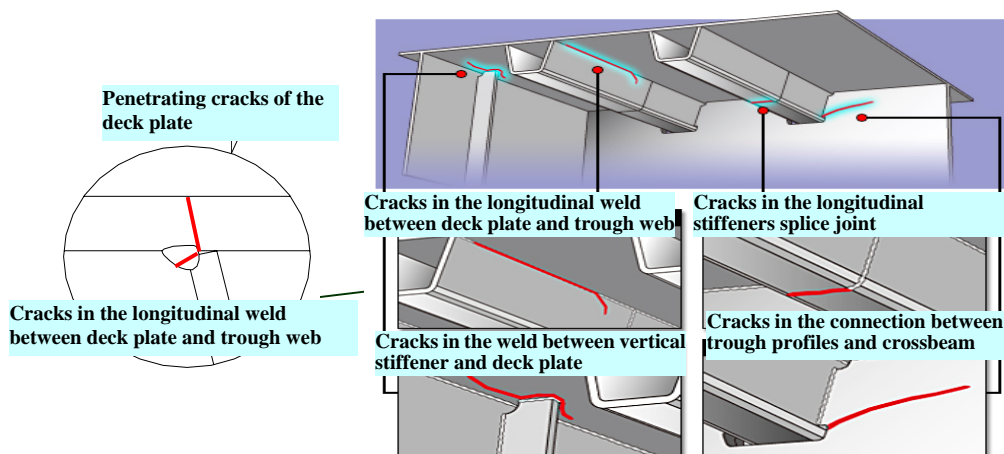
Figure 3 The typical types of crack in troughs

Firstly, the typical cracks generated in the trough are described briefly. These are crack penetrating the deck plate(1), cracks in the longitudinal weld between deck plate and trough web(2), cracks in the longitudinal stiffener splice joint(3), cracks in the weld between vertical stiffener and deck plate(4) and cracks in the connection between the trough profile and the crossbeam(5). Finally, it describes that the author also studied on emergency repair in order to prevent possible subsequent crack growth and road caving. In

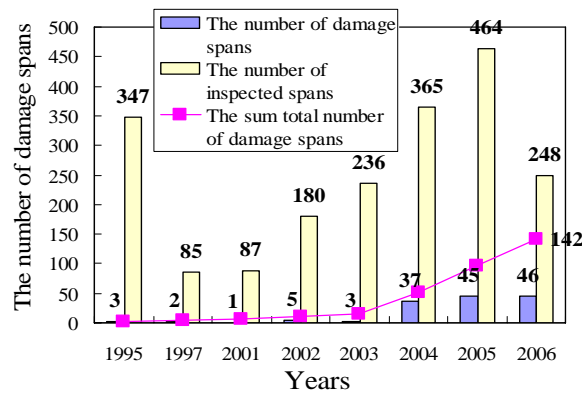
Figure 4 Correlation with the inspection and number of damaged spans

Figure 4 shows the number of damaged spans for every year in orthotropic steel decks based on the latest inspection results. The years are shown on a horizontal axis, and the number of spans is shown on an axis of ordinate. A bar graph shows the number of inspection spans and damaged spans, and a line graph shows the sum total number of damaged spans. The numbers of inspection spans for the past ten years are 80 to 360 span per year. The numbers of damaged spans have tended to increase since 2004. It is considered that frequency of the inspection are increased caused by discovery severe crack on existing bridge but also improvement of consciousness. However, the number of the fatigue cracks will certainly increase according with the service life will increase in the future. Figure 5 shows the number of spans for every completion year of the orthotropic steel bridge deck. Most of the orthotropic steel decks of the completion years pre-1979 are the bulb ribs, also completion years post-1979 are the troughs. The damaged spans of completion years pre-1969 have cracks in the connection between longitudinal stiffeners and crossbeam in the bulb rib. Besides these have characteristic with many cracks per a span. The damaged spans of through rib after 1995 have reconstructed by the Great Hanshin-Awaji Earthquake. It is necessary to consider that there are no correlation between the number of cracks and increasing service time.

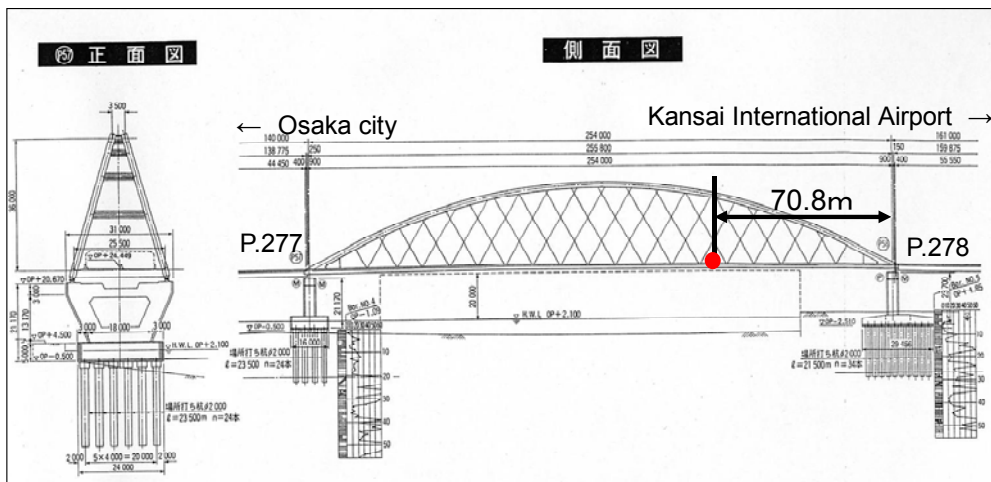
Figure 6 Elevation of Shinhamadera Bridge.

Penetrating crack of the deck plate in Hanshin Expressway was detected by Shinhamadera Bridge located in Wangan Route during repair work of pavement, as shown in Figure 6,7,8. This is a Nielsen-Lolse bridge with Basket-Handle type, and has a 254m center span carrying four traffic lanes. The bridge was opened in 1993. The crack occurred under the right axle location of truck wheels in the inner lane, 70.8m far from the pier. The total daily traffic in 2005 was 75,000, and 20 % were trucks. An estimated Figure 7 shows the crack on a orthotropic steel deck plate. This crack was detected by chance when asphalt paving was removed. The 6 mm thick trough were butt-welded to 12 mm thick orthotropic deck plates. The total thickness of a two-layer pavement is 65mm. Water spilled from trough rib below the fatigue crack during inspection.
