INSPECTION AND REPAIR OF THE DETERIORATED RT.72 MANAHAWKIN BAY BRIDGE

Xiaohua H. Cheng¹, Gregory Renman¹ and Richard Dunne¹

The paper presents the details of the bridge structures, inspection findings, fatigue damage, cause of the damage and repair of the damage.

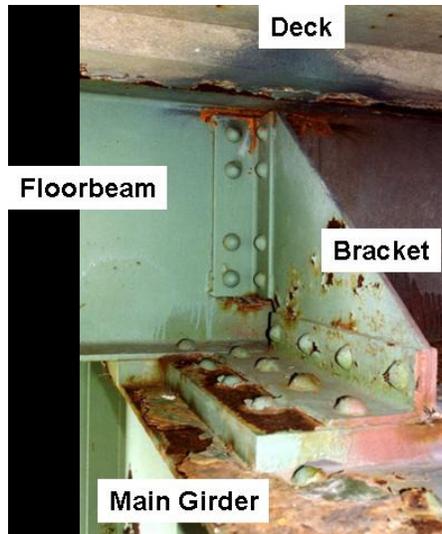
Figure 3 Floor-to-Girder Bracket Detail

Since fatigue cracks were uncovered during the repair/rehabilitation, NJDOT decided to take measures to test the locations and extent of the floorbeam fatigue damage by using dye penetrant method or magnetic particle method or UT, whichever was proper in the field, at all floorbeam web and bracket angle details. The connection detail is shown in **Figure 3**.
