REPAIR OF HIGH SHEAR STANDARD REINFORCED CONCRETE BRIDGE COLUMNS USING CFRP

Ashkan Vosooghi¹ and M. Saiid Saiidi²

Abstract

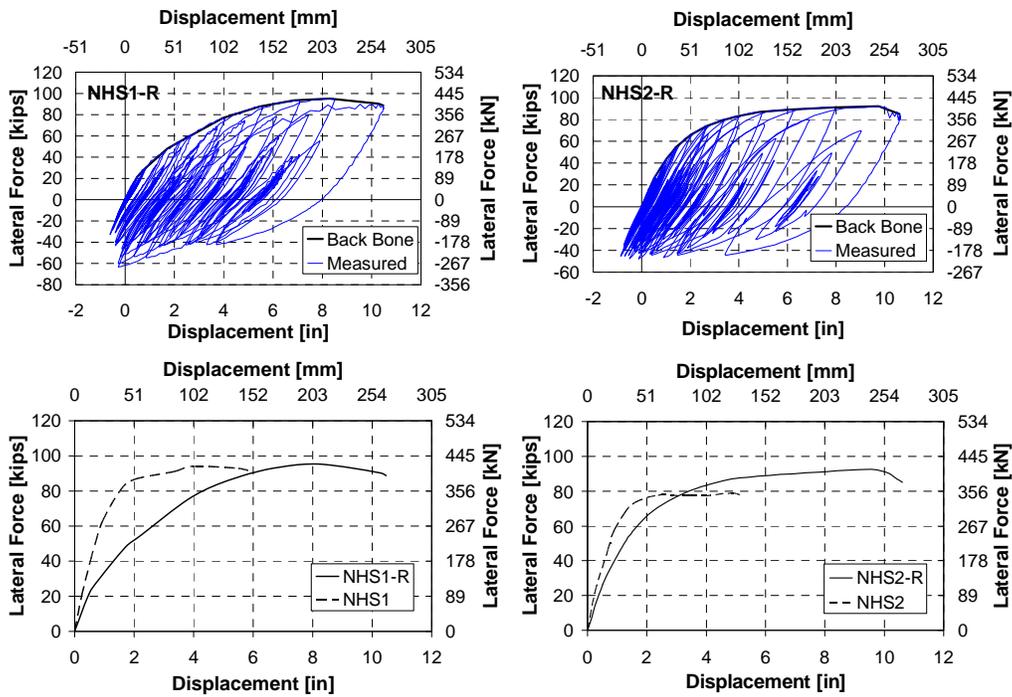
Fig 5. Lateral force-displacement relationships for the columns

The cumulative force-displacement hysteresis and back bone curves for NHS1-R and NHS2-R are shown in the upper graphs in **Fig. 5**. In the lower left graph, back bone curves for NHS1 and NHS1-R are plotted. Those of NHS2 and NHS2-R are plotted in the lower right graph.

Peak base shear, Kips (kN)	Maximum drift	Service stiffness, Kips/in (kN/mm)
NHS1	94.1 (418.6)	9% [1.2*7.5%]	73.2 (12.8)
NHS1-R	95.2 (423.6)	13.1%	28.3 (5.0)
NHS2	78.9 (350.9)	7.7% [1.2*6.4%]	71.0 (12.4)
NHS2-R	92.1 (409.7)	13.3%	44.0 (7.70)

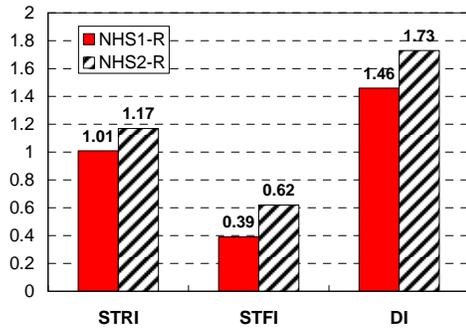
Fig 6. Response indices for the repaired columns

The response indices are plotted in **Fig. 6**. In general, all the response indices for NHS2-R are higher than those of NHS1-R. It implies that the repair procedure in terms of quality and application method of the repair mortar has significant role in the performance of the repaired column. In addition, the number of CFRP layers in NHS1-R was not optimized and giving 50% credit to the spirals for NHS2-R was a reasonable assumption. **Fig. 6** shows that the strength and deformability of both columns were fully restored. Although the service stiffness was not fully restored in both columns, but the stiffness reduction in NHS2-R was 2/3 of that of NHS1-R. The reason is that the higher quality repair mortar and better application method, pouring and vibrating instead of patching, were used in NHS2-R.
