Inspection and Rating of Gusset Plates – A Response to the I-35W Bridge Collapse

Abstract

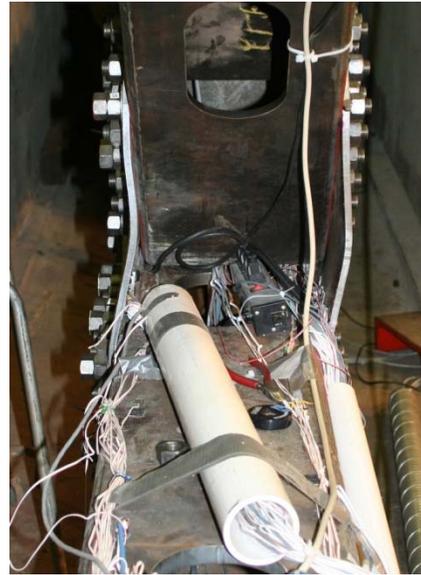
The two connections were tested under different equilibrium load combinations. The A307 connection loading scenario had unbalanced loads between the two diagonals, biasing the compression diagonal. The diagonal loads were balanced for the A490 connection. Despite the loading scenario, both connections failed by buckling of the gusset plate causing the compression diagonal to sway out-of-plane. Figure 9 shows a contour plot and picture of the failed shape of the A307 connection. The region of failure was concentrated around the compression diagonal for both connections.

Figure 9 – Final Shape Of Plates Showing Out-Of-Plane Movement Of Compression Diagonal For A307 Connection. (Left) Out-Of-Plane Displacement Contour Plot. (Right) Side View Of Failed Gussets Showing Out-Of-Plane Sway.
