FAST TRACK REPLACEMENT OF THE JEFFERSON STREET BRIDGE

Abstract

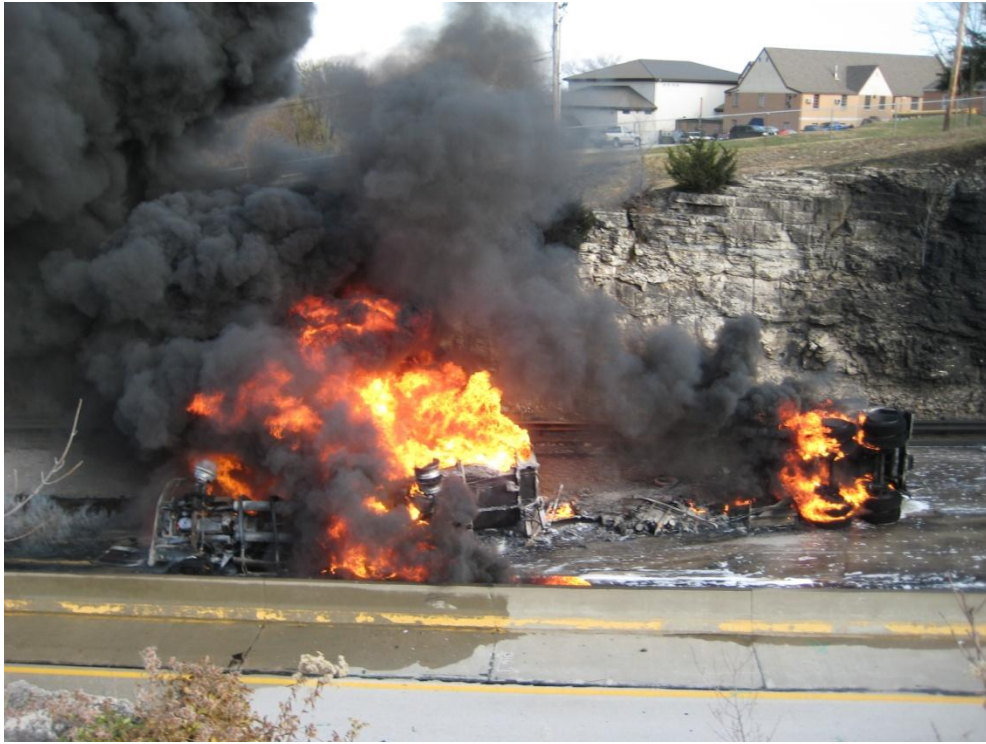
FIGURE 1

On the afternoon of Thursday, November 27, 2007, a tanker truck carrying eight thousand gallons (30.3 cubic meters) of fuel including gasoline, diesel and ethanol overturned on a curve on United States Highway 54, a major route through the city. The ensuing fire incinerated the truck in a blaze made especially high in temperature due to the presence of the ethanol (Figures 1 & 2). Sadly the crash and fire were not survivable for the driver of the truck. The burning fuel carried fire into the storm sewer system, ditches and down the slope of the roadway. In the path of the river of fire was the Jefferson Street Overpass.

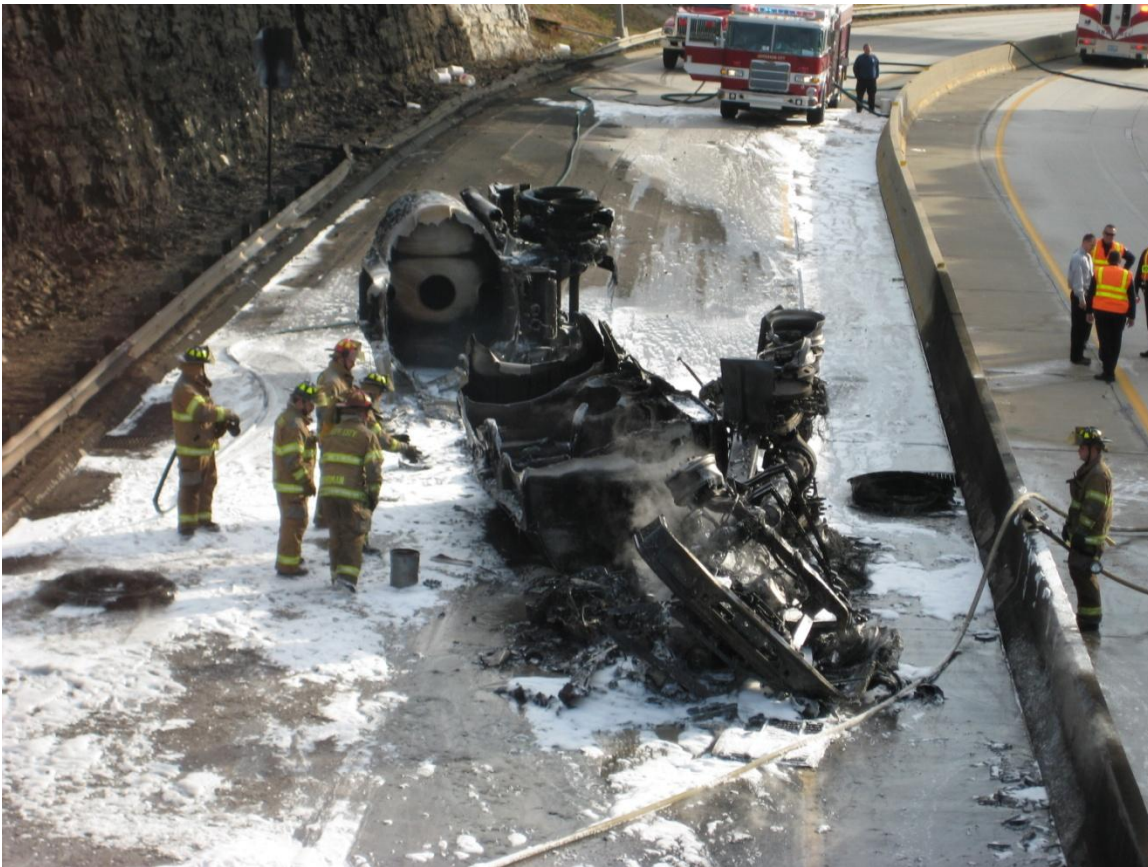
FIGURE 3

After the blaze was successfully extinguished, MoDOT personnel were ready to respond to the damage to the highway infrastructure. The accident and fire had immediately forced the closure of Route 54. It was also necessary to close Jefferson Street at the site of the overpass. Both District and Central office personnel were dispatched to evaluate the situation. Among those taking part were the District Maintenance Engineer, District Maintenance Superintendent, State Bridge Maintenance Engineer and a Bridge Inspection Technician. They found damage to Route 54 was mostly to incidental items including signs, guardrails and median barrier curb (Figure 3). So after clean up, Route 54 could be reopened. The damage to the overpass was more critical and Jefferson Street remained closed.

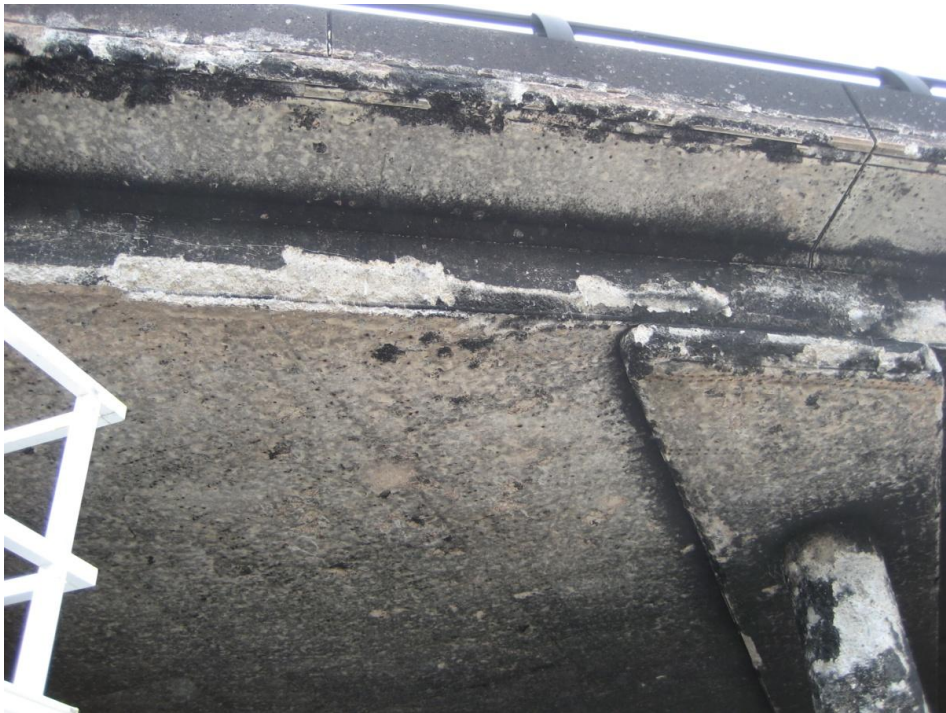
FIGURE 7

The worst findings were heavy delamination and severe spalling with resulting exposed reinforcing steel in the columns at Intermediate Bents No. 2 and No. 3 and in the under deck of the north half of span two (Figure 5). The north half of the under deck in span two also was severely scaled (Figure 6). Other damage included a handrail bent by the heat of the fire and melting of the asphalt chip seal (Figure 7). As a result the deck and superstructure were rated down from a seven to a five on a scale of nine. The substructure

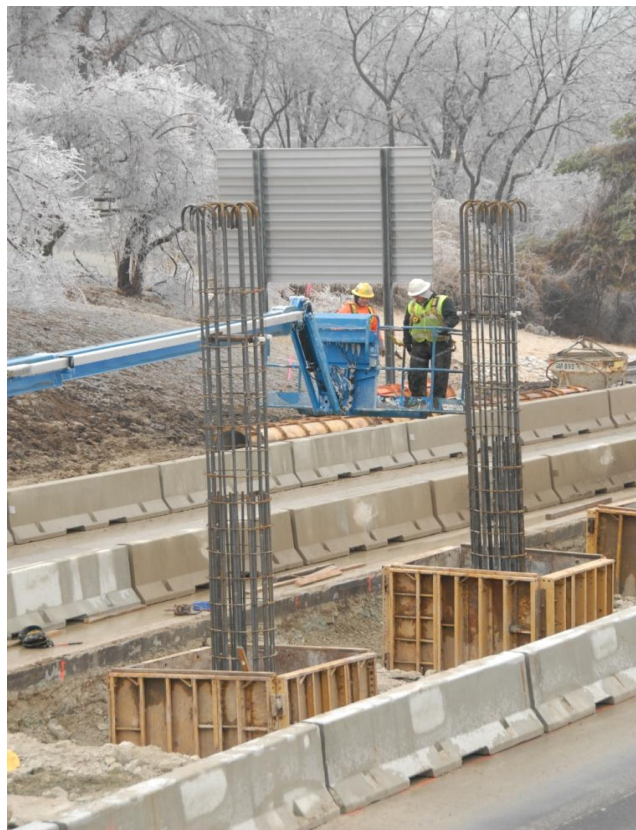
FIGURE 9

Under these conditions, demolition began on the evening of Friday, December 7. The contractor utilized the first weekend closure of Route 54. After installing a cushioning layer of sand on the roadway below, the bridge was dropped in large sections (Figure 8). Demolition was largely completed in twenty-four hours. To fully take advantage of the closure, the footings were excavated and poured that weekend (Figure 9). By the end of the first week of construction, columns had been poured at Bents 3 and 4, and the beam cap at Bent 3 was poured (Figure 10). The steel piles at Abutment 5 had also been pre-bored and
