2010 CHILE EARTHQUAKE IMPLICATIONS TO THE SEISMIC DESIGN OF BRIDGES

Genda Chen¹, Phillip W. Yen², Ian Buckle³, Tony Allen⁴,
Daniel Alzamora⁵, Jeffrey Ger⁶, and Juan G. Arias⁷

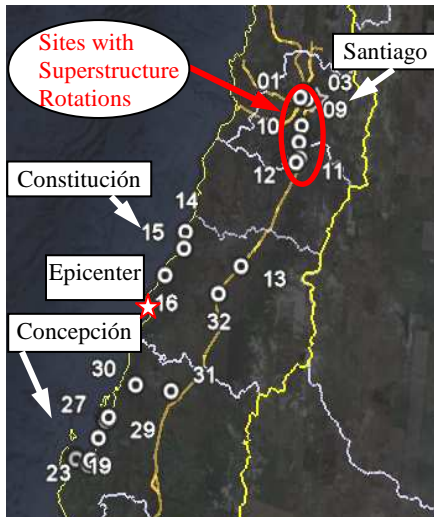
FIG.1 BRIDGE SITES

The 2010 Chile earthquake generated ground motions with long duration and multiple pulses [Boroschek et al., 2010]. In addition, the earthquake may also have induced significant rotational motions that can be inferred from the patterns of in-plane rotations of bridge superstructures. Fig. 1 shows the 32 bridge sites that were visited by the Federal Highway Administration (FHWA) reconnaissance team and highlights in red 7 of them with significant rotations in bridge superstructures. Located near Santiago, these seven sites are further away from the earthquake epicenter than Constitución and Concepción, but the bridges at these sites exclusively experienced significant rotations. A possible explanation for this observation is that, compared to Constitución and Concepción, the stiffer soil deposits near Santiago were favorable to the propagation and amplification of rotational motions during the Chile earthquake. The representative acceleration response spectra at the Hospital Station in Curicó are presented in Fig. 2 [Boroschek et al., 2010].
