Bridge Lessons Learned from the Chile Earthquake in 2010

W. Phillip Yen, Ian Buckle, Genda Chen, Tony Allen, Daniel Alzamora, Jeff Ger & Juan G. Arias

ABSTRACT

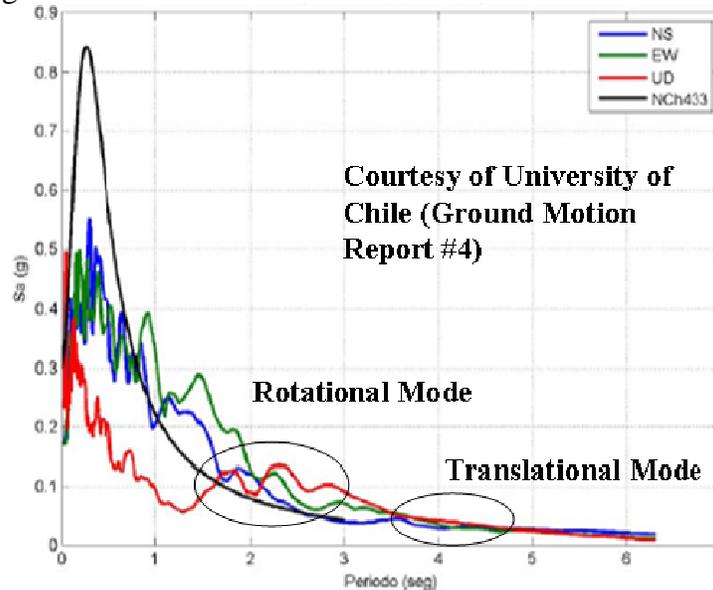
Figure 5 Rotational and translational mode responses to ground motions (University of Chile).

For the bridges with little or no skew (Chada and Las Mercedes), they rotated counter clockwise. Unlike the skewed bridges, the deck rotation of straight bridges cannot be explained by the skew effect. The possible factors contributing to significant rotations in these bridges are listed below:

1. The rotational mode of vibration of those bridges is very sensitive to ground motions. Any accidental eccentricity between the center of mass and the center of rigidity of the superstructure of a bridge could lead to substantial rotations.
2. The rotational component of ground motions could be significant.
3. The fault directivity effect could be significant since both bridges are approximately oriented along the E-W direction.

Considering both the skewed and straight bridges discussed, observations can be made on the overall plausible reasons for bridge deck rotation. Skew of bridges is a significant but not necessarily decisive factor contributing to the bridge rotation. The high sensitivity of rotational vibration mode of the bridge designs to ground motions, particularly rotational excitations, could be dominant. The fact that all bridges experiencing significant rotations are not far away from Santiago where soil conditions are relatively stiff according to the Chilean microzonation map also supports the possibility of having rotational ground motions at the bridge sites. Further analysis is required to understand the significance of rotational ground motions.
