USING POST-TENSIONING TO MITIGATE ALKALI-SILICA REACTION DAMAGE

Barney T. Martin, Jr.¹ and Wagdy G Wassef²

Opened in 1931, the Bayonne Bridge connects the cities of Bayonne, New Jersey, and Port Richmond on Staten Island, New York. The bridge is owned by the Port Authority of New York and New Jersey (PANYNJ). The main span of the bridge, supported on massive concrete abutments founded on diabase bedrock, consists of a two-hinged parabolic steel arch 1675 ft. (510.5 m) long (see Figure 1). The New Jersey arch abutment is a concrete block, measuring approximately 133 ft. (40.5 m) x 107 ft. (32.6 m) at the base and is 40 ft. (12.2 m) high. Over the years, this abutment exhibited signs of deterioration in the form of random cracking of the exposed concrete surfaces. Attempts were made in the late 1970's and the mid 1980's to seal and repair the surfaces but were not successful in stopping further cracking.

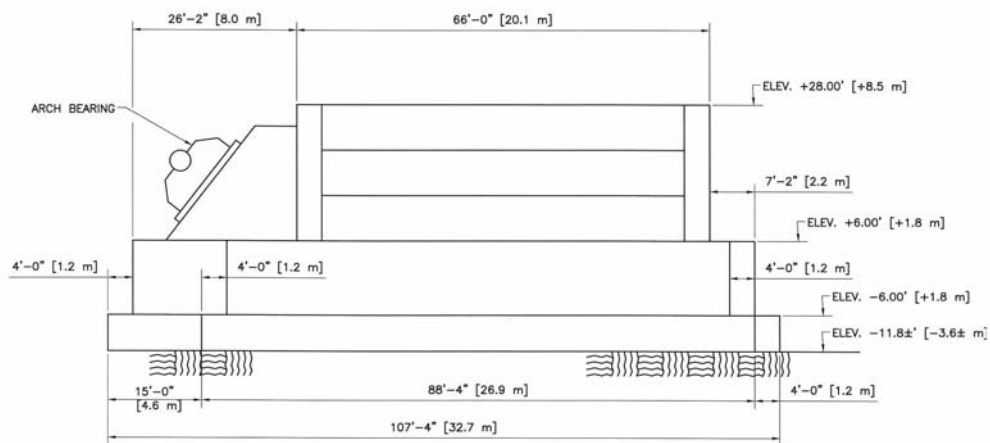
Figure 2. Abutment east elevation

The original abutment had heavy reinforcement only in the area surrounding the arch bearings. Only one layer of shrinkage reinforcement was used along the other exposed surfaces of the abutment.

SYMPTOMS OF THE PROBLEM AND EARLIER MITIGATION ATTEMPTS – Beginning decades ago, extensive random surface cracking on all vertical surfaces of the abutment as well as deterioration of the top layer of concrete at the top of the abutment were observed. Rehabilitation attempts using surface repairs and sealing techniques were made in the 1970's and mid 1980's.

the vertical faces of the abutment with a 1 inch (25 mm) thick layer of shotcrete. In spite of these efforts the deterioration continued with widespread random cracking and staining of the shotcrete and, in some areas, separation of the shotcrete from the original concrete. Figure 3 shows the staining and random cracking of the vertical surfaces of the abutment following the application of the shotcrete.

Several possible rehabilitation schemes ranging from lithium injection to reconstruction were studied. A rehabilitation scheme consisting of encasing the original abutment in new concrete and tri-axially post-tensioning the abutment was selected.

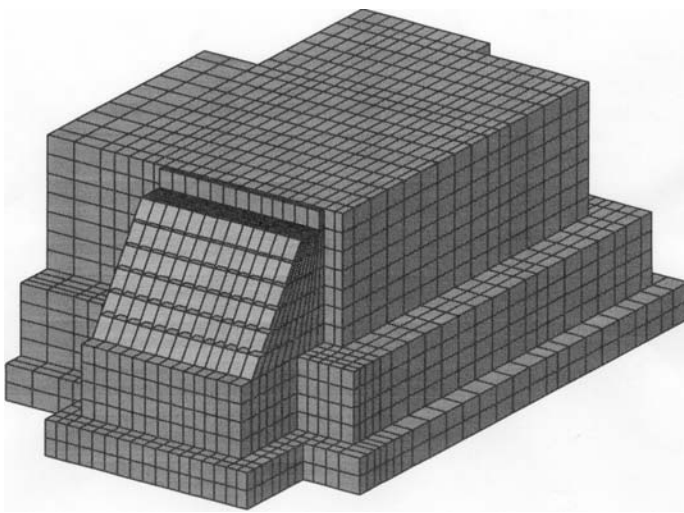
Figure 5. Three dimensional finite element model of one-half of the abutment

column and bearing locations. The model took advantage of the symmetry of the abutment and, thus, only one half of the abutment was included in the model. Figure 5 shows a view of the finite element model. Figure 6 shows the contours of the stresses in the abutment due to the arch reaction.

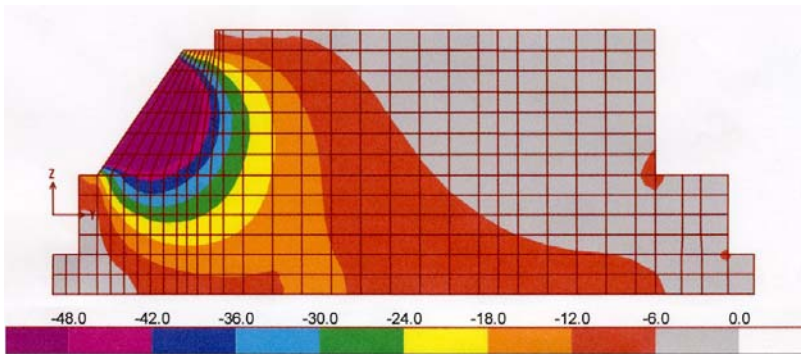
Figure 6. Stress distribution due to arch bearing reactions discrete locations.

In addition, several models representing one corner of the abutment were analyzed. These partial models were used to study the stress distribution in the concrete due to the application of high post-tensioning forces at discrete locations. This information was used to optimize the size and spacing of post-tensioning tendons as well as the thickness of new concrete required to reduce the stresses on the existing concrete to within the limits allowed by the low strength of the existing concrete.
