## Study on Rating the Deterioration of Weathering Steel Bridges

Toshikazu Sawamatsu<sup>1</sup>, Takashi Sato<sup>2</sup>, Mitamura Hiroshi<sup>3</sup> and Hiroaki Nishi<sup>4</sup>

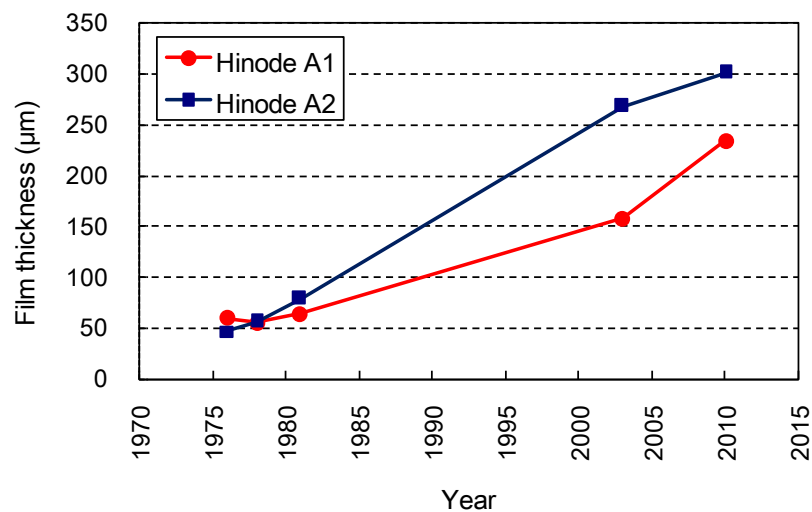
Fig-4 Film thickness over time (Hinode)

Hinode Overbridge is a two-span continuous, double-box-girder bridge whose span lengths are 22.4 m and 31.2 m. When the bridge was completed, survey points were established on the web plates of the main girders of the abutments, shown as A1 and A2 respectively in figures 4 and 5. Their external appearance was rated C in 2010 and 2003. Film thickness over time for the Hinode Overbridge is shown in Figure 4. At both A1 and A2, the film increased in thickness with time. It increased to 234  $\mu\text{m}$  from 158  $\mu\text{m}$  at A1 and to 301  $\mu\text{m}$  from 268  $\mu\text{m}$  at A2 between 2003 and 2010. It is presumed that because the bridge is close to a frontage road and there is little clearance under the girder, various substances containing anti-freezing agents, which hinder the formation of stable rust, have been splashed up by travelling vehicles and have adhered to the bridge. The volume of chemicals applied to prevent ice formation on the road surface has been increasing since the 1980s. The ratings by external appearance of C in 2003 and 2010 are appropriate because no residual protective film was observed (Figure 5) and the films were 300  $\mu\text{m}$  thick. Considering that the film thicknesses increased and are expected to keep increasing as long as the bridge continues to be exposed to the various substances that hinder the formation of stable rust, it is necessary to monitor the bridge over time.

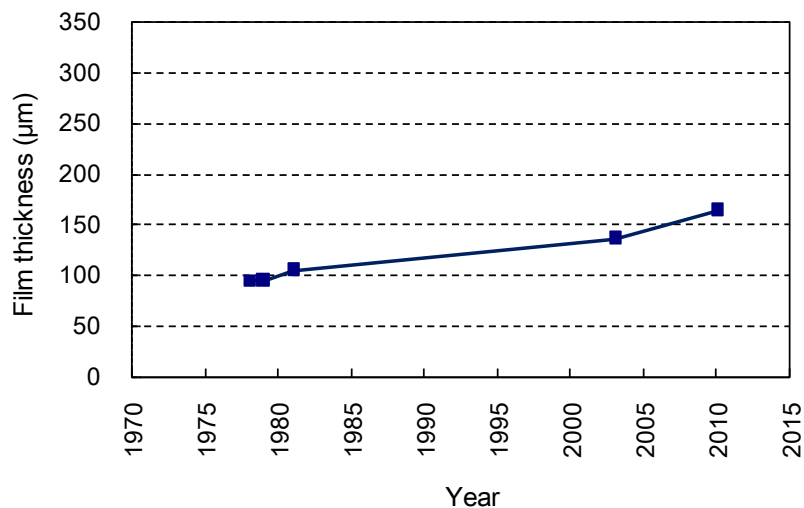
Fig-6 Film thickness over time (Wanishi)

Figure 6 shows the changes in the film thickness over time for Wanishi Overbridge. Since 1978, the film has become thicker only gradually. As compared to the 136  $\mu\text{m}$  measured in 2003, the film thickness surveyed in 2010 evidenced a slight increase to 164  $\mu\text{m}$ . As shown in Figure 7, the external appearance did not change greatly in the same period. Residual protective film was observed and a stable iron oxide film is unlikely to have formed. The external appearance was rated B. Judging from the external appearance and the film thickness at present, the bridge remains at B. The rating of the bridge is likely to shift to C as a stable iron oxide protective film gradually forms. However, because the protective film is not thick enough, it is also possible that the bridge will be down-rated to D or E in the future, due to the effects of snow-melting agents.
