Static Ice and Observed Damage to the Lake Champlain Bridge

Theodore Zoli, PE¹

On December 28th, 2009, the Lake Champlain Bridge between New York and Vermont was explosively demolished given extensive pier damage and the potential for catastrophic failure. Visible pier damage was consistent with ice abrasion and freeze thaw damage at the waterline. Diving inspections indicated large cracks around the entire perimeter of these large unreinforced substructures, even for expansion piers, which suggest that static forces associated with lake ice contributed significantly to observed damage. Lake ice is often considered benign and does not warrant consideration in pier design. Thermal movements of a large intact ice sheet induce sizeable forces on pier elements and contributed strongly to the observed damage. This paper explores design issues associated with static ice for bridges that traverse lakes in cold regions.

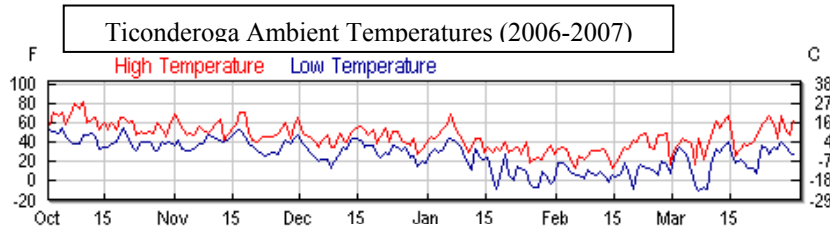
The graph depicts temperatures

for winter months in 2006-2007. The high variability illustrates conditions conducive for ice formation followed by a rapid thaw period in which ice can break apart and ice floes form. For the static ice condition, the formation of a large thick ice sheet between the shore and piers represents the most severe case.

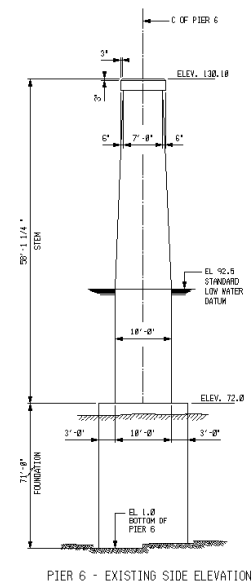
Pier slenderness for all the pier stems of the Lake Champlain Bridge exceeds the slenderness limit of 4 for unreinforced concrete. Even the use of standard batters of 1/2" per ft (~40mm/m) which was consistent with the practice of the time for highway bridges was not strictly followed, with the batter stopping at elevation +28.2m, when a 3m width in the longitudinal direction was achieved and remained constant to the top of caisson (elev. 22m for piers 6 and 7, and 24.4m and 26.8m for piers 5 and 8 respectively). Of particular concern is pier 6, where all longitudinal forces from wind, live load, and seismic are transmitted via fixed bearings for the main span unit.
