INVESTIGATION AND COUNTERMEASURES FOR FATIGUE CRACKS THAT EMERGED ON THE FINGER JOINT OF THE CABLE-STAYED BRIDGE "TSURUMI-TSUBASA BRIDGE"

Abstract

As a result of a follow-up investigation for fatigue crack damages of the finger joint of the Tsurumi-tsubasa Bridge in 2012, where emergency repair had been carried out from 2008 to 2010, 140 cracks were found along the root of the welded part of the face-plates. Due to analysis of tendency for crack causing, it was confirmed that weld detail at the time of fabrication was one of the factors for crack causing.

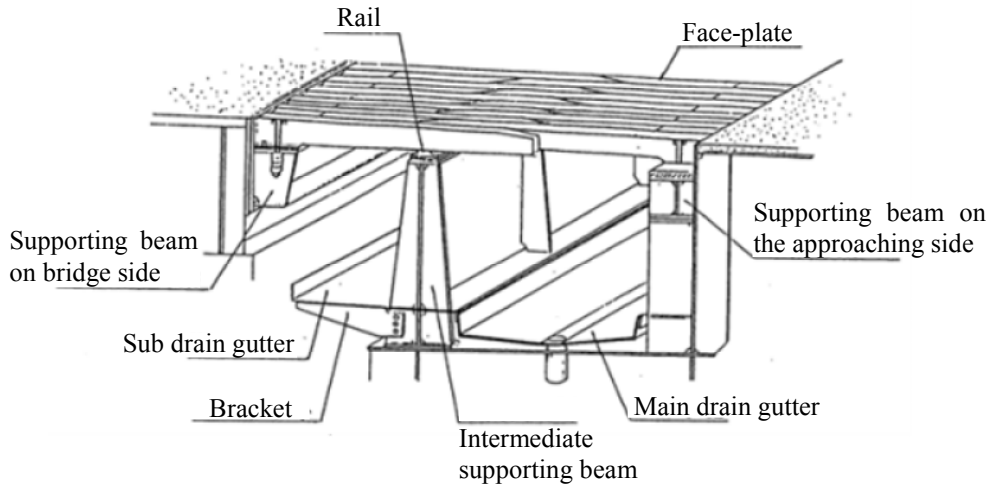
Fig.3 Structure of finger joint

As for the finger joint of the Tsurumi-tsubasa Bridge, joint clearance is 3220mm, the length of design movement is ± 320 mm on a steady basis, and ± 700 mm in times of an earthquake. The length of the finger joint is approx. 2000mm, and as the cantilevered length is long, approx. 1700, it is designed as a simple beam with an intermediate supporting beam. Structure of the finger joint is shown in Fig.3.

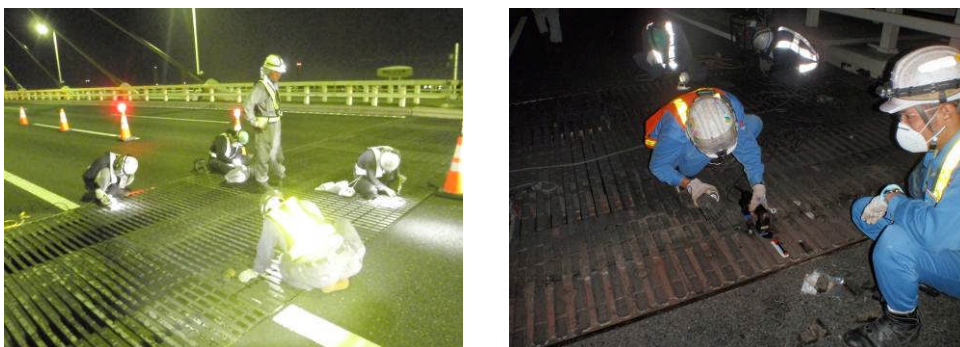
Fig.8 Research status of investigation for the top surface of the face-plate

In this follow-up investigation, magnetic particle examination for crack investigation was applied to the root of the top and bottom surface of the face-plates, where crack damages had been found up until then. Examinations were applied to all parts of welding done to the root of the top surface of the face-plates, except for those having been installed under the road shoulders, as well as the bottom surface of the face-plates where corrosion was remarkably serious and loading positions of the wheels of over-sized vehicles. In total, there were 1500 investigation points, including 1100 points on the top surface and 400 points on the bottom surface. Research status of the investigation is shown in Fig.8 and 9.

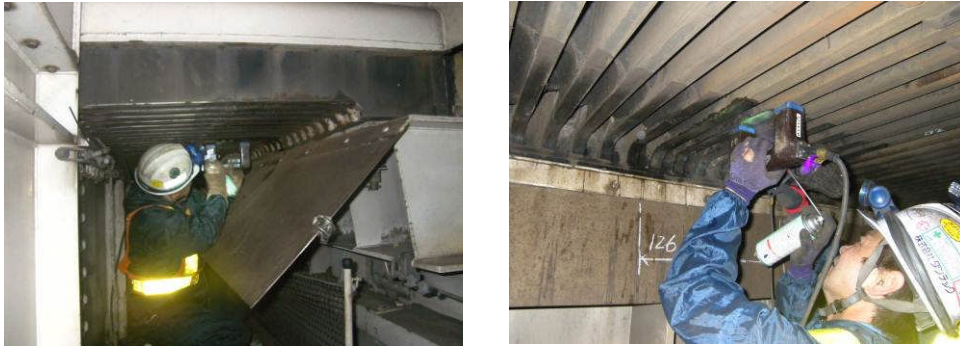
Fig.9 Research status of investigation for the bottom surface of the face-plate

As for the corrosion of the bottom surface, it had not advanced or prevailed compared to the status when the inspection for the corrosion of the bottom surface was carried out two years ago, in 2010. This might be because cover plates on the bottom surface of the face-plates were removed during that inspection, and there was no place for water to gather.
