SOUNDNESS EVALUATION OF PRESTRESSED CONCRETE STRUCTURES BY VIBRATION MEASUREMENT

Hidetaka Homma¹, Yoshitomi Kimura¹, Akiko Hiroe¹

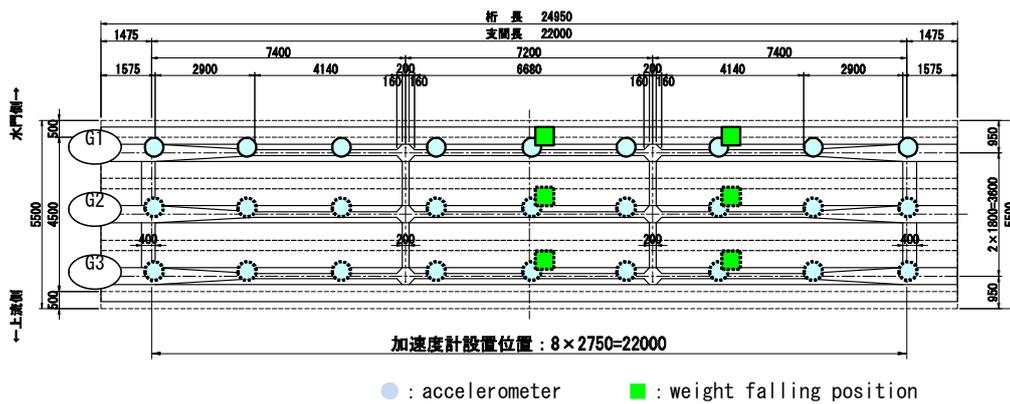
Figure 3. Measurement position and excitation position

As shown in Figure 3, we have measured the vibration by excitation in the weight falling method with nine accelerometers evenly spaced between end crossbeams.

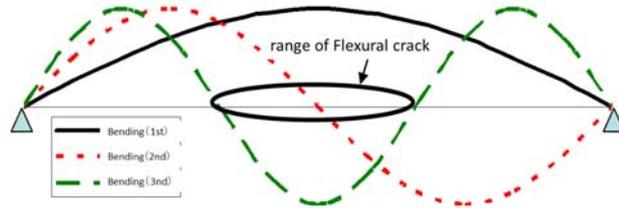
Figure 5. Bending vibration mode of the simple

mechanical damage. Reduction rate of the second bending mode in the 3rd. span was small compared to the first bending mode and the third bending mode. The reason of this difference is that the portion of the maximum amplitude of the 1st and 3rd modes coincides with the severely damaged portion of the girders as shown in figure 5. Moreover, in the 4th. span, reduction of vibration frequency of higher mode was remarkable.

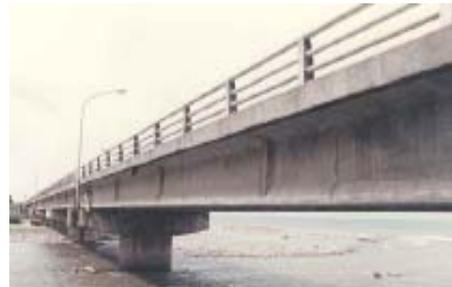
Figure 9. PC bridge

The PC bridge at which the vibration measurement was performed is shown in Figure 9. The structural type is a five-span simple PC T-section girder bridge. It was constructed in 1967 and served more than 40 years. Since the bridge was constructed on the coast of Japan Sea and therefore severely damaged by chloride attack, repairs had been performed more than once as damages of concrete or corrosion of steel were identified. However, because of confirmation of re-deterioration due to corrosion and breakage of PC wires as shown in Figure 10, rebuilding of the bridge was planned, and its service was terminated in September, 2010. Before its demolition, the vibration test was performed by vehicle falling method, weight falling method, and ambient vibration method as shown in Table 2. Excitations were applied at 1/2 and 1/4 points of the span on the G3 girder, and measurements were performed at points that divide the G1 and G5 girders equally into 8 segments.
