Application of NDT method for the concrete girder damaged by chloride

Applicability of NDT on decommissioned PC girder

This is a pedestrian bridge in Ishikawa, Japan (Photo 1). It was a 2-spaned simple post-tensioned PC T -girder bridge placed 90m from sea. The details of this bridge and standard section were shown on Table 1 and Figure 1. In past 2 times detailed inspection, flaking of concrete was found on girders and it was revealed in chipping inspection that two of the eight prestressing tendons were broken. Therefore, this bridge was judged that

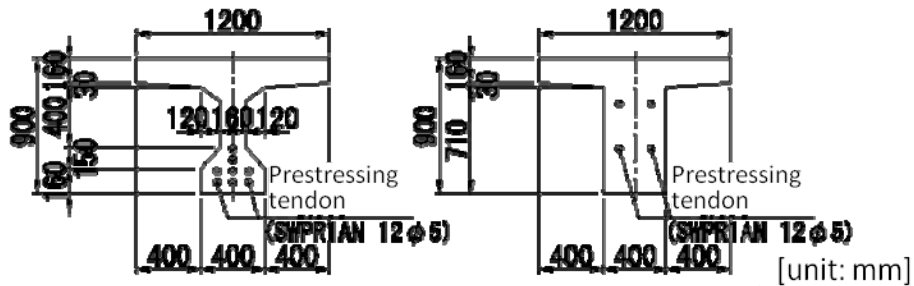
Figure 1 standard section

the replacement was superior than repair from the view point of Life cycle cost. It was replaced after 38 years use.

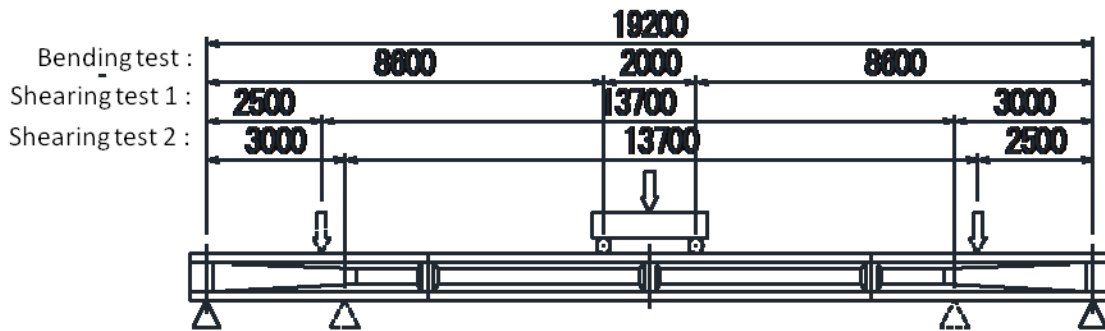
Figure 5 the way of loading test

Loading tests were done 3 times, the bending test at the center of the girder and the shearing test at both girder end, as shown in Figure 5. Hereafter, the shearing test at the origin side is represented as "Shearing test 1", the shearing test at the terminus side is represented as "Shearing test 2" and the bending test is described as "Bending test". The results of the loading tests are shown in Figure 6. In Shearing test 1, the indication of yield of prestressing tendons appeared in the load-displacement curve after shear cracking. The maximum load in Shearing test 1 is 500 kN. Load was removed in order not to influence to Shearing test 2 after 500kN was recorded. Shearing test 2 showed similar behavior to Shearing test 1 before flexural cracking occurred. After that, the displacement became greater than Shearing test 1 and Maximum load 575 kN was recorded.

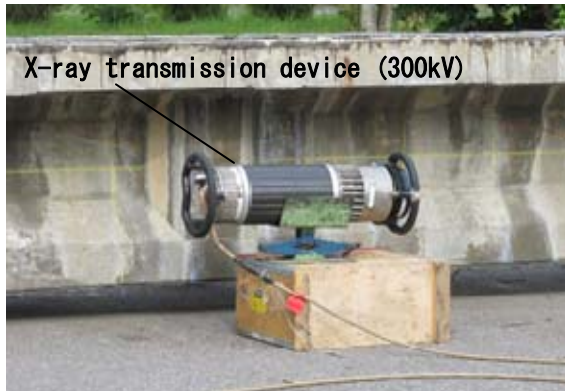
Photo 2 X-ray transmission method

The grout sufficiency was investigated by X-ray. X-ray radiography was also applied the place where the breaks of prestressing tendons were found by a check in service and the corrosion of rebar was shown in visual survey. The applicability of X-ray transmission method was confirmed.

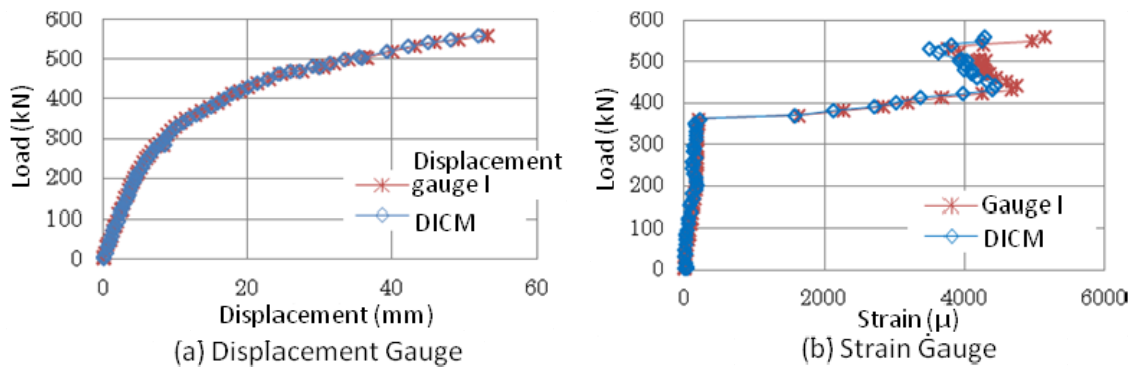
Figure 9 comparison of measurement

The results of the comparison among DICM, contact-type displacement gauge and strain gauge is shown in Figure 9. In Figure 10, the distribution of strain from the full-field optical measurement is drawn and the crack found by visible check is also in the figure with a black line. The full-field optical measurement captured displacement and strain generally. Strain gauge is only able to measure a point but the full-field optical measurement is able to capture strain planarly. Development of this method is expected.

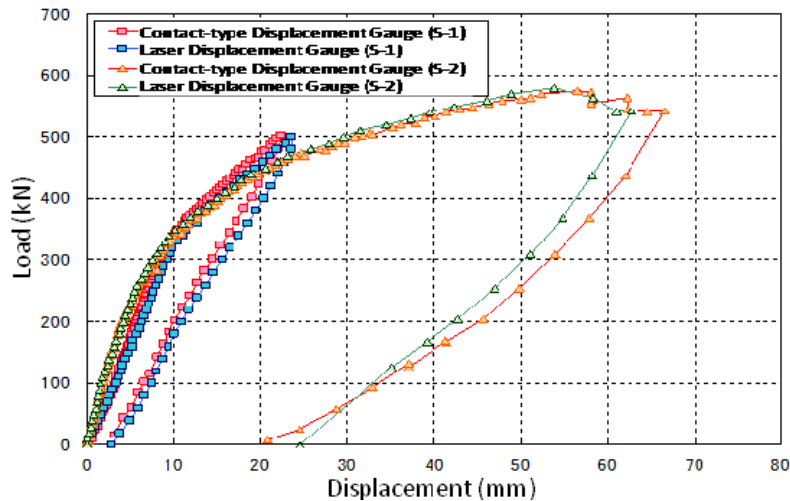
Figure 11 the results of comparison

The comparison of the displacement measurement by laser and contact-type gauge is represented in Figure 11.

In Shearing test 1, the result of laser generally coincides with that of contact-type displacement gauge and displacement motion was captured relatively accurately. In Shearing test 2, the results generally coincides up to the maximum load but 3~4mm difference appeared during the load removing. The cause of this difference is considered that a gap occurred on either gauge because of damage by loading.

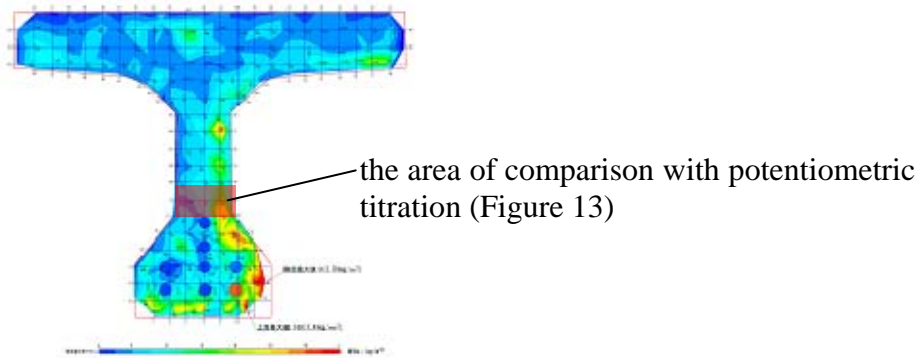
Figure 12 The results of measurement by X-ray fluorescence

The calibration curve which is used to quantify from X-ray intensity to chlorine content was compensated for this investigation. The results of measurement by X-ray fluorescence using the compensated calibration curve is shown in Figure 12.

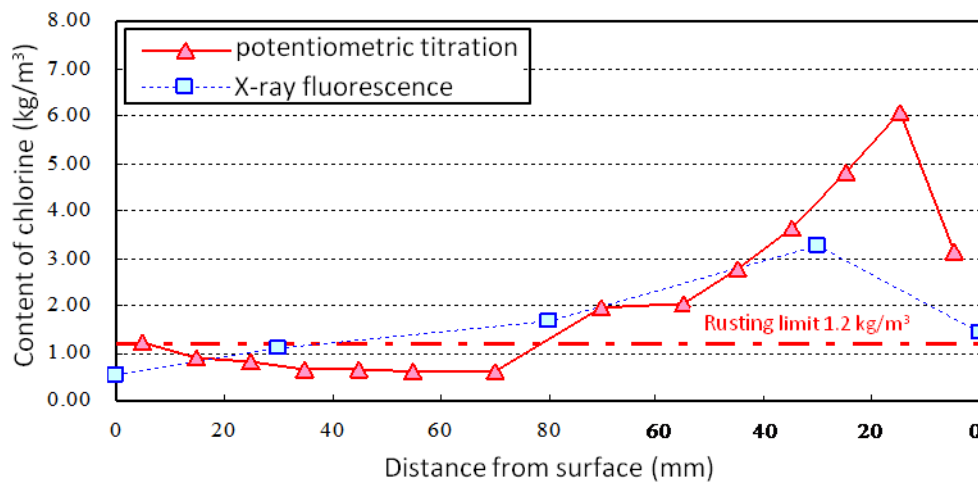
Figure 13 the result of measurement by X-ray fluorescence

Figure 13 represents the comparison between measurement by X-ray fluorescence and potentiometric titration of the core taken from near the place of X-ray fluorescence measurement. Interrelation can be found generally but the result of X-ray fluorescence records higher value than that of potentiometric titration when the chlorine content is low. This reason is conceivable that the X-ray fluorescence measurement was done on the mortar with avoiding aggregate, or the calibration curve was compensated with powder sample including coarse aggregate. The side of the specimen was also measured and the side contain lower chloride ion than the section at no flaking area. X-ray fluorescence measures very thin area, tens of μm from the surface. If the neutralization occurs in the investigation area, the measured value become low because of concentration of chloride ion. It need to notice when X-ray fluorescence device is used in a field.

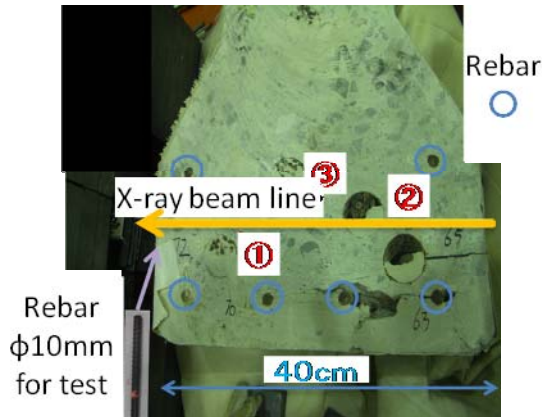
Photo8 the part of PC girder

The portable 3.95 MeV X-band linac X-ray sources consists of X-ray source, radio frequency source, electric power source and water-cooled device. Its weight is less than 200kg in order to be able to mount on the bridge inspection vehicle, and it is lighter than other high-power devices. To confirm the basic performance of the device, The part of the lower flange of the decommissioned PC girder (Photo 8) was x-rayed.

This part is 40 cm thick. It takes approximately 1 hour to x-ray by former X-ray devices but Photo 9 could get an image with only several seconds. This girder adopted a post-tension system and 12 prestressing tendons which are 7mm in diameter are settled in each sheath. In each sheath, only 3 prestressing tendons is able to recognize from Photo 9 because this image is taken from one direction. However this X-ray device can take plural images with different angles in short time. Therefore, CT technology is developed in parallel with the development of device itself for improvement of accuracy.
