# Report on the Western Tottori Prefecture earthquake of October 6, 2000

MATSUO Osamu<sup>1)</sup>

## ABSTRACT

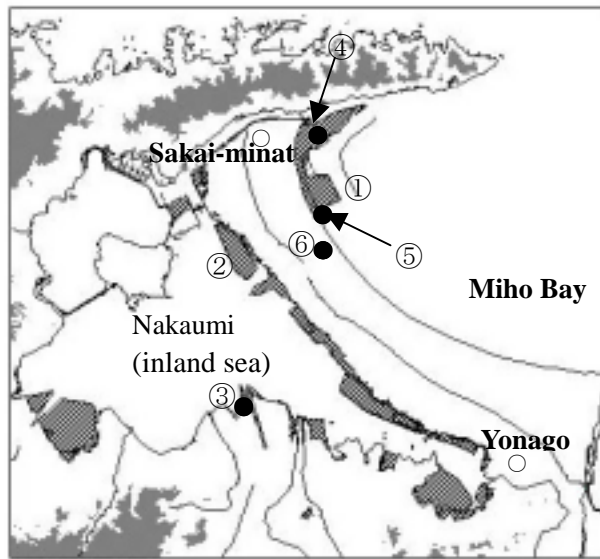
**Figure 4 Reference map showing location of major damaged site (only for coastal area)**

- ① Takenouchi Industry Complex
- ② Yumigahama Reclaimed Land
- ③ Arashima strong motion observation station
- ④ Sakai-minato strong motion observation station
- ⑤ Yumeminato bridge
- ⑥ Sakai-minato sewage Treatment Center

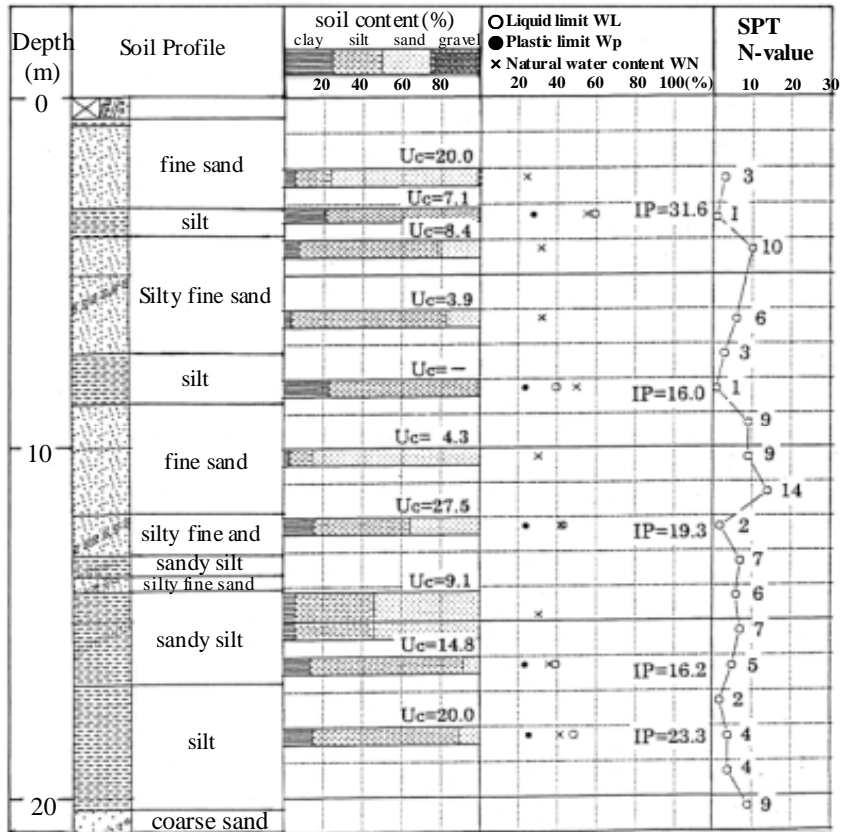
Figure 6 Soil profile data at Takenouchi Industry Complex

**Figure 6** shows a representative boring data

(reclaimed fill = 0~8.5m, natural deposit = 8.5m~)

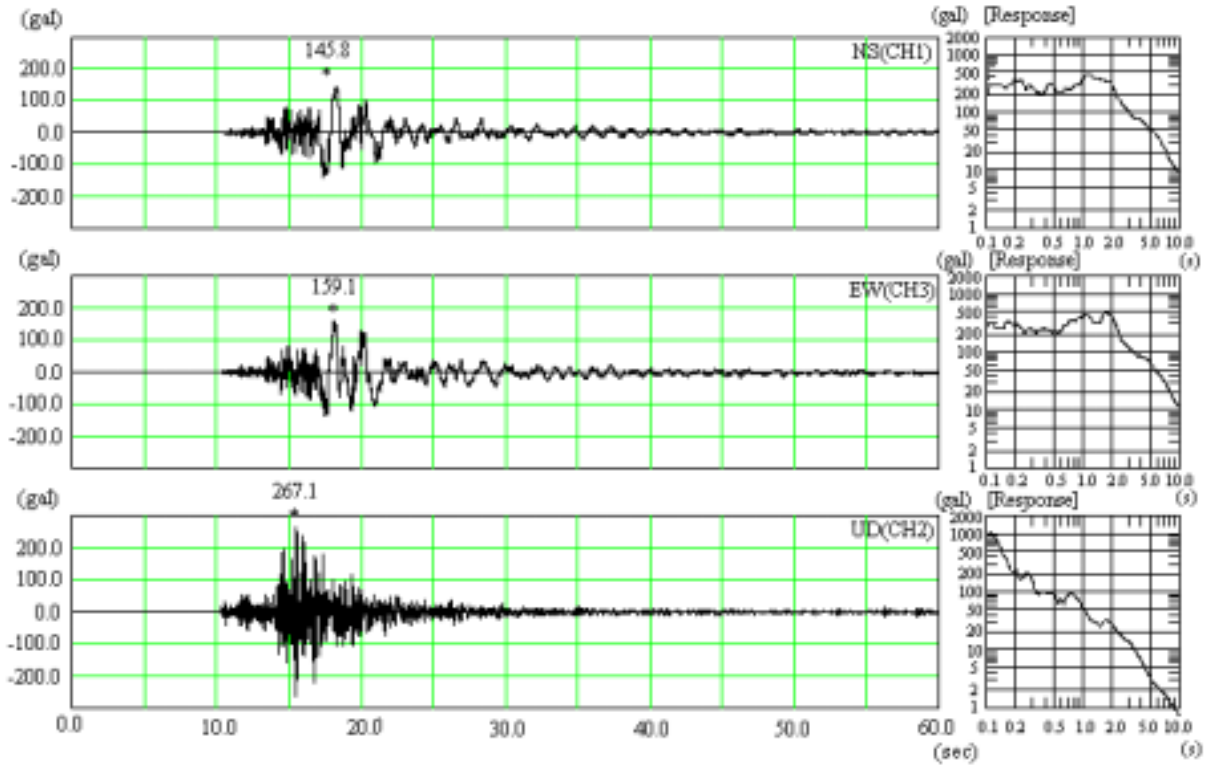
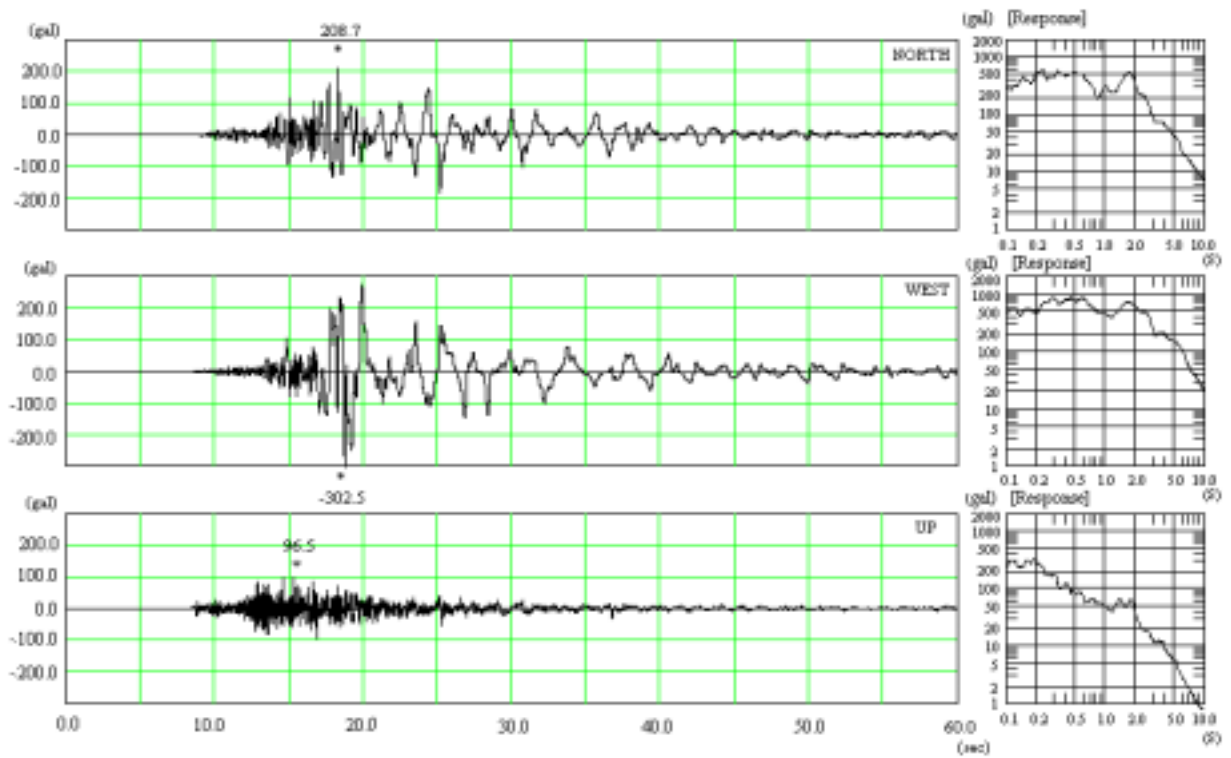
Figure 8 Strong motion records indicating subsoil liquefaction

(a) Recorded at Arashima (Izump Construction Office, 2000)

(b) Recorded at Sakai – minato (PHRI, 2000)

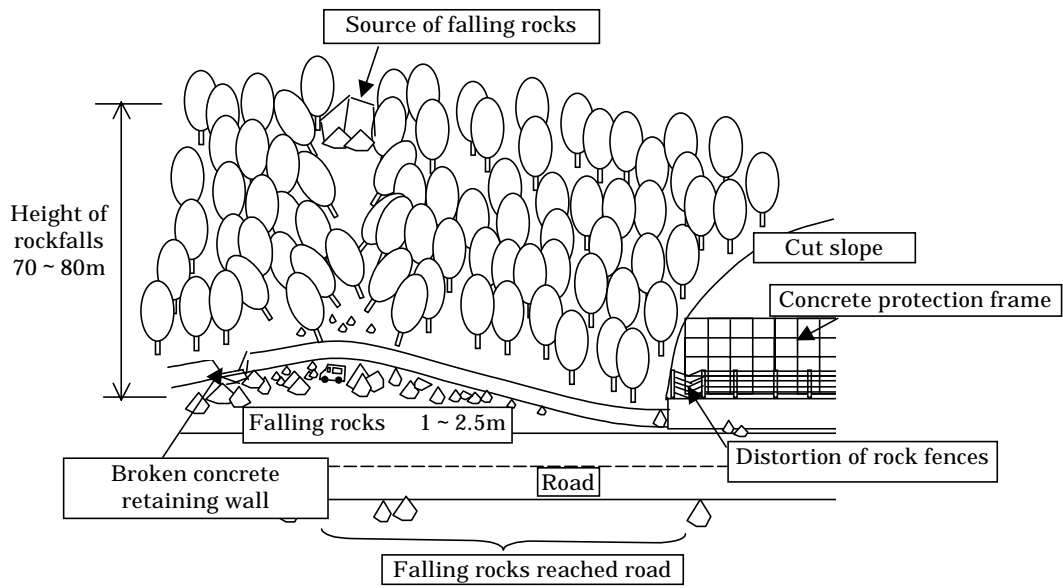
**Figure 9** Rockfalls at Mizoguchi town

Rockfalls also took place at many sites. At several locations, falling rocks hit the roads. As an example, **Figure 9** and **Photo 1** show a rockfall damage that occurred at the Hino-Mizoguchi Line (regional road), Mizoguchi town. A total of about 30 rocks with diameters of approximately one to 3 meters fell down the neighbouring steep slope from a scarp of about 70 meters high. The rocks rolled down the hillslope, crushing down trees. Many of them stopped at the slope toe but some crossed a paved road. Unfortunately, one of the rocks hit a car that parked at the parkway locating at the slope side. The front side of the car was flattened by the large rock, resulting two aged passengers injured but very fortunately survived.

frequently observed. Rockfalls also occurred in many places as already shown in **Figure 9** and **Photo 1**. A number of differential settlements of approaching fill with bridge abutment took place, ranging from a few centimeters to 20 centimeters. They were rapidly repaired by overlaying crushed stone within half a day after the quake.

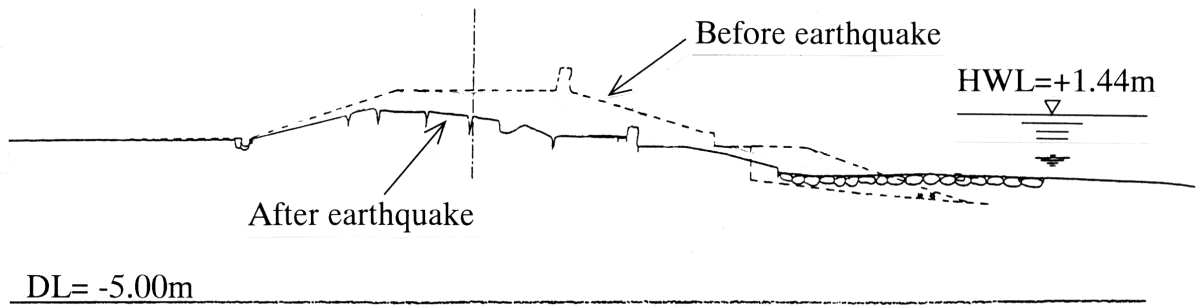
Figure 11 Cross section of the embankment at Yumigahama Reclaimed land

Embankments surrounding the reclamation lands located in Nakaumi Inland Sea slumped and cracked. Most seriously damaged were the embankments surrounding the Yumigahama and the Hikona reclamation lands. These lands were constructed in 1970's to 1980's by filling the dredged waterbed soils in Nakaumi. In Yumigahama, the embankment had a height of 2.0 to 2.5 m from the normal water level, a crest width of 5.5 m, and slope inclination of 1:2.0-3.0. In most part of the length, the embankments were protected with berms from being washed out by wave action. The most seriously damaged was the embankment locating at the south-east corner of the land. As illustrated in **Figure 11** and **Photo 6**, the front side slope spreaded out laterally (the lateral movement of the parapet wall was 2.5 meters) and the crest settled 1.2 m. Sand boiling was observed widely in the area. From the boring data given in Figure 10 and the evidence of sand boiling, it is no doubt that the embankment distortion was induced by the subsoil liquefaction.

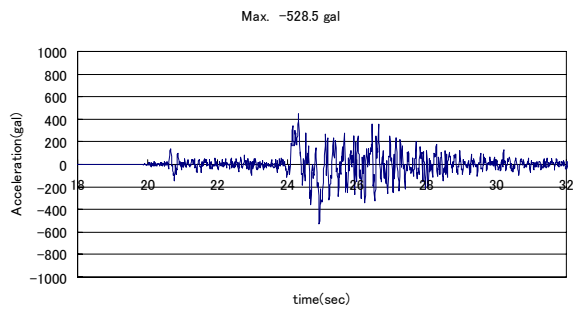
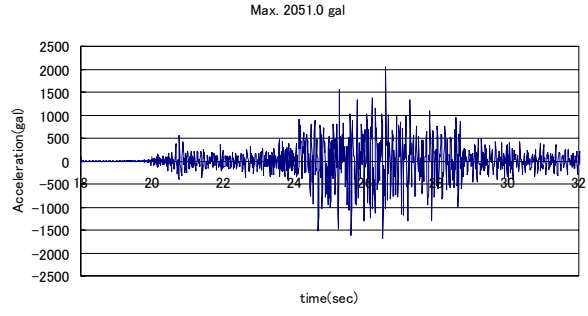
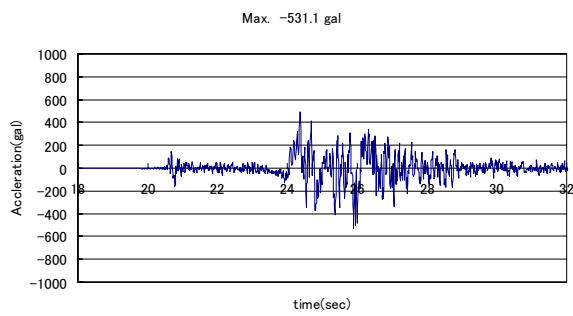
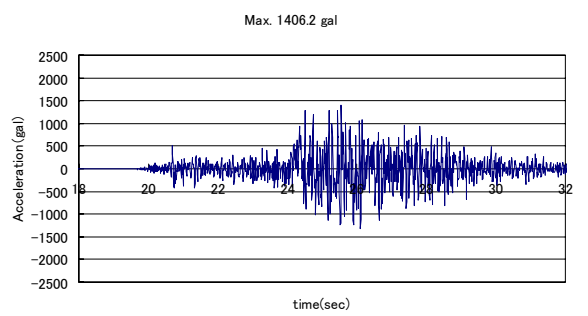
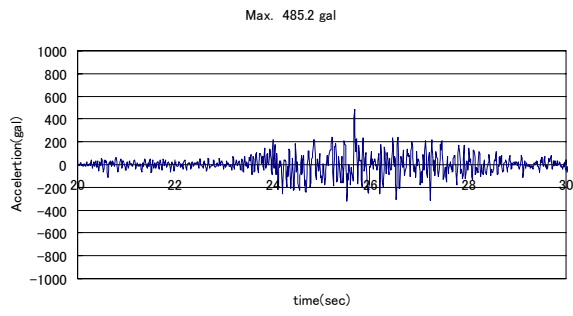
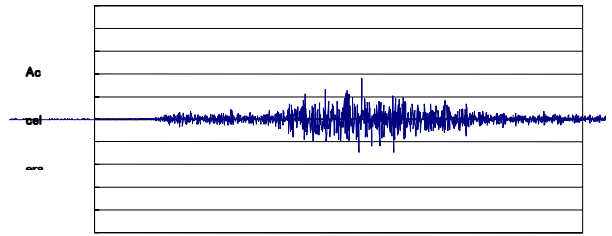
**Figure 12 Strong motion records at the Kasho Dam**

In the epicentral area and the vicinity, there existed a lot of dams. In general, all dams constructed in the legislative rivers performed well with little or no damage. According to the inspection conducted immediately after the quake by the dam maintenance offices, minor damage were reported for two dams located in the epicentral area. At Kasho dam, a gravity-type concrete dam with a height of 46.4 m, peak accelerations of 0.54 g (NS), 0.54 g (EW) and 0.49 g (UD) were recorded in the inspection gallery at the base elevation of the dam and 2.09 g (NS), 1.44 g (EW) and 0.90 g (UD) at the top of the elevator tower, as shown in **Figure 12**. Hair cracks appeared at the wall and base of the auxiliary gate room. At Sugisawa dam, a gravity-type concrete dam with a height of 73.5 m, peak accelerations of 0.16 g (transversal), 0.13 g (longitudinal) and 0.11 g (UD) were recorded in the inspection gallery at the base elevation. Hair cracks were observed in the auxiliary gate room. Unoike
