Bolu Viaduct: Damage Assessment and Retrofit Strategy

Hamid Ghasemi, Ph.D.

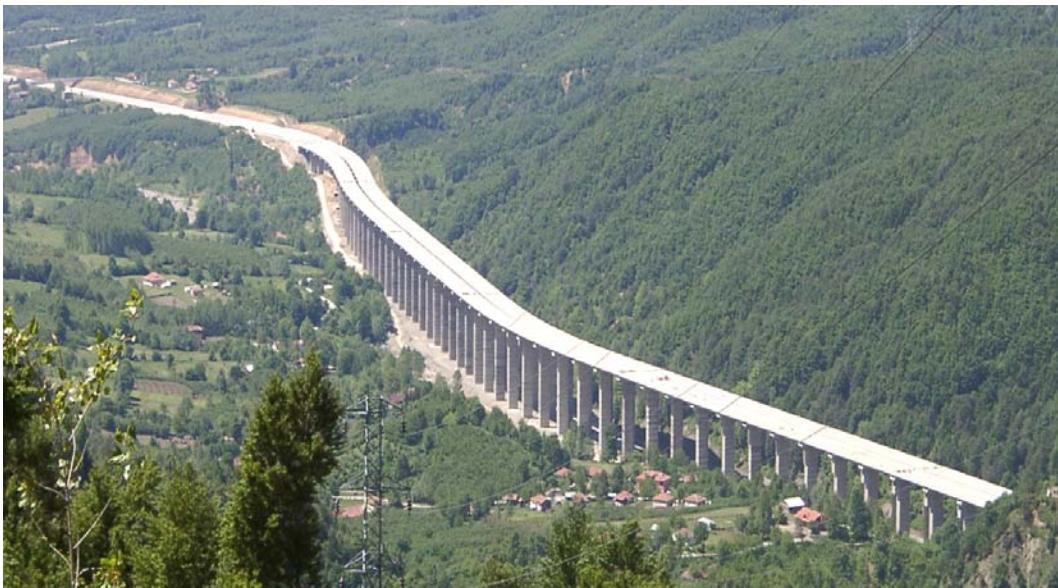
The Bolu Viaduct, with its 59 spans and dual 2.3 km structures, was approximately 95% complete and awaiting installation of expansion joints to complete the project at the time of the earthquake (*Figure 2*). Its 40 m spans are comprised of 7 lines of simply-supported, prestressed concrete box girders (V-girders) seated on pot bearings with stainless steel PTFE-slider interface. The V-girder is a precast, open-box beam with narrow bottom flanges, moderately battered webs, and small top flanges. The cast-in-place (CIP) deck slab is continuous

Figure 2- General view of the Bolu Viaduct

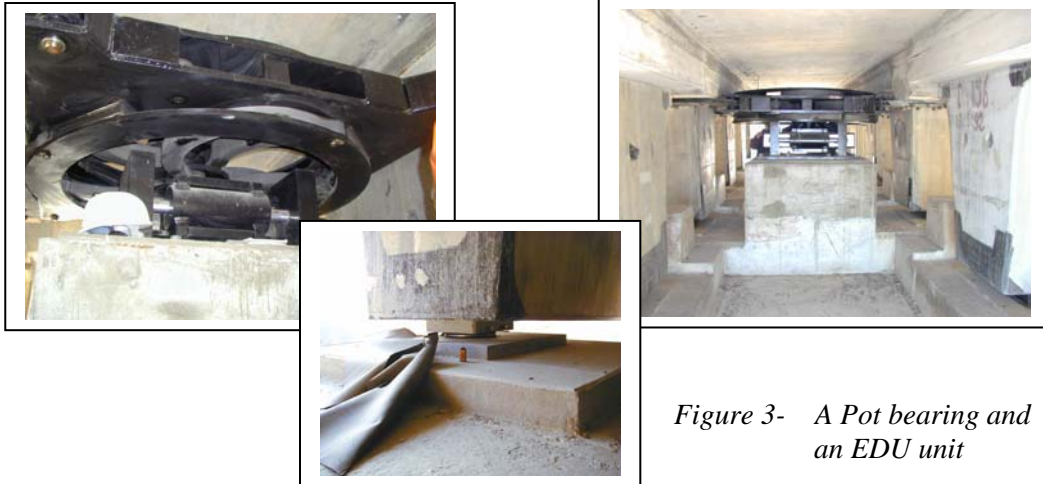
The Viaduct had also incorporated an Energy Dissipation Unit (EDU) system, which is installed on each pier cap to accommodate longitudinal thermal movements and to reduce seismic forces through energy dissipation during a major event. The EDU's consisted of C-shaped energy dissipating steel elements, which are referred to as crescent moons (*Figure 3*). These elements provide hysteretic behavior through yielding of the steel elements. In addition to the crescent moons, a piston and a sliding unit were incorporated into the EDU's at the expansion joints and at the center pier of each 10-span continuous segment. Therefore, seismic resistance relied primarily on the EDU systems and pot bearings. Shear blocks adjacent to beams 3 and 5 restrained transverse displacements as a secondary line of defense in the event of extreme displacements. Longitudinal movements at expansion joints were constrained by cable restrainers to prevent the end girders from falling off their supports (*Figure 4*).

Figure 3- A Pot bearing and an EDU unit

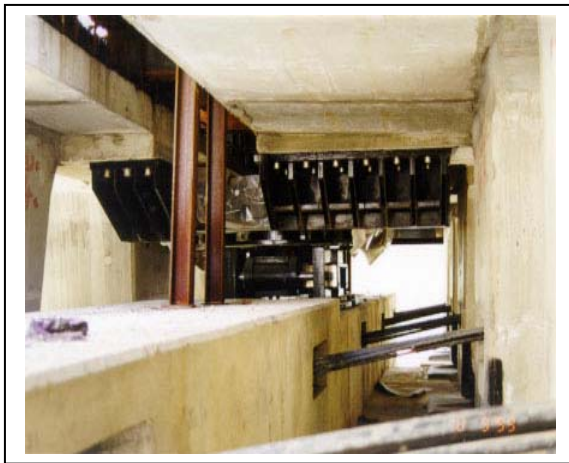
Figure 4- Cable restrainers at the expansion joint
