High Wind Damage in Japan from Typhoon Maemi and Choi-wan on September 2003

Hitomitsu Kikitsu¹, Yasuo Okuda² and Hisashi Okada³

This paper presents outline of field investigations of high wind damage by two typhoons occurred in September 2003. Typhoon Maemi attacked Miyako Island and typhoon Choi-wan did Hachijo Island, respectively. Not only low-rise buildings but also wind turbine generator systems in Miyako island experienced collapses or severe damage, and traditional timber houses in Hachijo island had damage on roofing materials and so on.

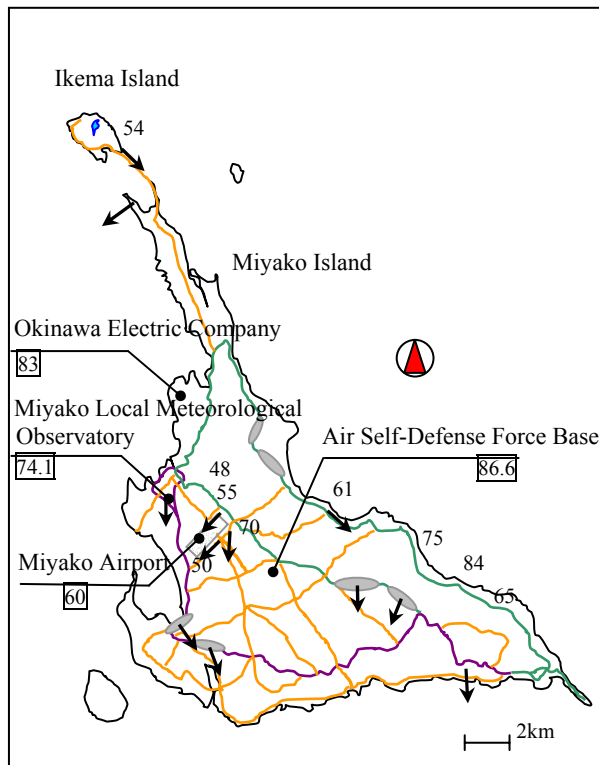
In this section, the outline of buildings and public facilities damaged due to the attack of typhoons is illustrated. Houses in Miyako Island are usually constructed with reinforced concrete, since timber houses experienced wind damage in past three strong typhoons on September 15th, 1959, September 5th, 1966 and September 22nd, 1968. Therefore, in Miyako Island, not so much damage of houses was reported except that of very old timber ones. In spite of relatively small damage of houses, lots of shops and public facilities such as public halls and gymnasiums received significant damage, most of which were peeling-off of roofing materials and breakage of shop windows and walls due to flying debris. There were seven wind turbine generator systems in this island and high wind damage were observed on all of them. Fig.4 shows wind speeds observed at several points and estimated by damaged traffic signs and so on. According to this figure, it is possible that the wind they experienced was thought to be over 80m/s.

Fig.4 Wind Speed Observed at Several Points and Estimated by Damaged Signs, etc in Miyako Island (unit: m/s)

(Framed Values indicate wind speeds observed at each point and non-framed values indicate wind velocities estimated with wind pressure coefficients and material strength of damaged traffic signs. Arrows indicate directions of fallen telegraph poles.)
