Damage to Dams due to Three Large Earthquakes Occurred in 2003, in Japan

ABSTRACT

In 2003, three comparatively large earthquakes occurred in Japan. They were Miyagi-oki earthquake of Japan Meteorological Agency magnitude (Mj) 7.1 on May 26, 2003, Miyagi-hokubu earthquake of Mj 6.4 on July 26, 2003 and Tokachi-oki earthquake of Mj 8.0 on September 26, 2003. The National Institute for Land and Infrastructure Management (NILIM) and the Public Works Research Institute (PWRI) dispatched joint teams to conduct field surveys of the dams. This paper reports the outlines of the damages to the dams due to the earthquakes and the acceleration data observed at dam sites.

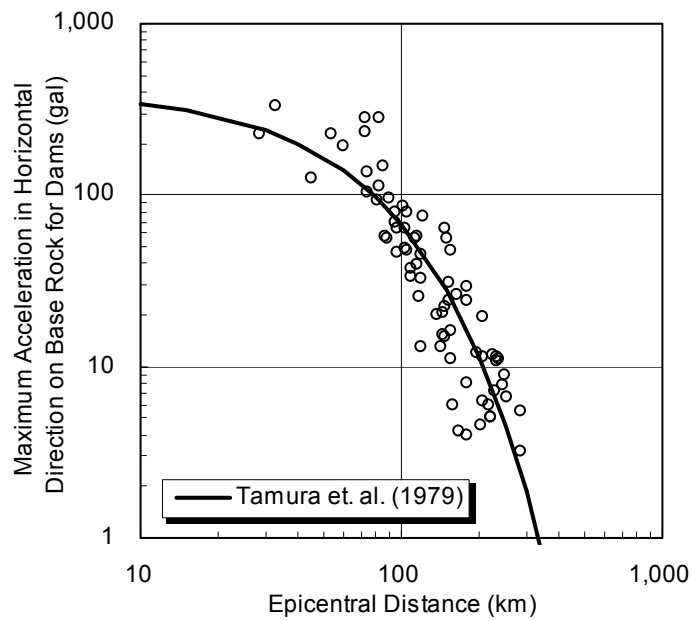
Figure 7 Attenuation of Maximum Acceleration in Dam Foundation Bedrock (Miyagi-oki Earthquake)

During the earthquake, stream-direction horizontal acceleration of 200gal or more in dam foundations was observed at five dams, and 1,000gal or more at dam crests was observed at 4 dams. Figure 7 shows the attenuation of the maximum acceleration (the largest value among two horizontal directions) observed in the dam foundation (bottom inspection galleries of concrete dams or of embankment dams). In the figures, the attenuation equation after Tamura et al. (1979) [6] for maximum acceleration in bedrock under a magnitude 7.1 earthquake that corresponds to the scale of the earthquake was also drawn. This figure shows that the attenuation of the maximum acceleration in the dam site bedrock caused by the earthquake can be generally approximated by the estimation

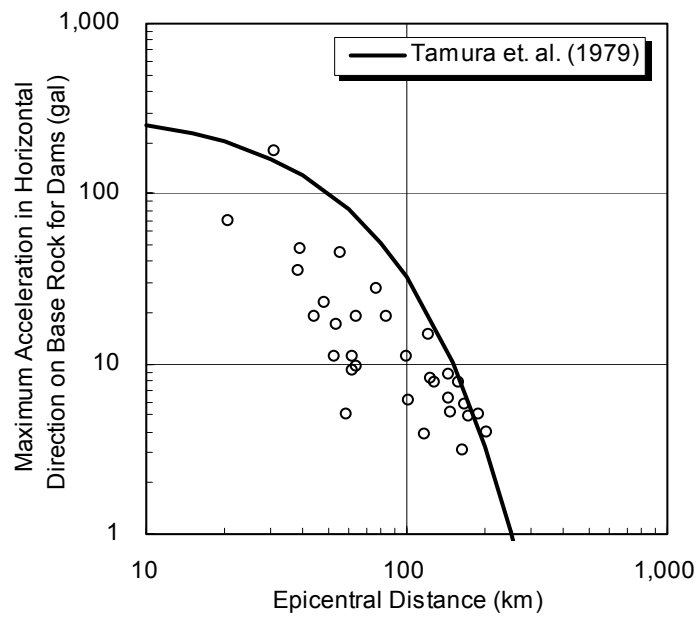
Figure 9 Attenuation of Maximum Acceleration in Dam Foundation Bedrock (Miyagi-hokubu Earthquake)

Figure 9 shows the attenuation of the maximum acceleration (the largest value among two horizontal directions) observed in the dam foundation (bottom inspection galleries of concrete dams and of embankment dams). In the figures, the attenuation equation after Tamura et al. (1979) for maximum acceleration in bedrock under a magnitude 6.4 earthquake that corresponds to the scale of the earthquake was also drawn. This figure shows that the values the maximum accelerations in the dam site bedrock caused by the earthquake are smaller than the values by the estimation equation after Tamura et al.

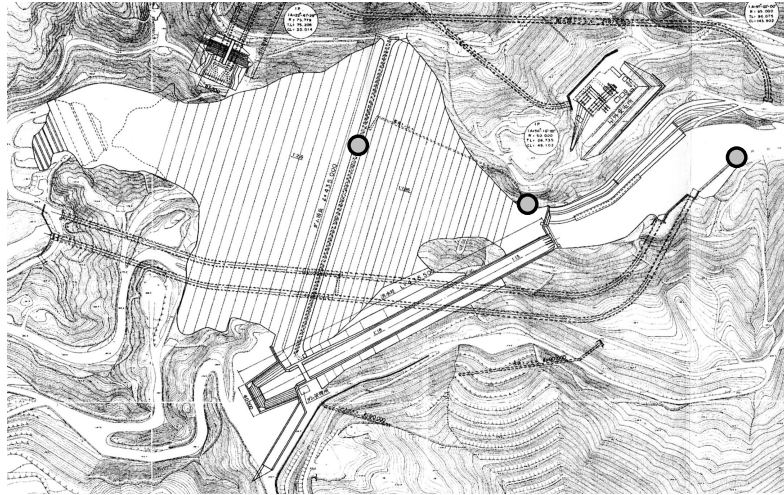
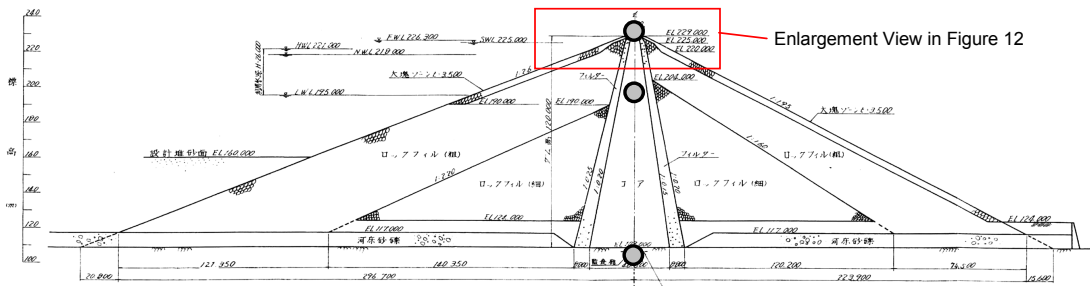
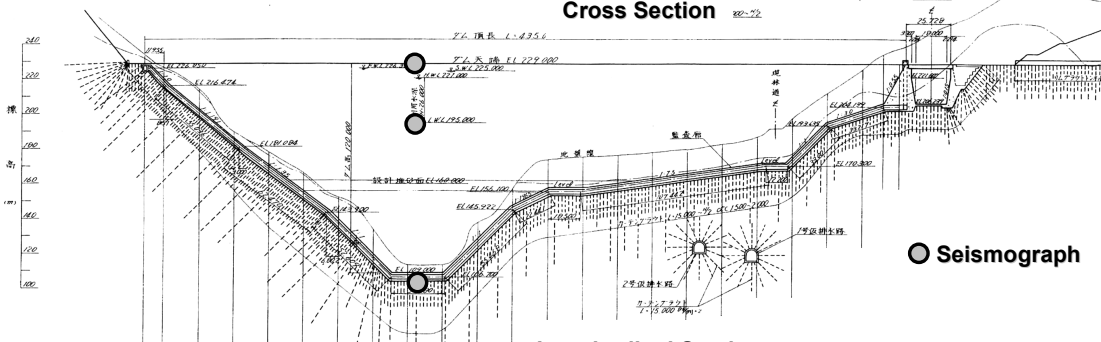
Figure 11 Takami Dam

At the Takami Dam, a rockfill dam with a height of 120m, completed in 1983 (Figure 11), the maximum accelerations of 57.8 gal (dam axis direction) and 325.3 gal (stream direction) were recorded in the dam foundation and at the crest respectively. The epicentral distance was 140.4km.

The special inspection after the earthquake found longitudinal cracks parallel to the dam axis at the crest of the dam (Photograph 5). The cracks were up to 160m long in the dam axis direction. The maximum width of the cracks at the surface was 50mm. Accordingly, on the same day, Hokkaido Prefecture that is the dam manager excavated an exploratory pit at the locations of the widest crack to measure the depth of the crack (Photograph 6 and Figure 12). The results confirmed that the cracks remained within the crest protective layer with a thickness of about 90cm without reaching the core zone. The excavated pit was filled in immediately after the survey, and to prevent seepage by rainfall from expanding the cracks to the core, the entire cracked area was covered with impervious sheets (Photograph 7).

On October 20, a follow-up survey of the crack depth at the crest of the Takami Dam was carried out. The results confirmed that as in the case of the previous survey, none of the cracks extended beyond the protective layer. Accordingly, after October 21, the locations of the cracks inside the protective layer were repaired by backfilling them with identical material (Photograph 8). During the backfilling, density measurements inside the protective layer were done to control compaction so that the density would be the same as that before

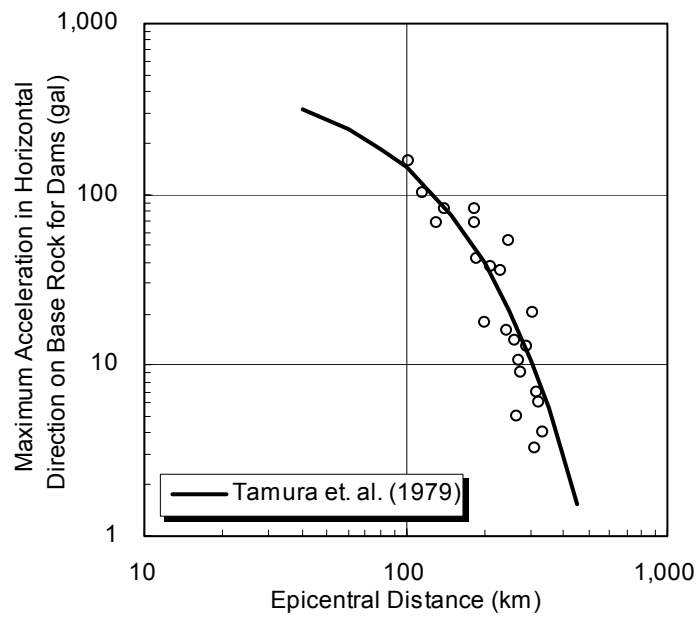
Figure 14 Attenuation of Maximum Acceleration in Dam Foundation Bedrock (Tokachi-oki Earthquake)

Figure 14 shows the attenuation of the maximum acceleration (the largest value among
